**Final
Bevan Avenue Groundwater Supply
Development Project

Year 10 Environmental
Monitoring Report**

City of Abbotsford
32315 South Fraser Way,
Abbotsford, BC
V2T 1W7

Project No.: 1021-024

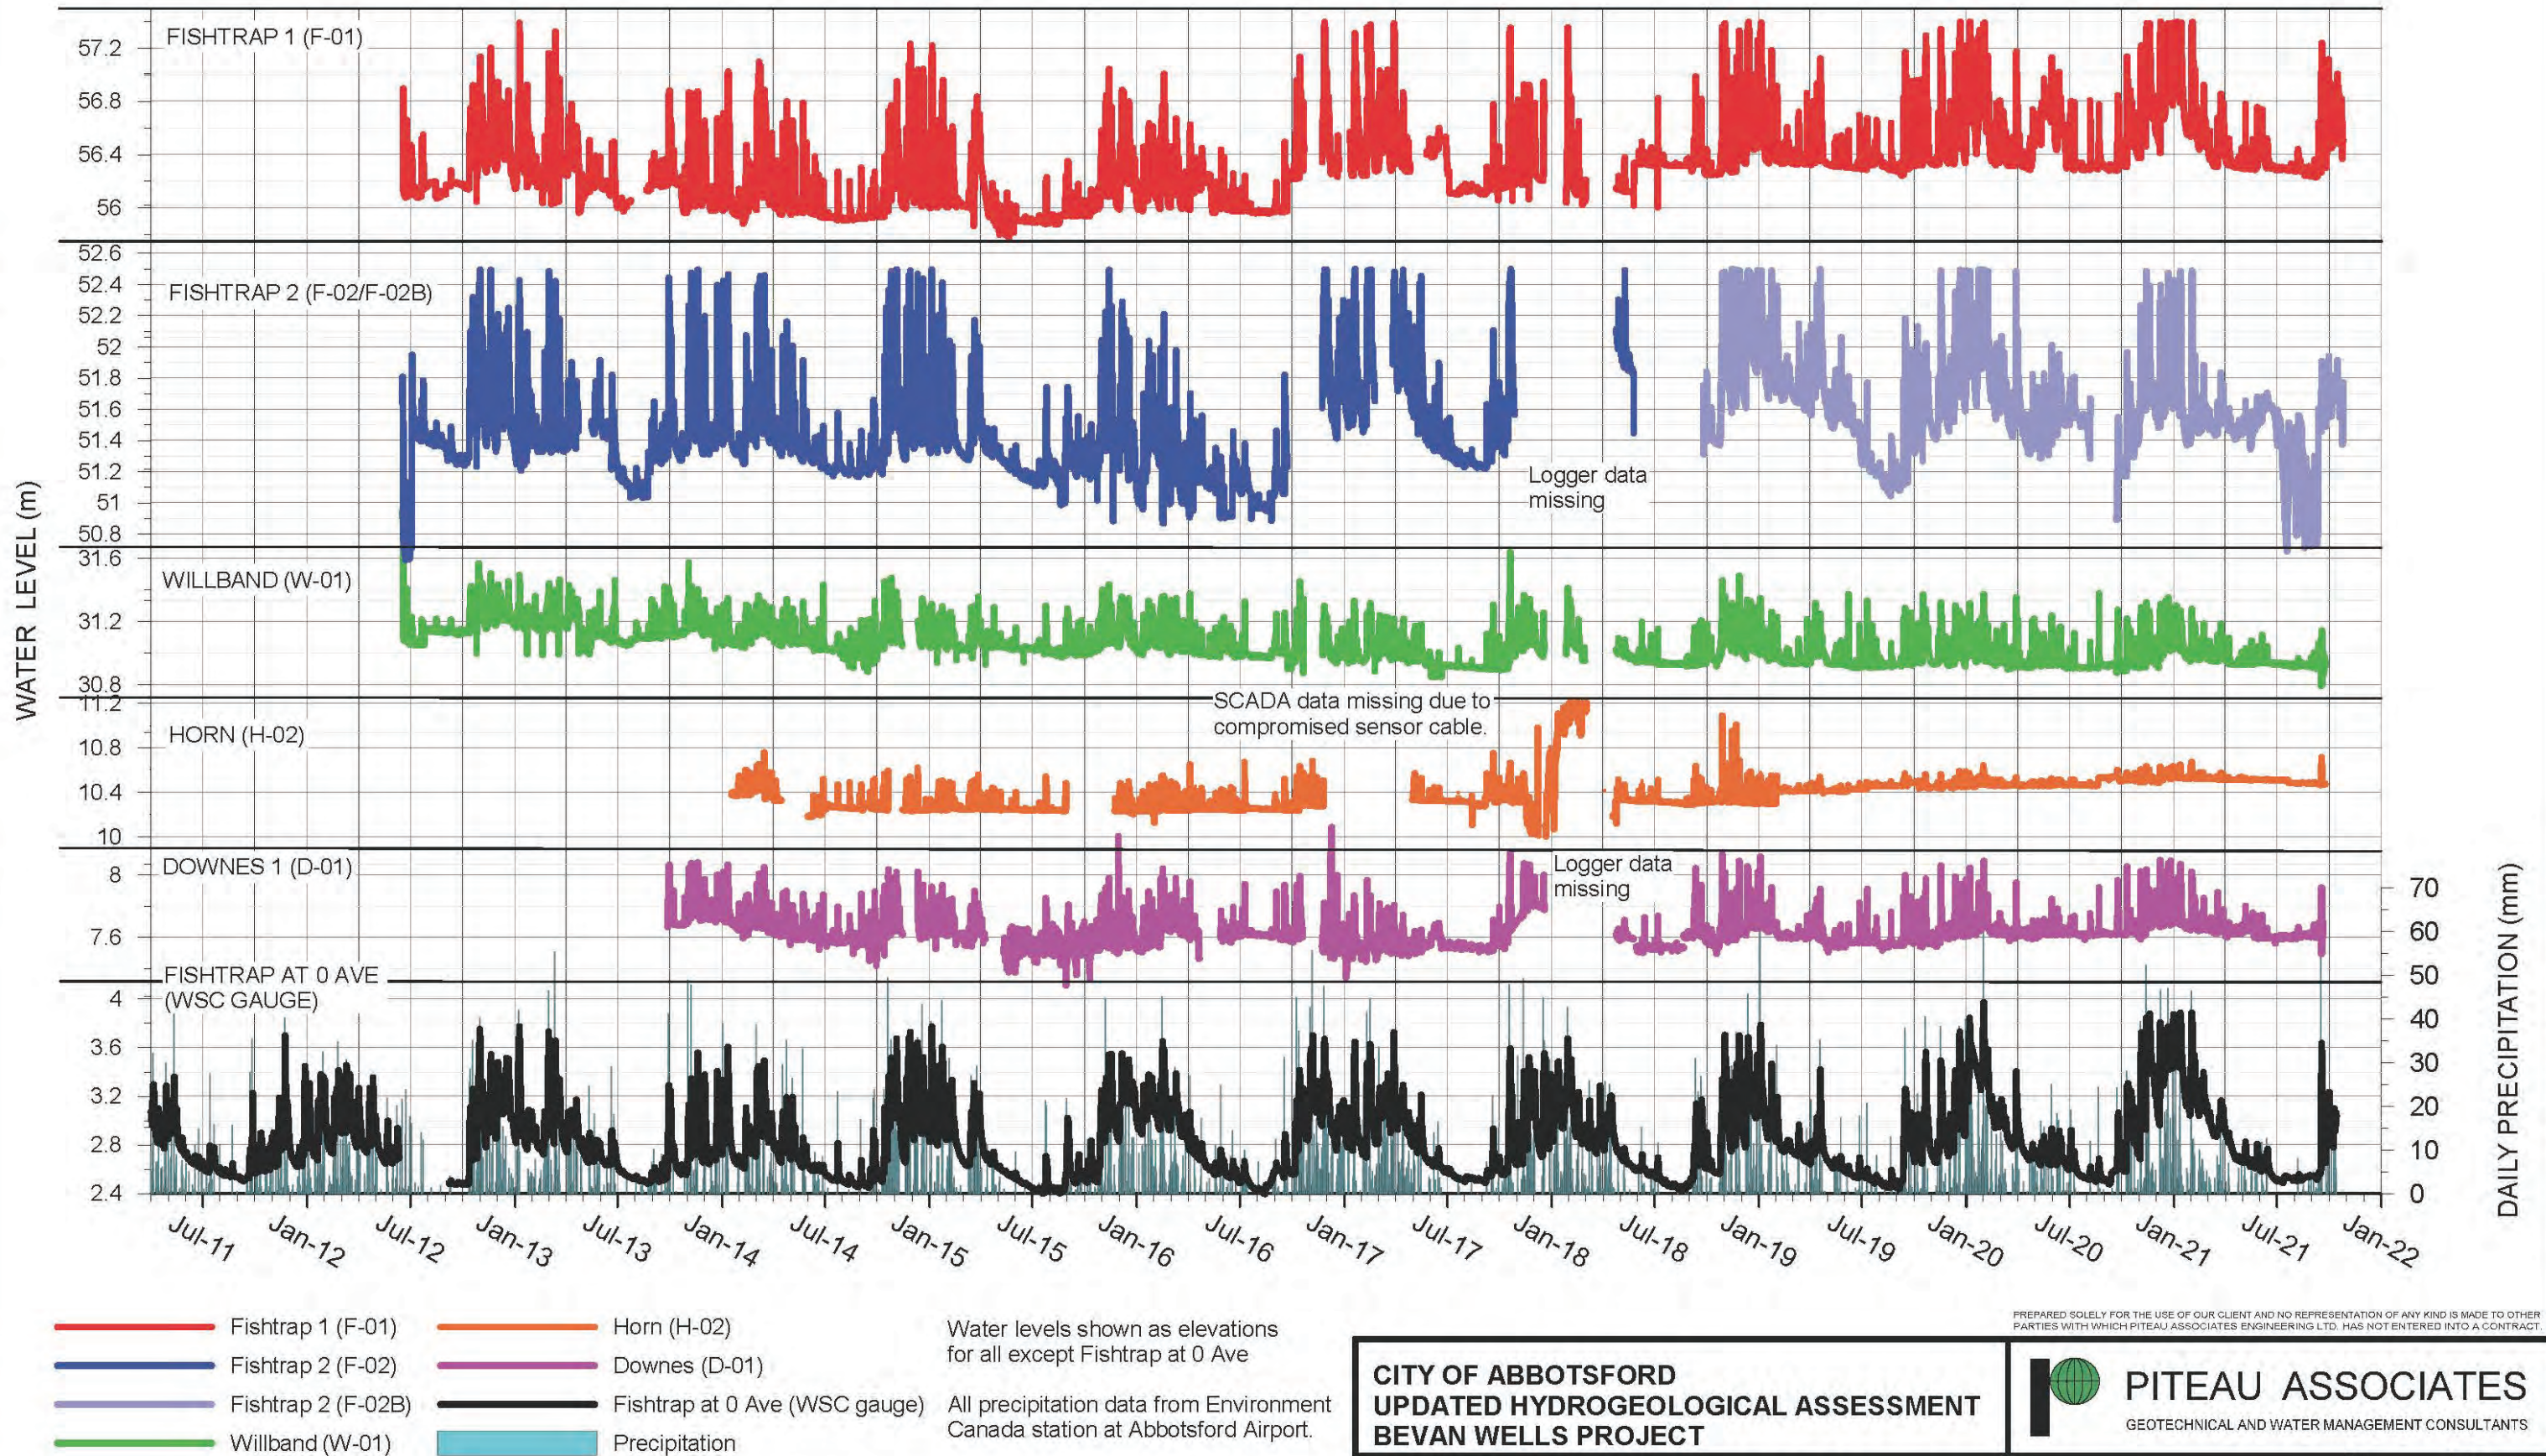
BY:	SC	DATE:	NOV 21
APPROVED:	DJT	FIG:	2-4

The original hydrometric monitoring sites include Horn Creek 2 (H-02), Fishtrap Creek 1 (F-01) Fishtrap Creek 2 (F-02B, which replaces station F-02), Downes Creek D-01), and Willband Creek (W-01). Water levels are graphed in Figure 2-4, and flows are shown in Figure 2-5. Total daily precipitation at the Abbotsford Airport (recorded by Environment Canada) is included on Figure 2-4. The graphs and discussion of stream flow data for these stations extends to October 2020.

**HYDROGRAPHS OF 2011 TO 2021
SURFACE WATER LEVEL TRENDS**

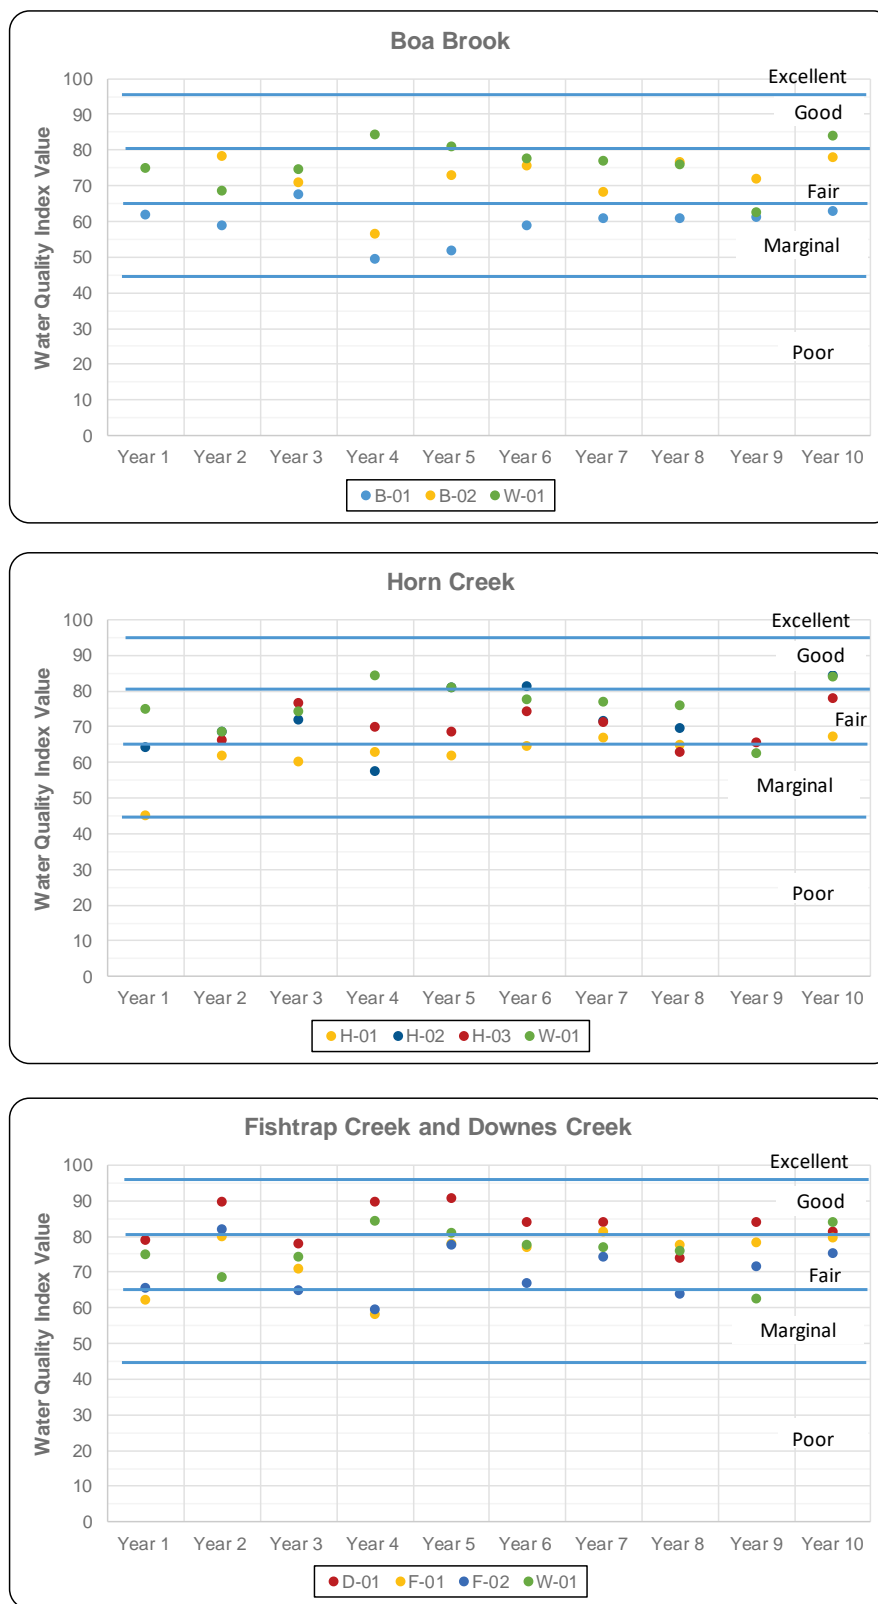
Figure 2-8 Variability in the CCME Water Quality Index, Year 1 to Year 10

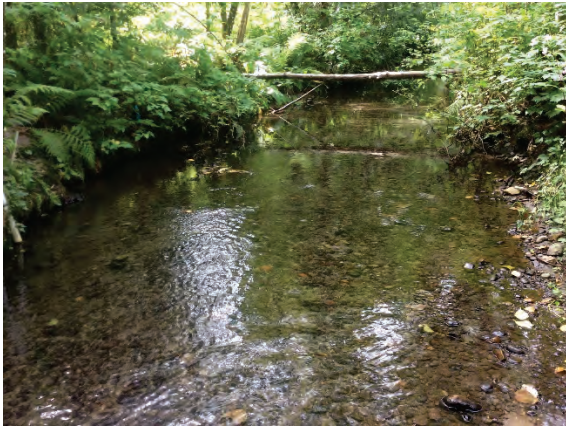
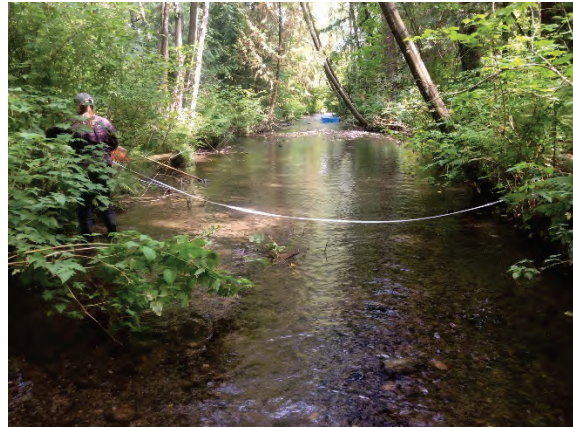
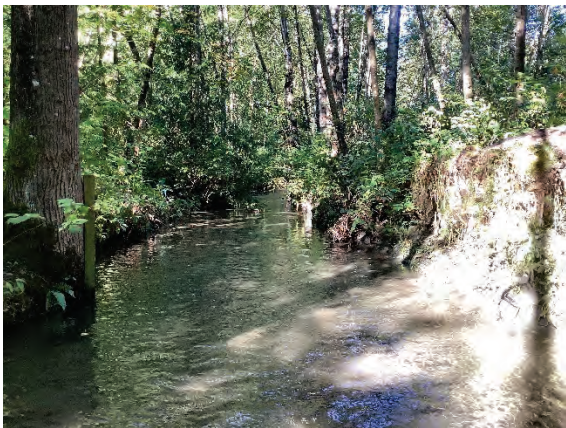
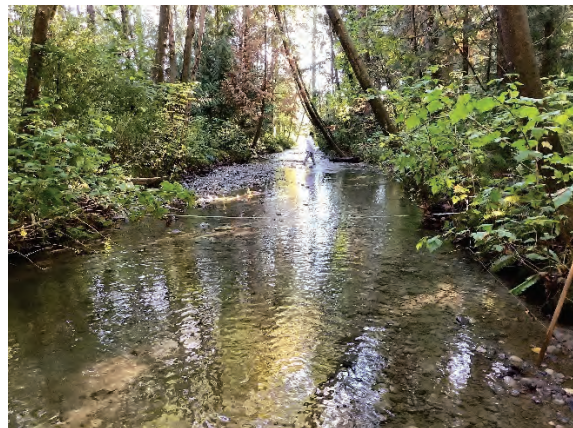
Photographs 3-1 Site 1 (Horn Creek) – August 2020 (top) and September 2020 (bottom)

Channel morphology at Site 1 was straight, unconfined, and had a low gradient (1-2%). The reach has undercut banks, over hanging vegetation and trace amounts of instream vegetation and small woody debris (SWD). One piece of suspended large woody debris (LWD) upstream from Site 1A was swept downstream between the August 2020 and September 2020 monitoring visits. Deep pools were only observed at Site 1A.

In Year 10, The substrate at Site 1A shifted from a fines (40%) and gravel (55%) mix to primarily fines (83%) in September 2020. Minimal cobbles (5%) were present. D95 ranged from 9 cm to 14 cm for both sites. Embeddedness for the reach remained consistent throughout the four monitoring visits averaging 27.5%. Canopy closure was moderate for both sites, averaging 35% and 48% for Site 1A and Site 1B, respectively.

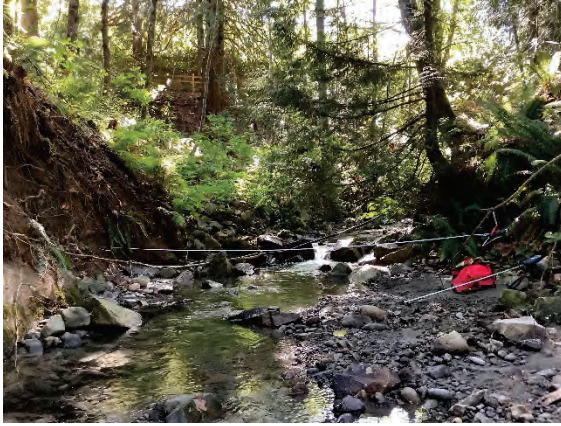
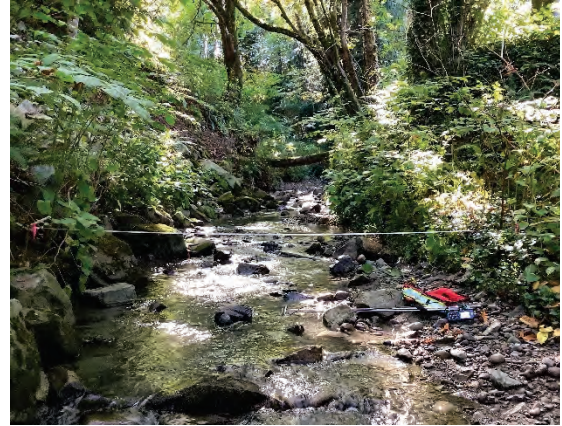
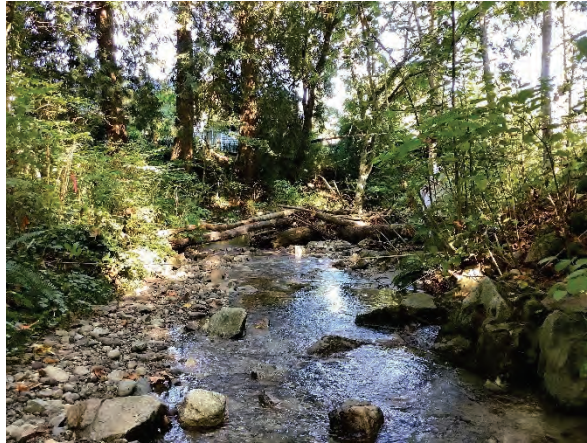
Photographs 3-2

Site 2 had a confined sinuous and straight channel and gradient of 2%. Sand and gravel side bars were observed during all monitoring events. This site had good salmonid rearing habitat values, along with moderate values for overwintering and spawning habitat. During the August 2020 visit, soap suds were observed in the water coming from an unknown upstream source.

Site 2 (Horn Creek) – September 2020

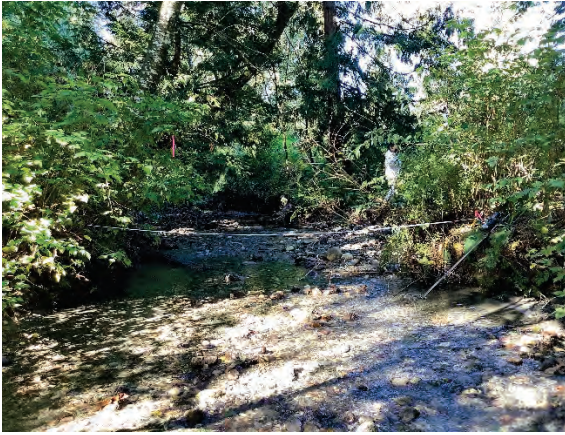
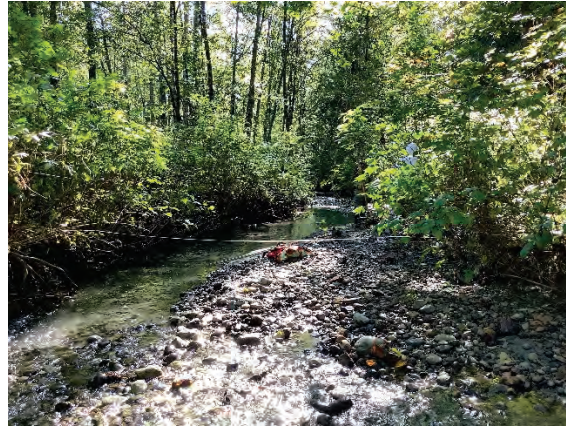
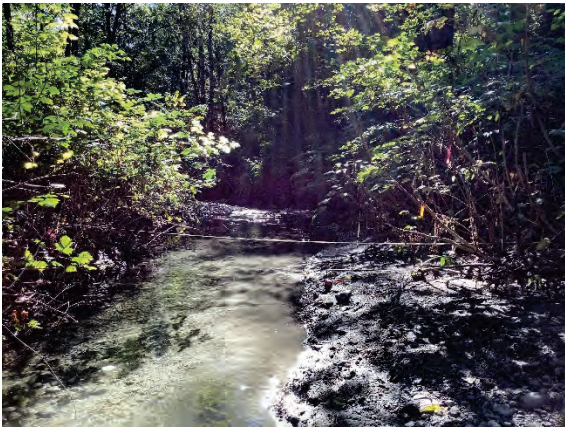
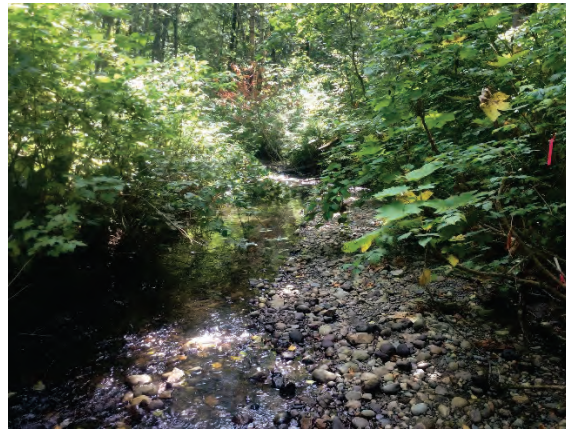
Photographs 3-3

Site 3 (Horn Creek) – September 2020

Channel morphology at Site 3 was straight and frequently confined with a gradient of 1%. Sand and gravel side bars were observed during all monitoring events. Site 3 had good rearing and overwintering habitat values, along with moderate spawning habitat values for salmonids.

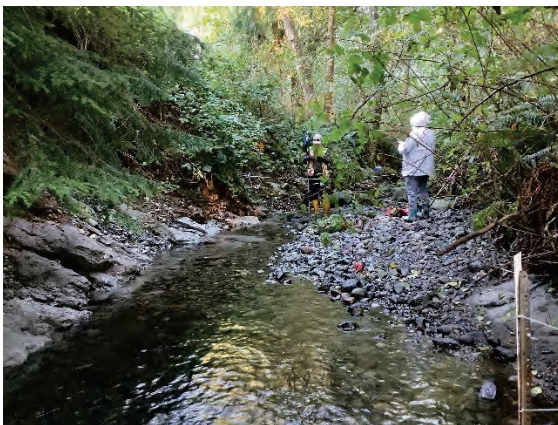
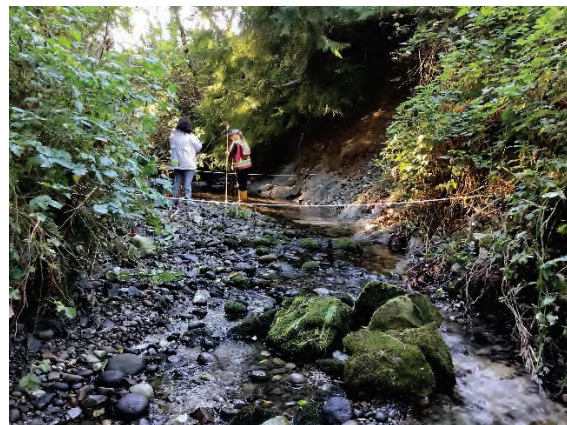
Photographs 3-4 Site 6 (Horn Creek) – September 2020

The channel pattern at Site 6 was straight and sinuous. The site had a confined channel, with an average gradient of 1.5%. Site 6 had good rearing and moderate overwintering habitat values, but limited spawning habitat potential for salmonids. Soap suds from an unknown source were also observed at this site during the August 2020 monitoring site visit.

At the pool mesohabitat site (6A), substrate consisted of gravel (69%), fines (30%), and cobbles (9%). The amount of fines increased slightly after the August 2020 site visit. Monitors noted that sediment deposition had occurred between the August 2020 and September 2020 site visits. Deep pools were the dominant cover type for this site with overhanging vegetation and LWD being the subdominant. Other cover types were present in trace amounts; they included instream vegetation, undercut banks, and SWD. Crown closure was high at 80%, much higher than the riffle site (6B).

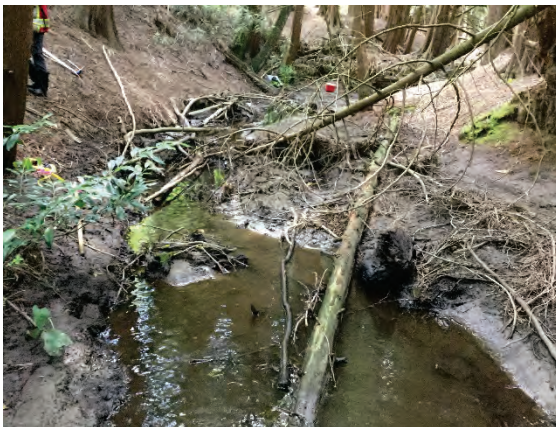
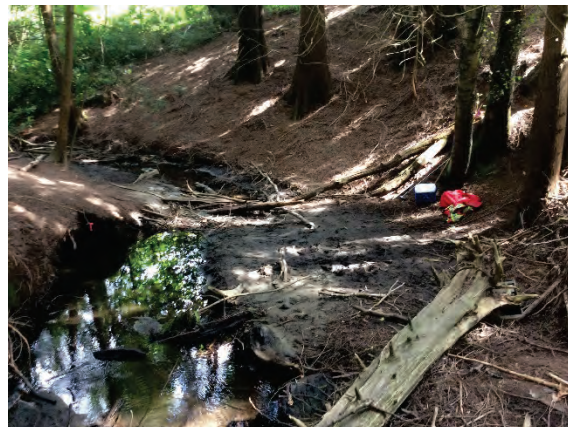
Photographs 3-5 Site 4 (Boa Brook) – August 2020

Site 4 had a confined, sinuous channel with a gradient of 1.5%. Side bars consisting of fines were present during most monitoring visits. Crown closure was high, ranging between 75-90%. The substrate at both Site 4 mesohabitat sites was entirely fines. Cover at the run mesohabitat (4A) site was dominated by LWD and SWD with some trace amount of overhanging vegetation. Dominant cover at the pool mesohabitat (4B) was undercut banks with subdominant deep pool habitat. Trace amounts of small and large woody debris were also present. Overall fish habitat quality at Site 4 was poor due to the location in the upper headwaters of Boa Brook, along with the lack of spawning habitat, overwintering habitat, and limited cover for salmonids.

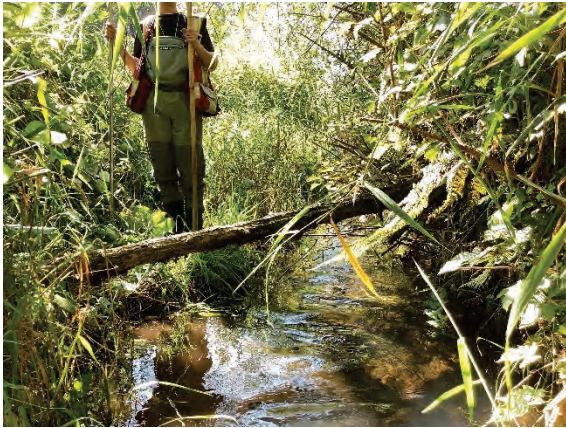
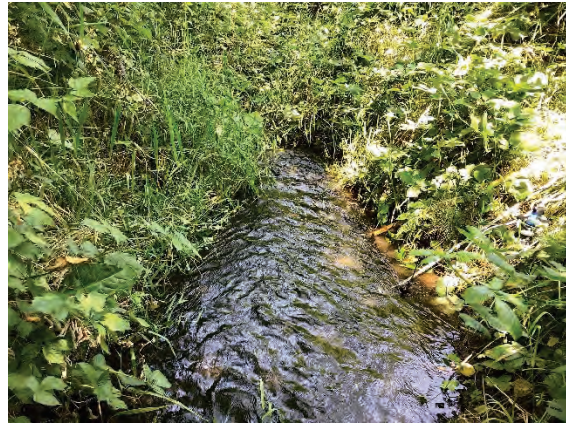
Photographs 3-7

On average, substrate at the D-02 riffle site consisted of gravel (70%) and fines (30%). An increase in the fines component was noted in October 2020. The dominant cover type at the riffle was overhanging vegetation with subdominant instream vegetation. Crown closure was high, averaging at 90%. D95 equated to 5 cm with embeddedness averaging at 14%. The pool mesohabitat substrate was 100% fines. Cover types at the pool site were similar to those at the riffle site with trace amounts of undercut banks and SWD. Crown closure was less than at the riffle site ranging from 15-30%.

D-02 (Downes Creek) – August 2020

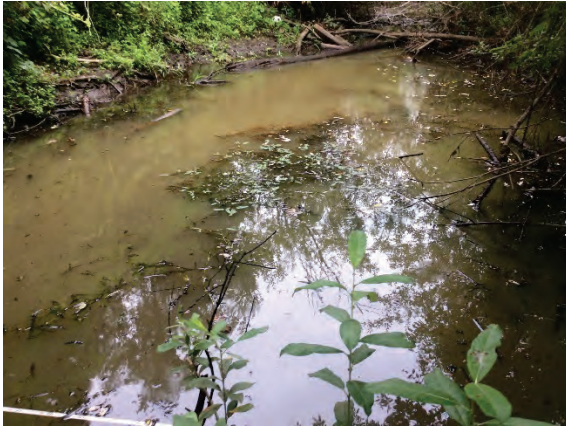
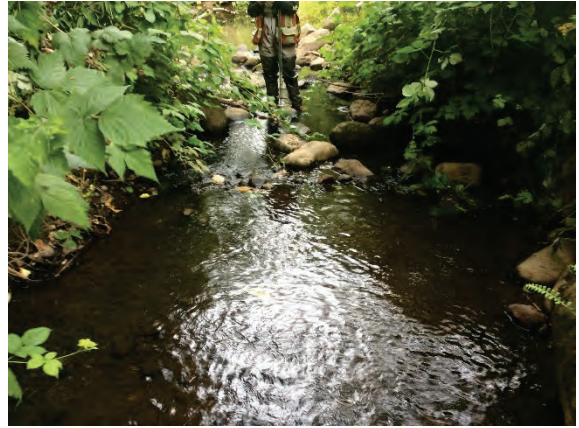
The pool site substrate was entirely fines. The dominant cover type was deep pool with overhanging/instream vegetation and SWD as the subdominant types. Trace amounts of undercut banks and LWD were also present. Canopy closure was estimated to be 30%.

Photographs 3-10 F-01 (Fishtrap Creek) – July 2020

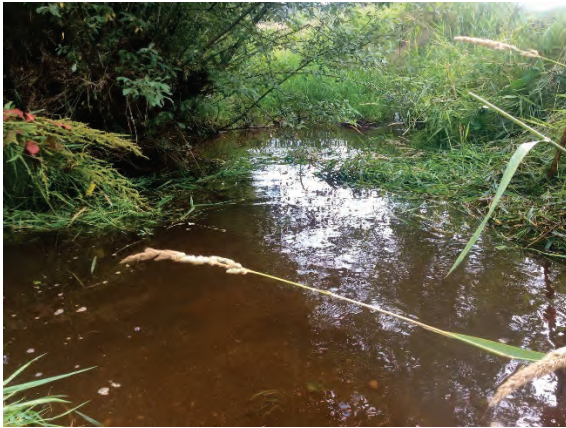
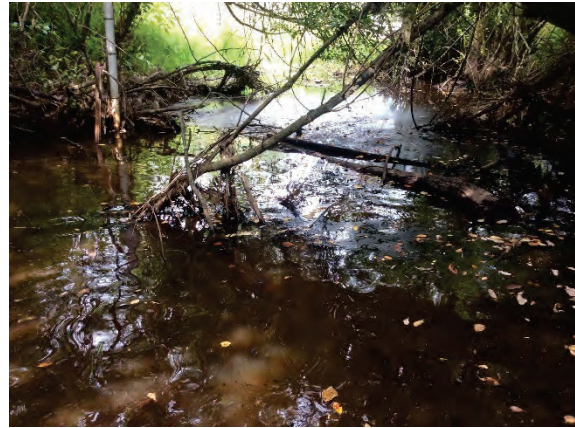
The pool mesohabitat was dominated by fines (57%) with some gravel (25%) and cobble (18%). A trend of increasing gravel and decreasing fines was noted through the monitoring season. Average D95 was 8.75 cm with an average embeddedness of 15%. Cover for fish consisted of deep pool (dominant), with subdominant overhanging and instream vegetation, and undercut banks. Trace amounts of SWD and LWD were also present. There was 0% crown closure at the pool mesohabitat site.

Photographs 3-11 F-02 (Fishtrap Creek) – July 2020

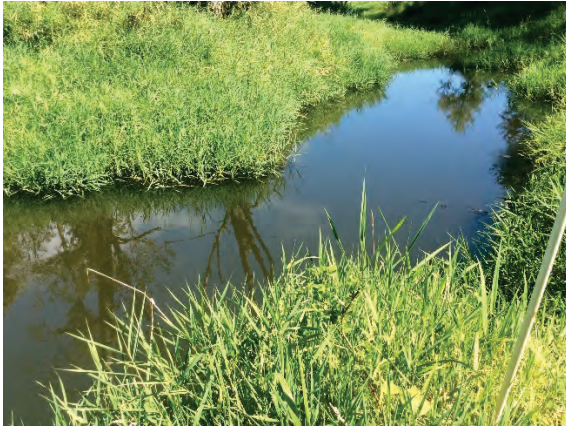
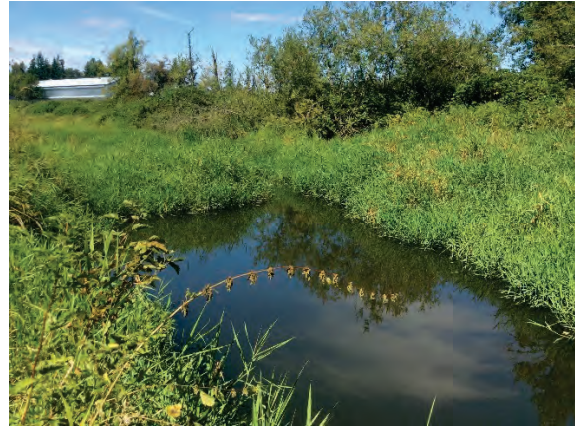
F-03 lies within an agricultural area and is characterized as a low gradient ($<1\%$), frequently confined, sinuous channel. Substrate was dominated by fines (75%), followed by gravel (20%), and cobble (5%). No canopy cover was present at the site. Cover was primarily deep pool with trace levels of undercut banks, overhanging vegetation and instream vegetation. Water depth and clarity limited the visual assessment of substrate composition; therefore, estimates were made by probing channel bottom with a wading staff where possible.

Photographs 3-12 F-03 (Fishtrap Creek) – August 2020

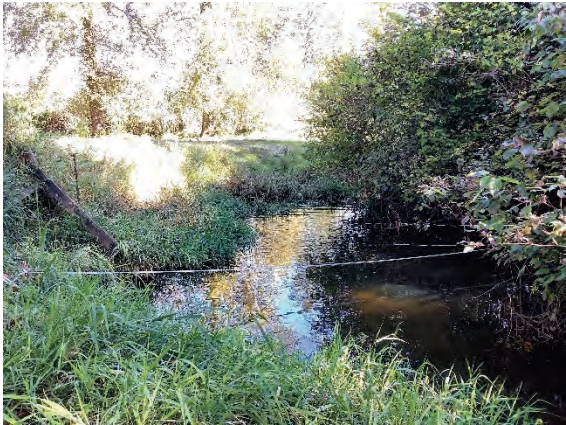
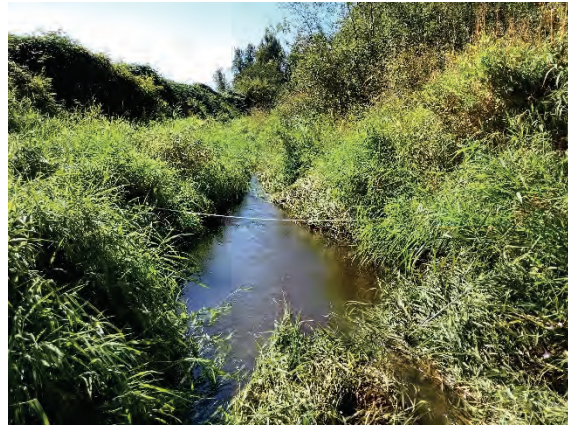
Water depth and clarity limited the visual assessment of substrate composition at the pool mesohabitat; therefore, estimates were made by probing across the channel. Substrate for the pool mesohabitat is approximately 90% fines, 6% gravel and 4% cobble on average. Cover was primarily deep pools with undercut banks and overhanging and instream vegetation as the subdominant cover. Trace amounts of SWD were present.

Photographs 3-13 F-04 (Fishtrap Creek) – July 2019
