CITY OF ABBOTSFORD
UPDATED HYDROGEOLOGICAL ASSESSMENT
BEVAN WELLS PROJECT

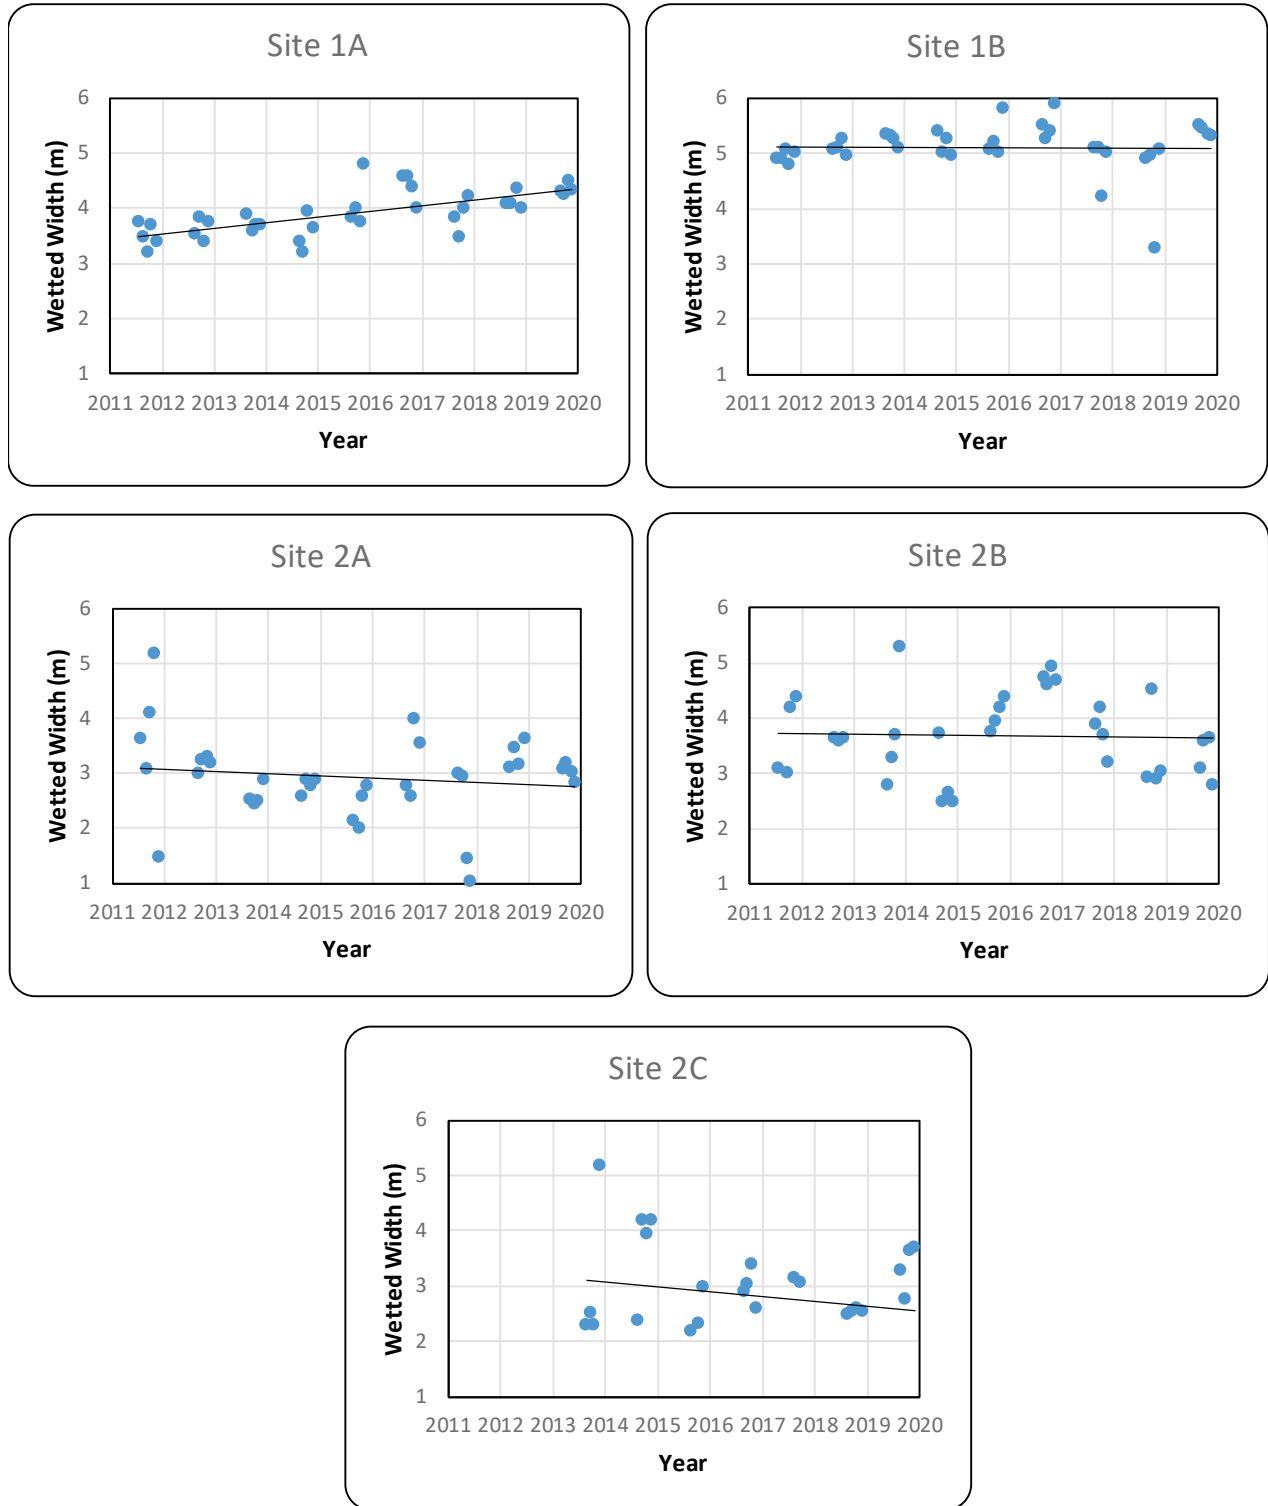
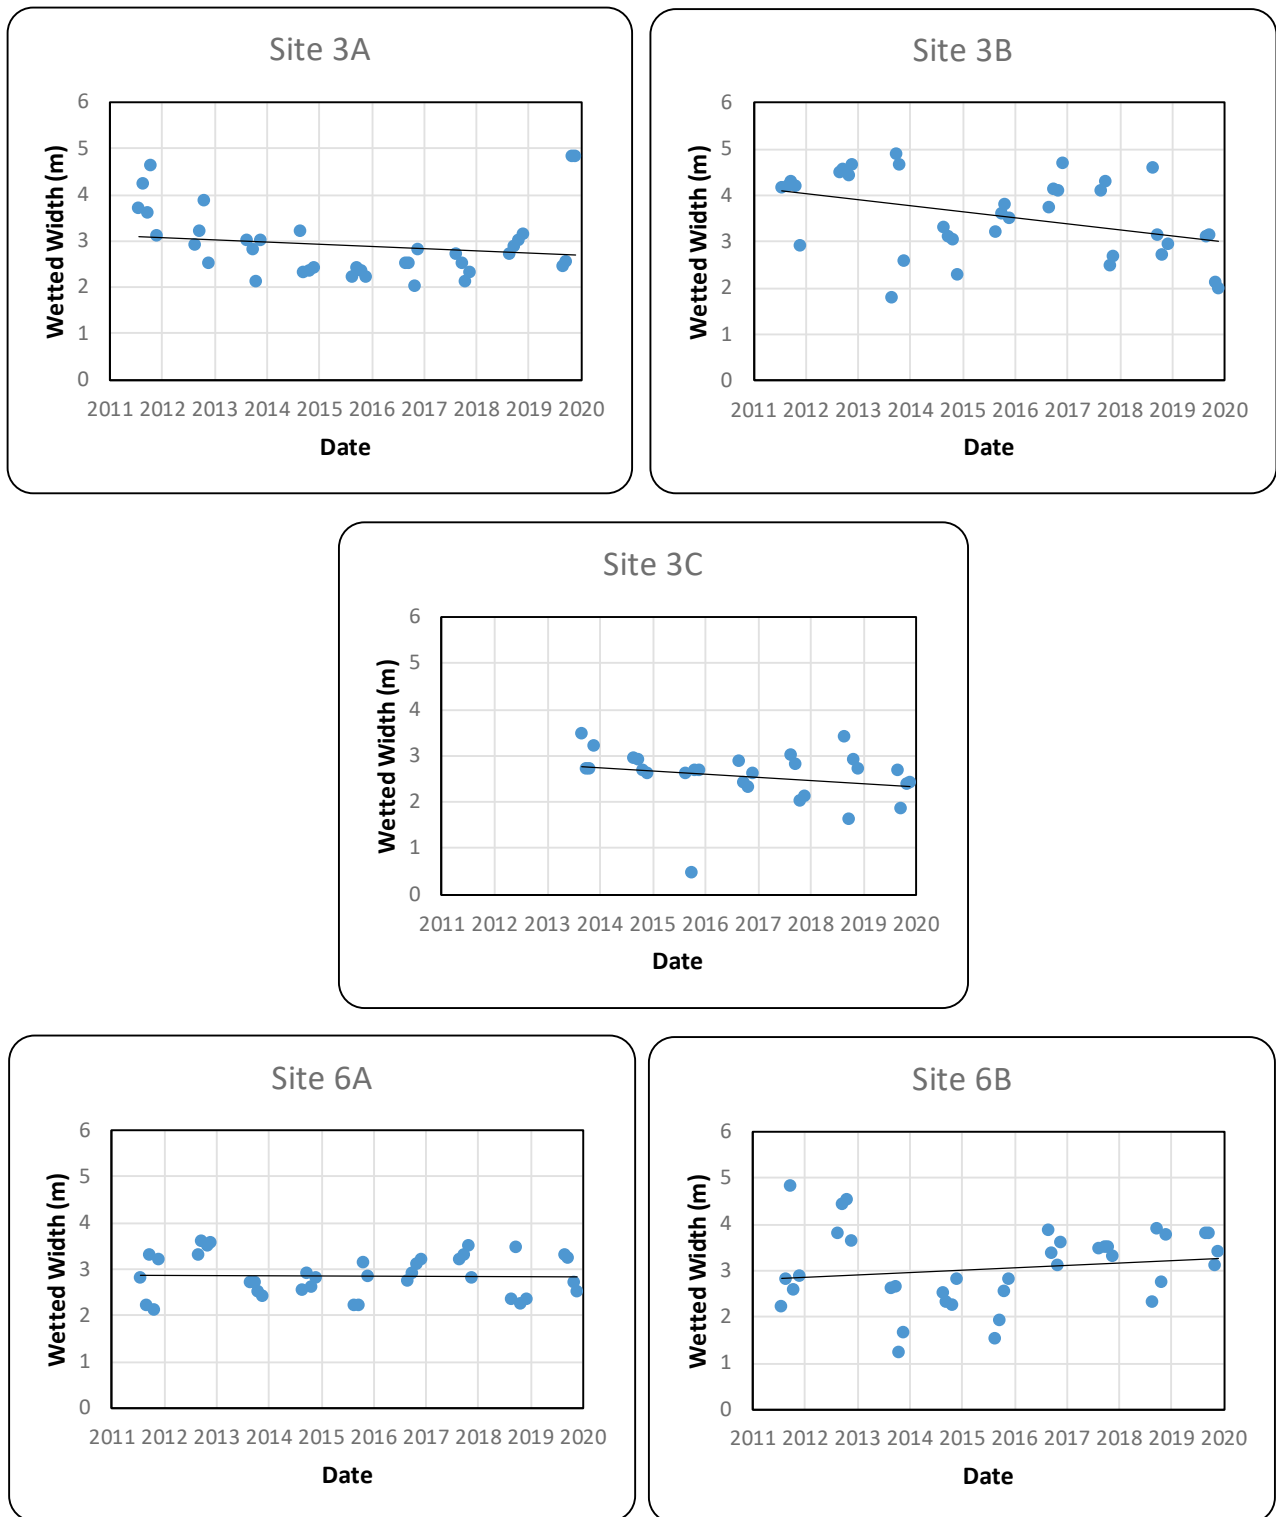
Figure 3-5 Wetted Width at Horn Creek Mesohabitat Sites (2012 to 2020)
(Continued)

The Mann-Kendall tests showed no significant negative or positive trends in the average wetted width at the Boa Brook mesohabitat sites during the 2012 to 2020 monitoring period (Table 3-2). At Horn Creek, a significant increasing trend in the average wetted width was observed at site 1A ($p < 0.05$). No significant trends (increasing or decreasing) were observed at the other Horn Creek sites.

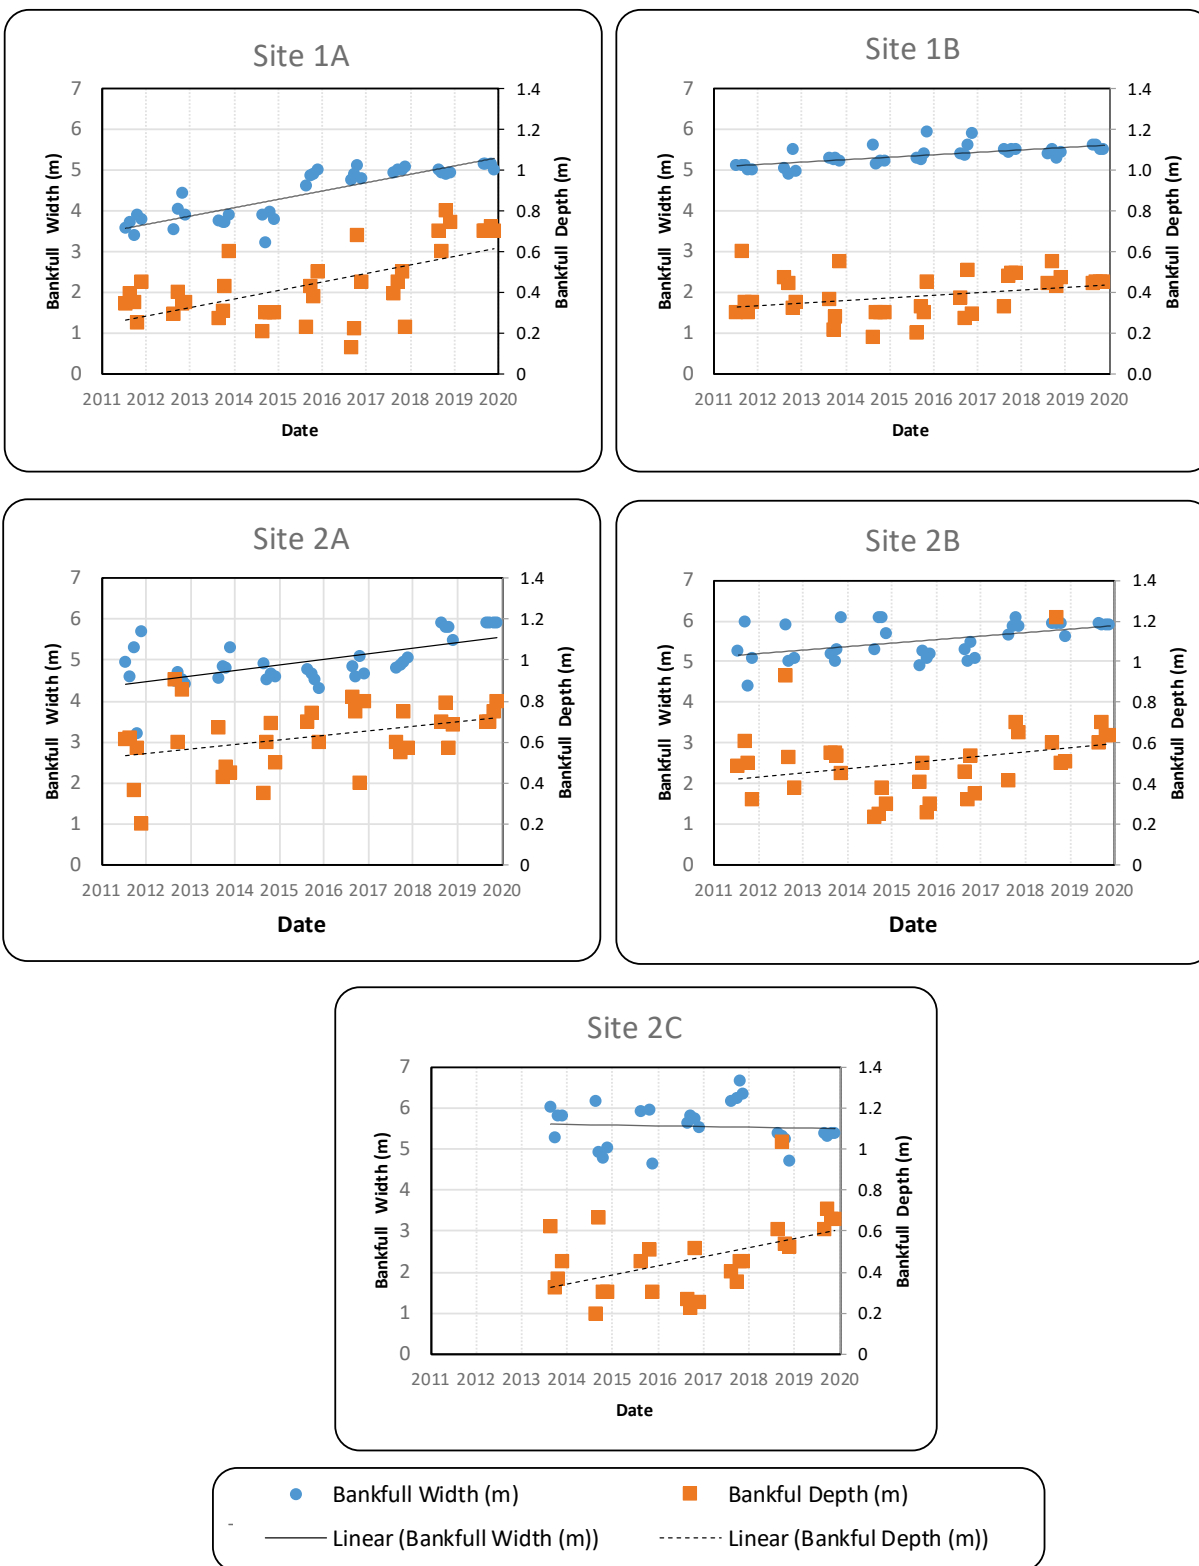
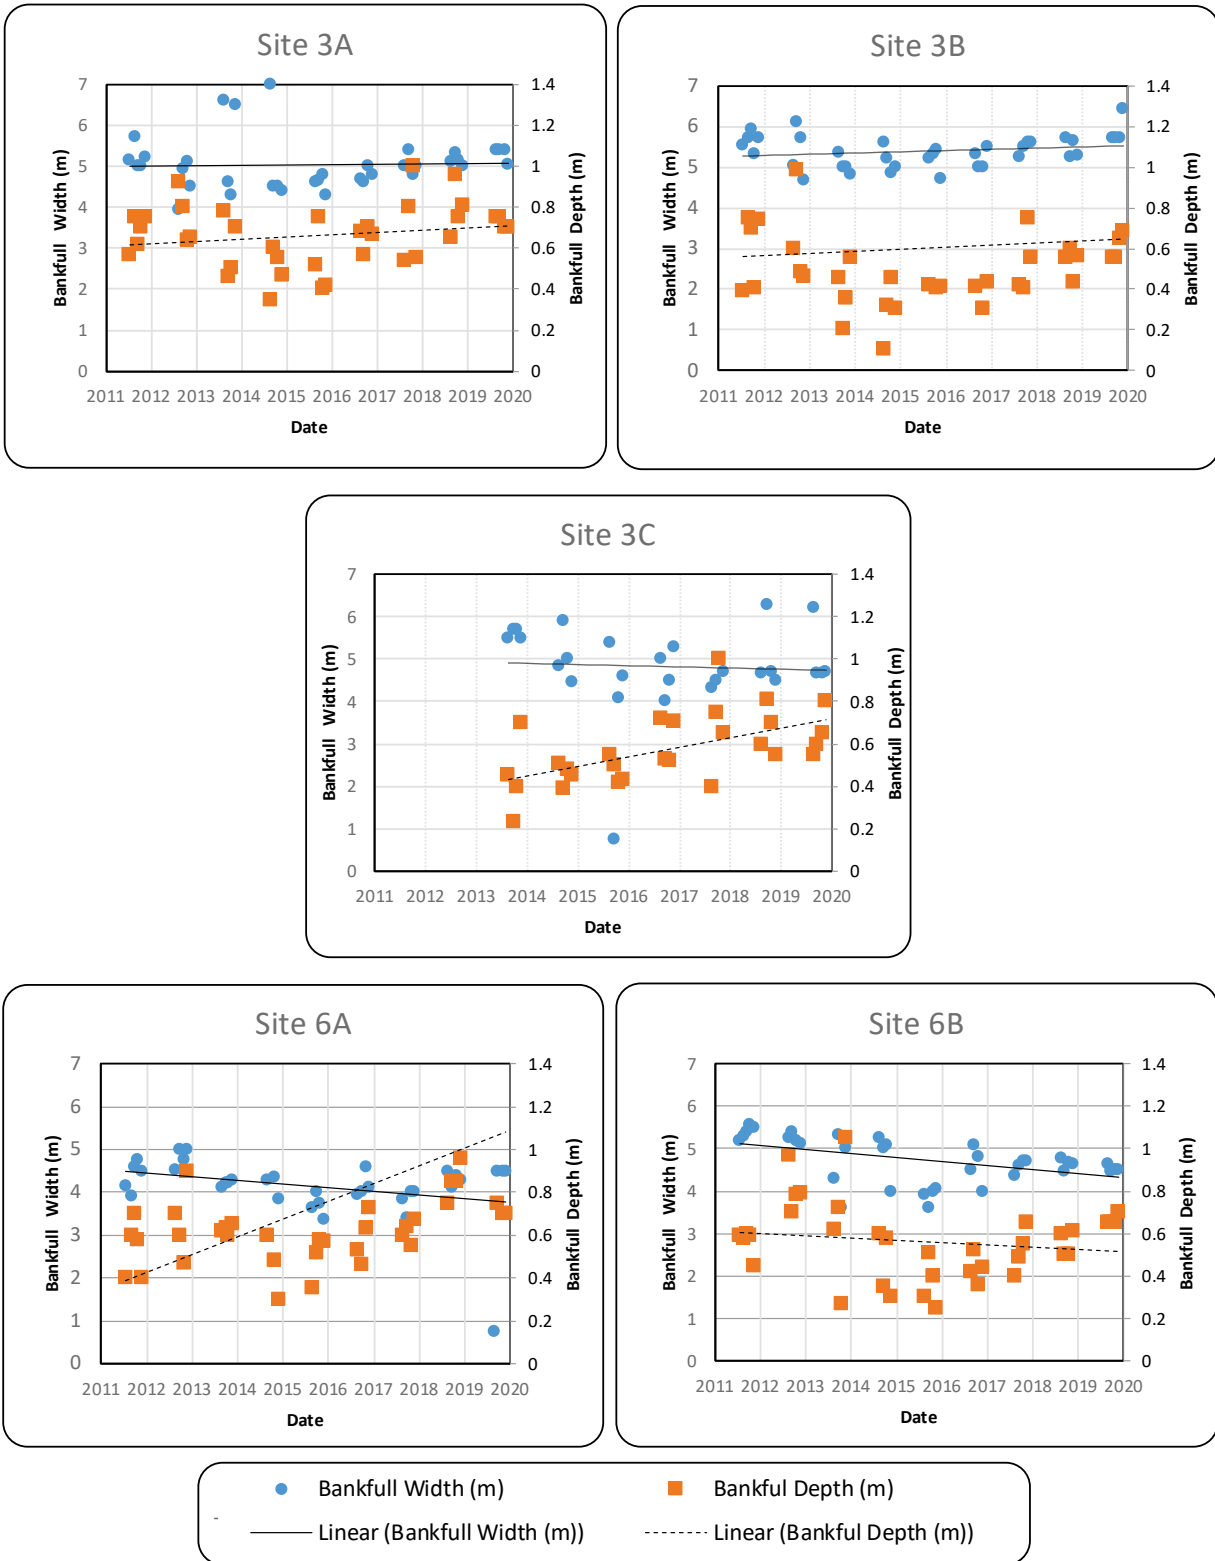
Figure 3-9 Bankfull Width and Depth at Horn Creek Mesohabitat Sites (2012 to 2020)

Figure 3-10 Bankfull Width and Depth at Horn Creek Mesohabitat Sites (2012 to 2020) (Continued)

Figure 3-8 to Figure 3-11 show the results of the bankfull width and depth monitoring at the mesohabitats monitoring sites through 2020. In a system where flows are decreasing, a negative trend in bankfull width and depth over time may be expected. The Mann-Kendall tests showed no significant negative trends in bankfull width at the Horn Creek and Boa Brook mesohabitats over the monitoring period (Table 3-3). However, the analysis showed significant increasing trends in bankfull width at mesohabitat sites 1A and 1B ($p < 0.01$) and 2A and 2B ($p < 0.05$) on Horn Creek and 4B ($p < 0.001$) and 5B ($p < 0.05$) on Boa Brook.

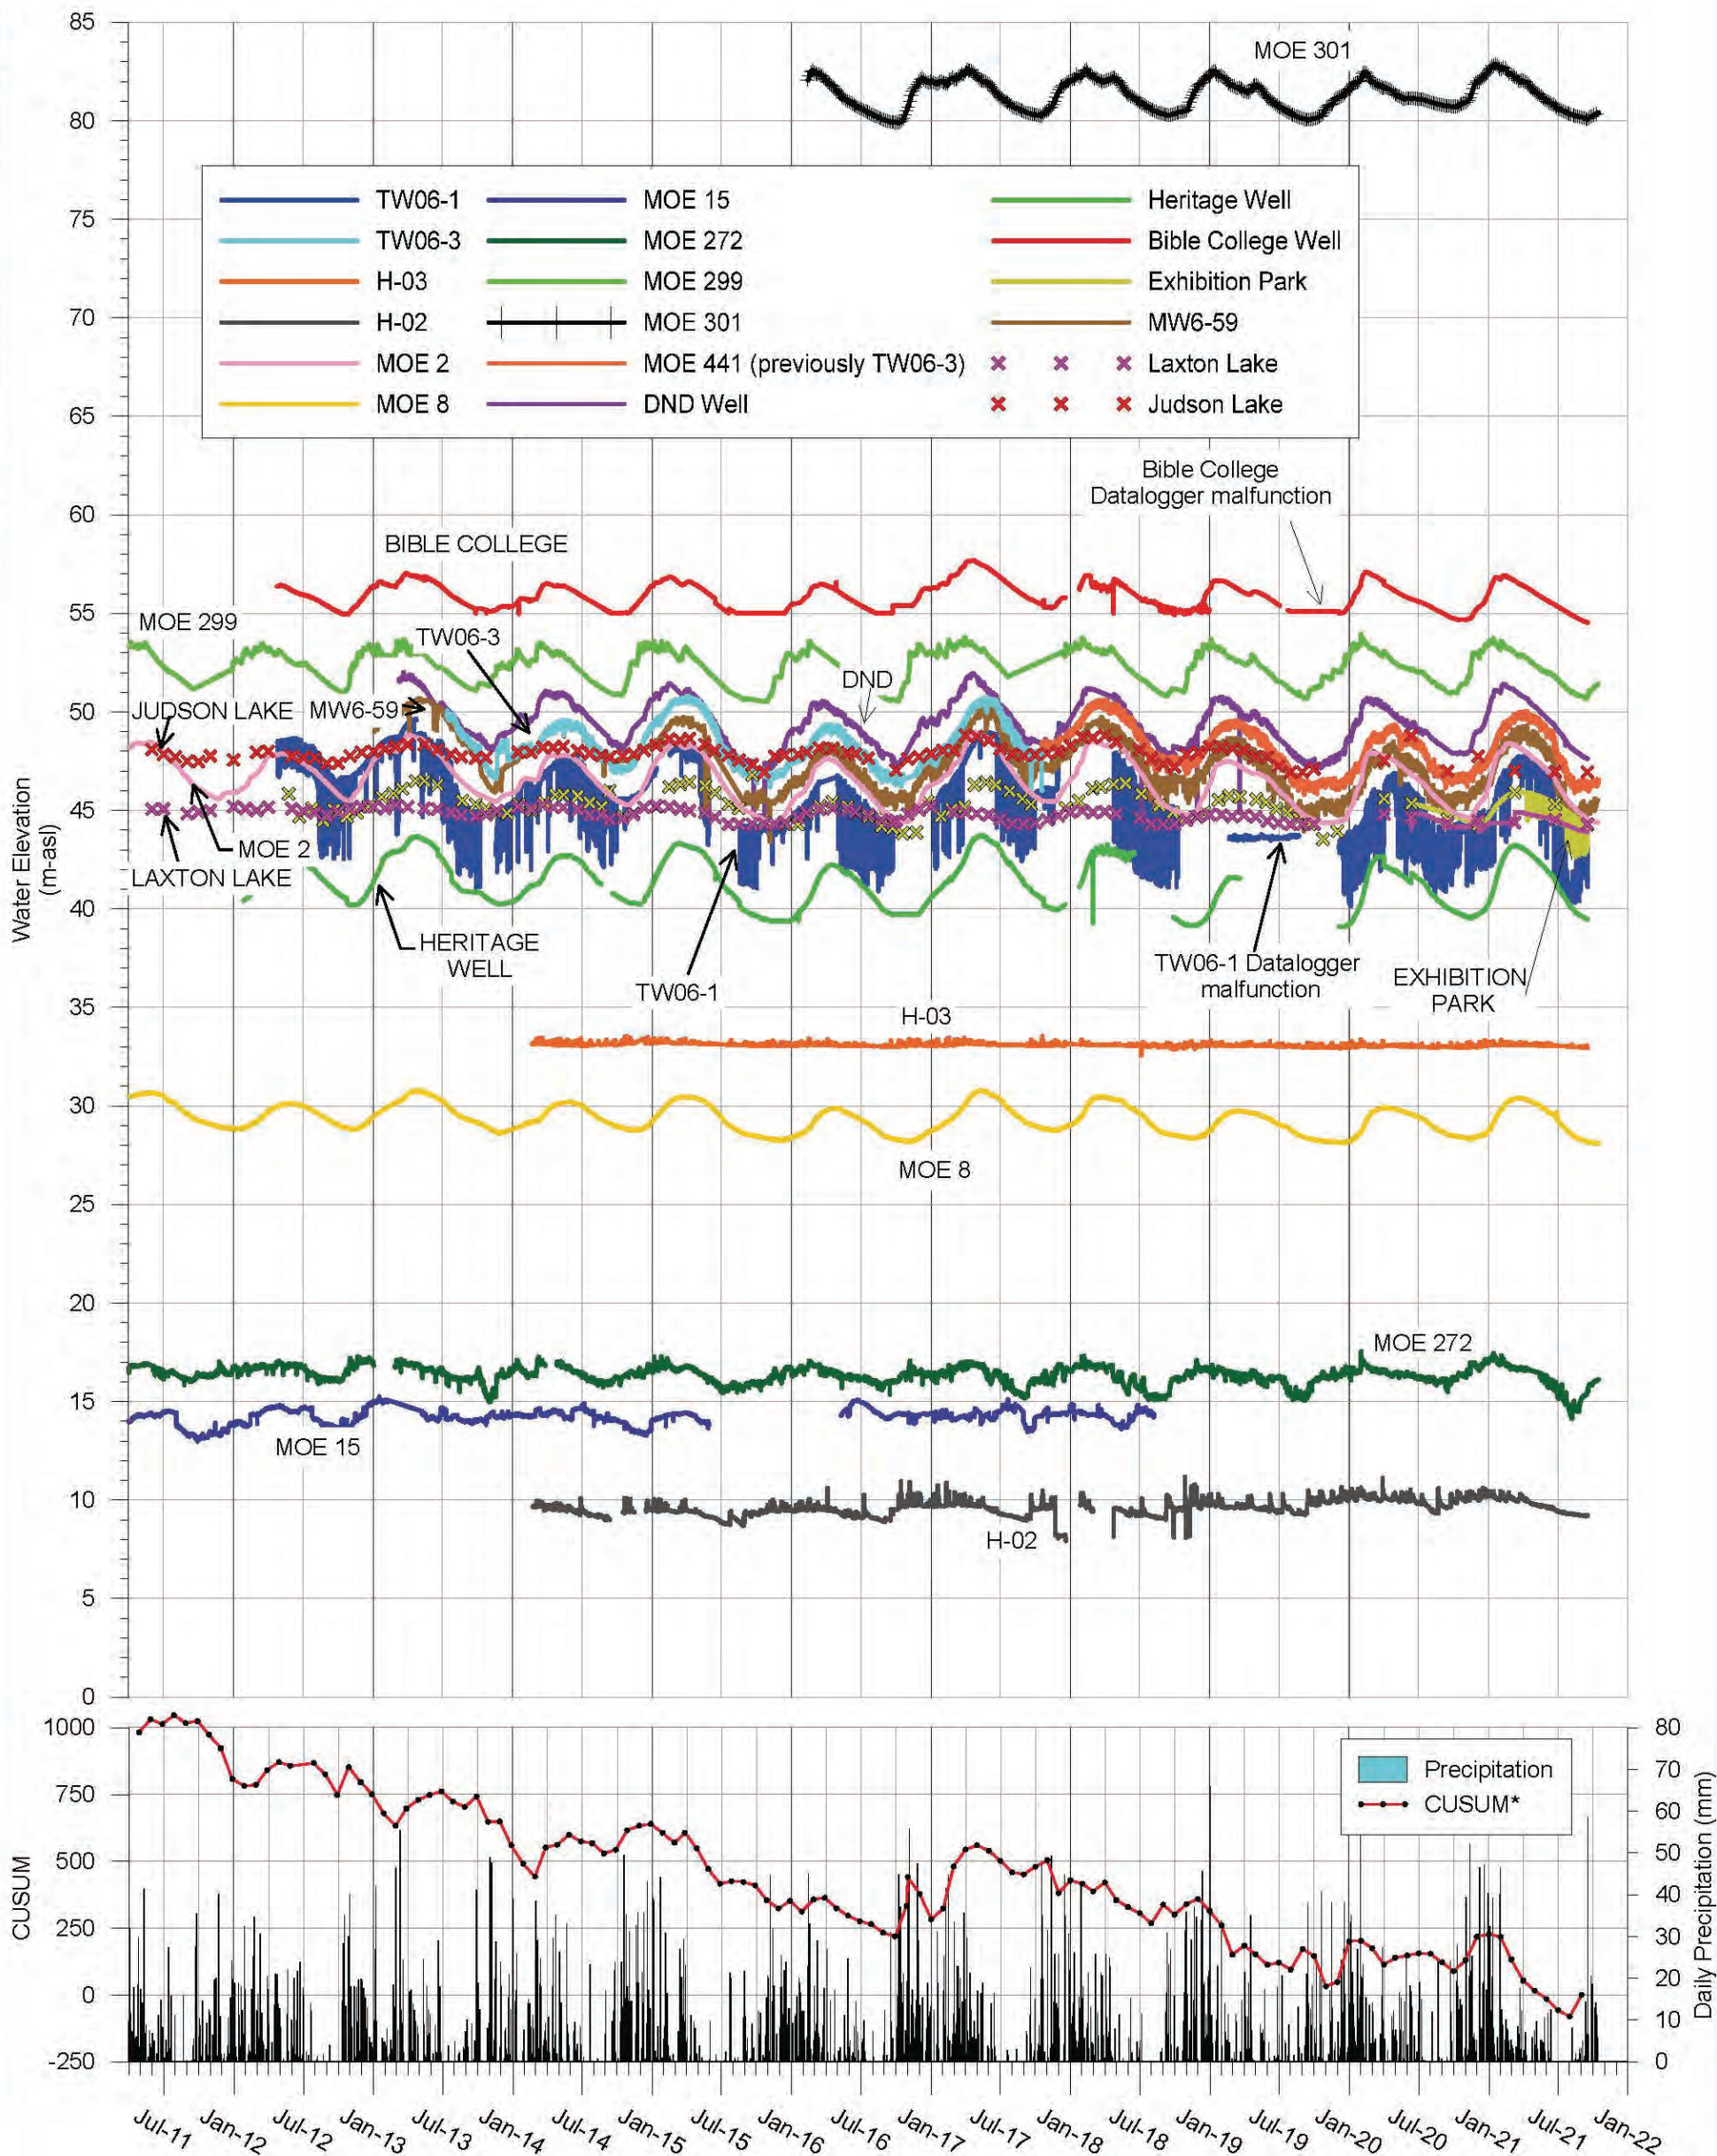
BY:	SC	DATE:	NOV 21
APPROVED:	DJT	FIG:	4-3

Manual readings denoted with "X"

* CUSUM= Cumulative sum of deviation from mean monthly precipitation based on data collected between January 1945 and September 2021. All precipitation data from Environment Canada station at Abbotsford Airport.

Aquifer water levels observed in 2020-2021 were within seasonal ranges observed during previous years. There was no evidence of a progressive year-over-year decline in water levels at any of the locations monitored. Trends in most observation wells did not indicate any obvious changes relating to pumping the Bevan Wells, the CWD wells, or the Marshall Road Wells (Figure 4-4 and 4-6). Exceptions include TW06-1, which is located within the Bevan wellfield and experiences rapidly fluctuating water levels caused by cycling of the Bevan Wells, and MOE 441 and MW6-59, which are the next closest monitoring wells and exhibit some short-term influence attributed to pumping of the CWD and Bevan Wells.

Wetland water levels recorded from May 2018 through April 2021 are illustrated in Figure 5-7. This graph shows an overall declining trend in the depth of water within the wetland. The reason for this trend is unclear. It does not appear to be related to the operation of the Bevan wells as no similar trends were observed in the flow of Downes Creek (Section 2.4.1), water levels in the (deeper) monitoring wells (Section 4.1.3), or water levels in the shallow groundwater wells (Section 5.2.1). However, a decline is consistent with the drying trend indicated by the cusum line on Figure 4-3.

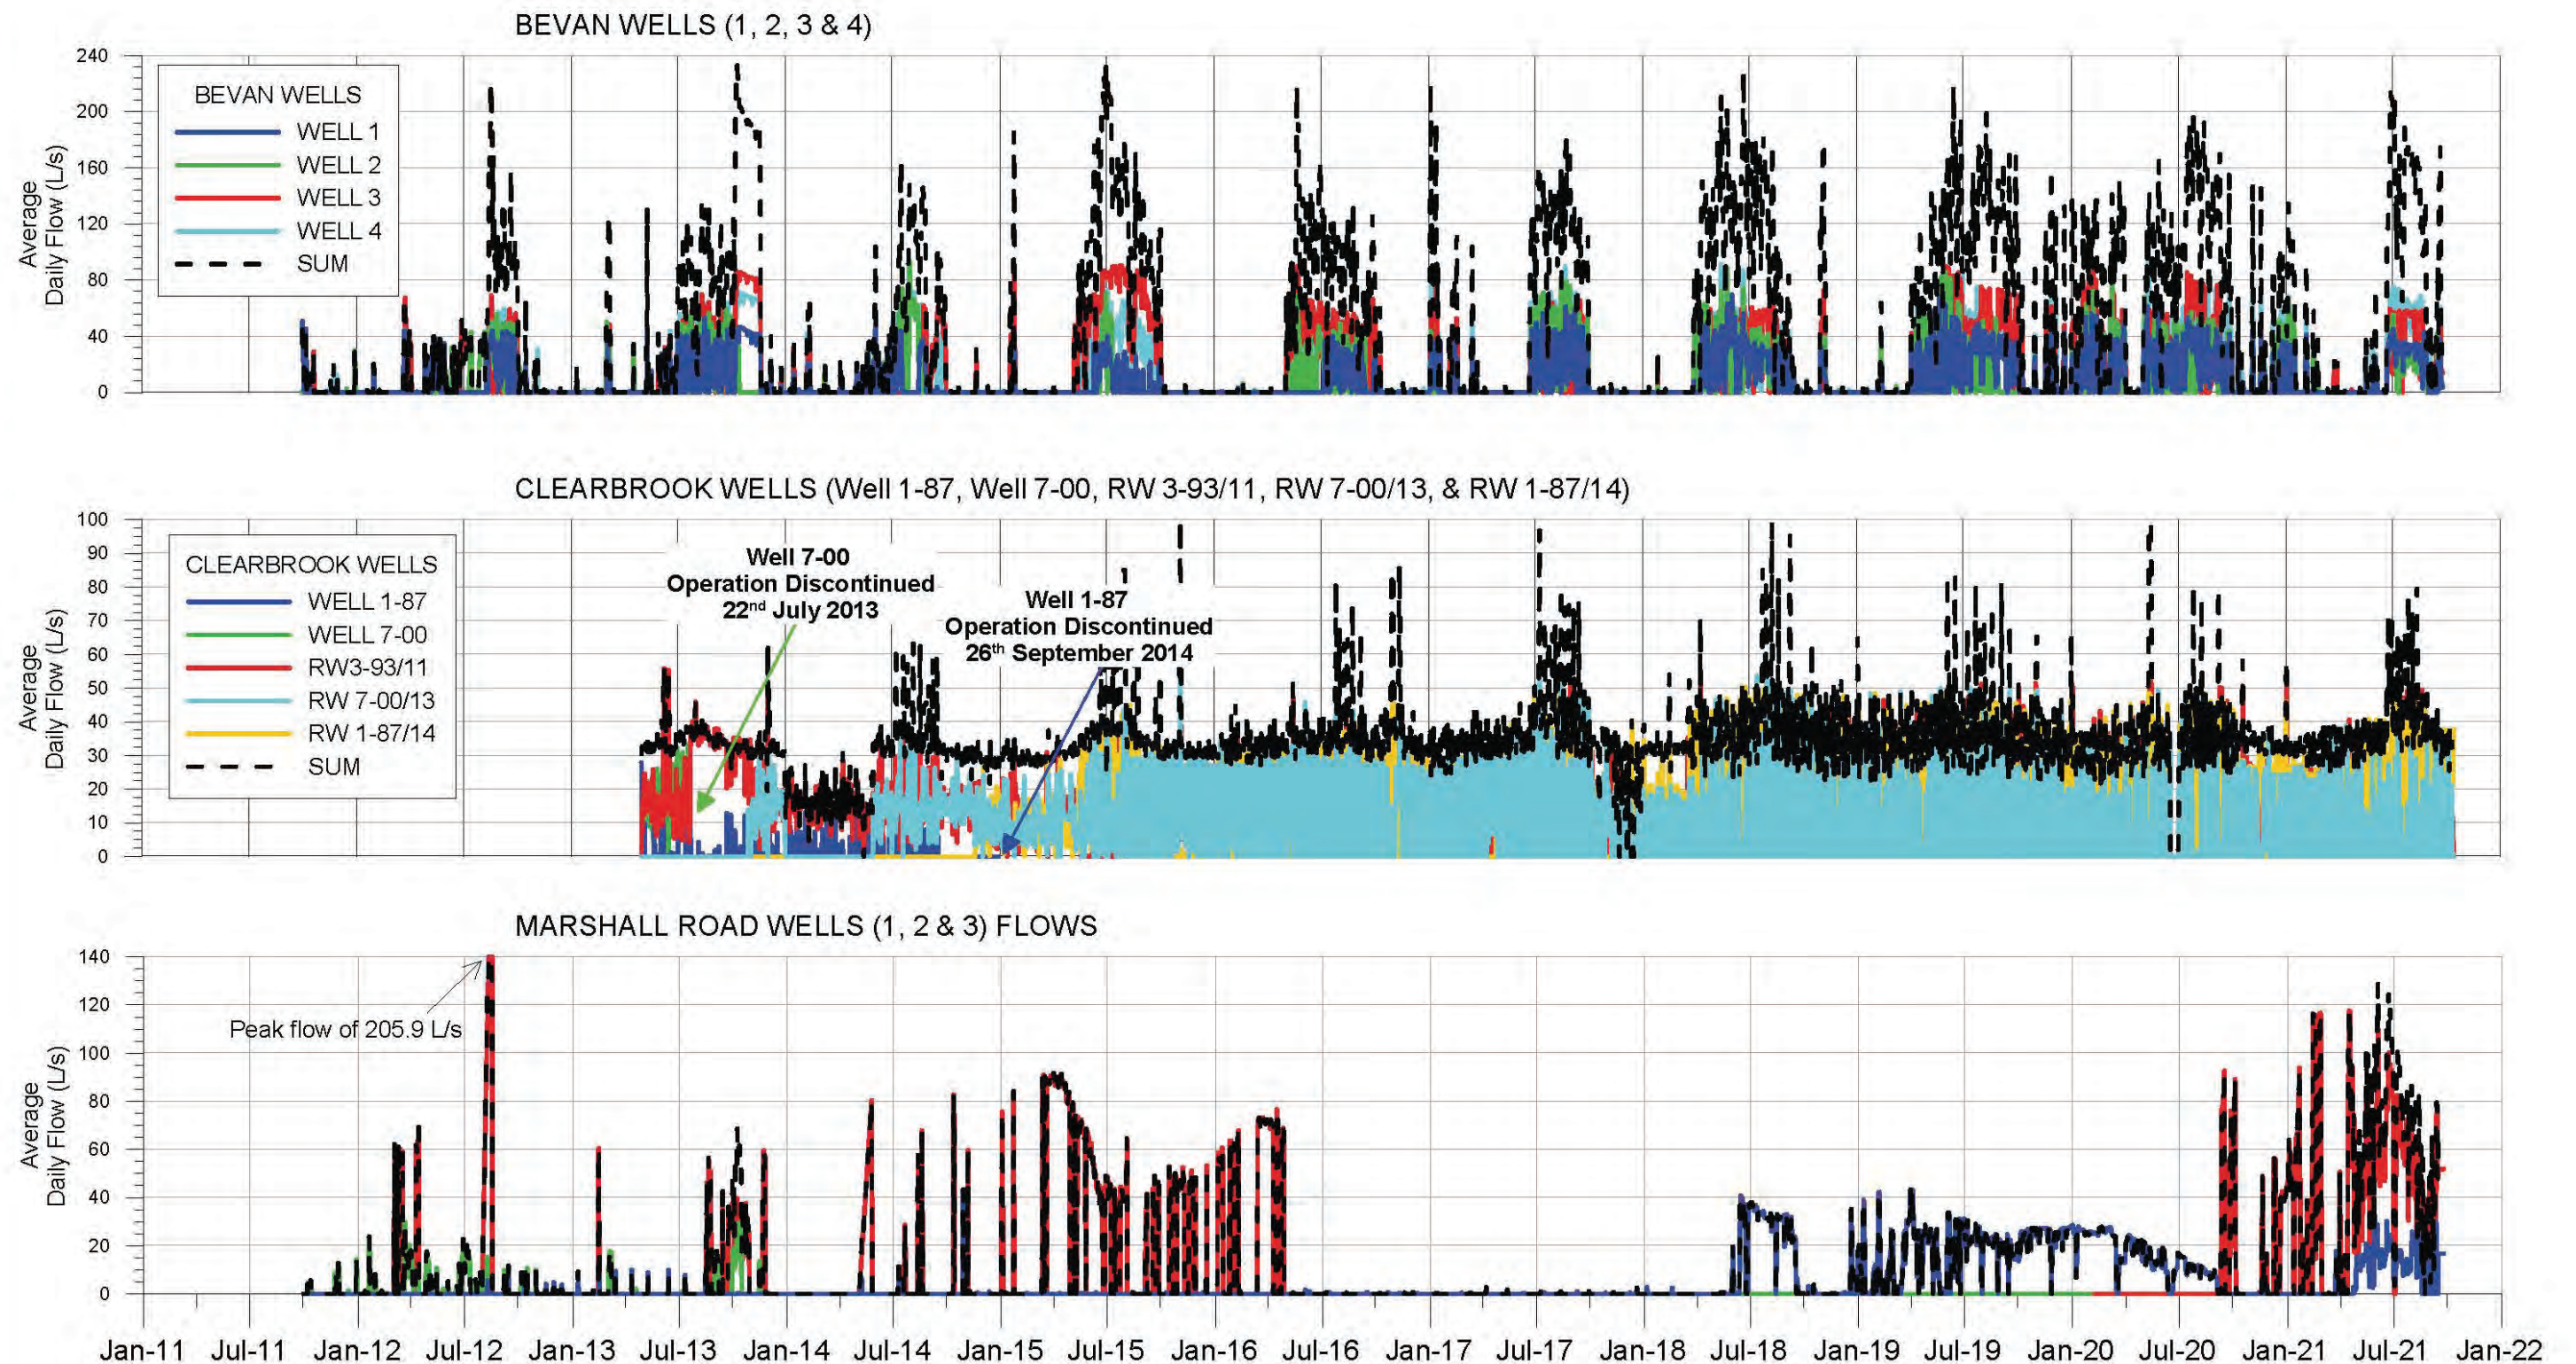
BY:	SC	DATE:	NOV 21
APPROVED:	DJT	FIG:	4-4

PUMPING RATES FOR BEVAN, CLEARBROOK
AND MARSHALL WELLS

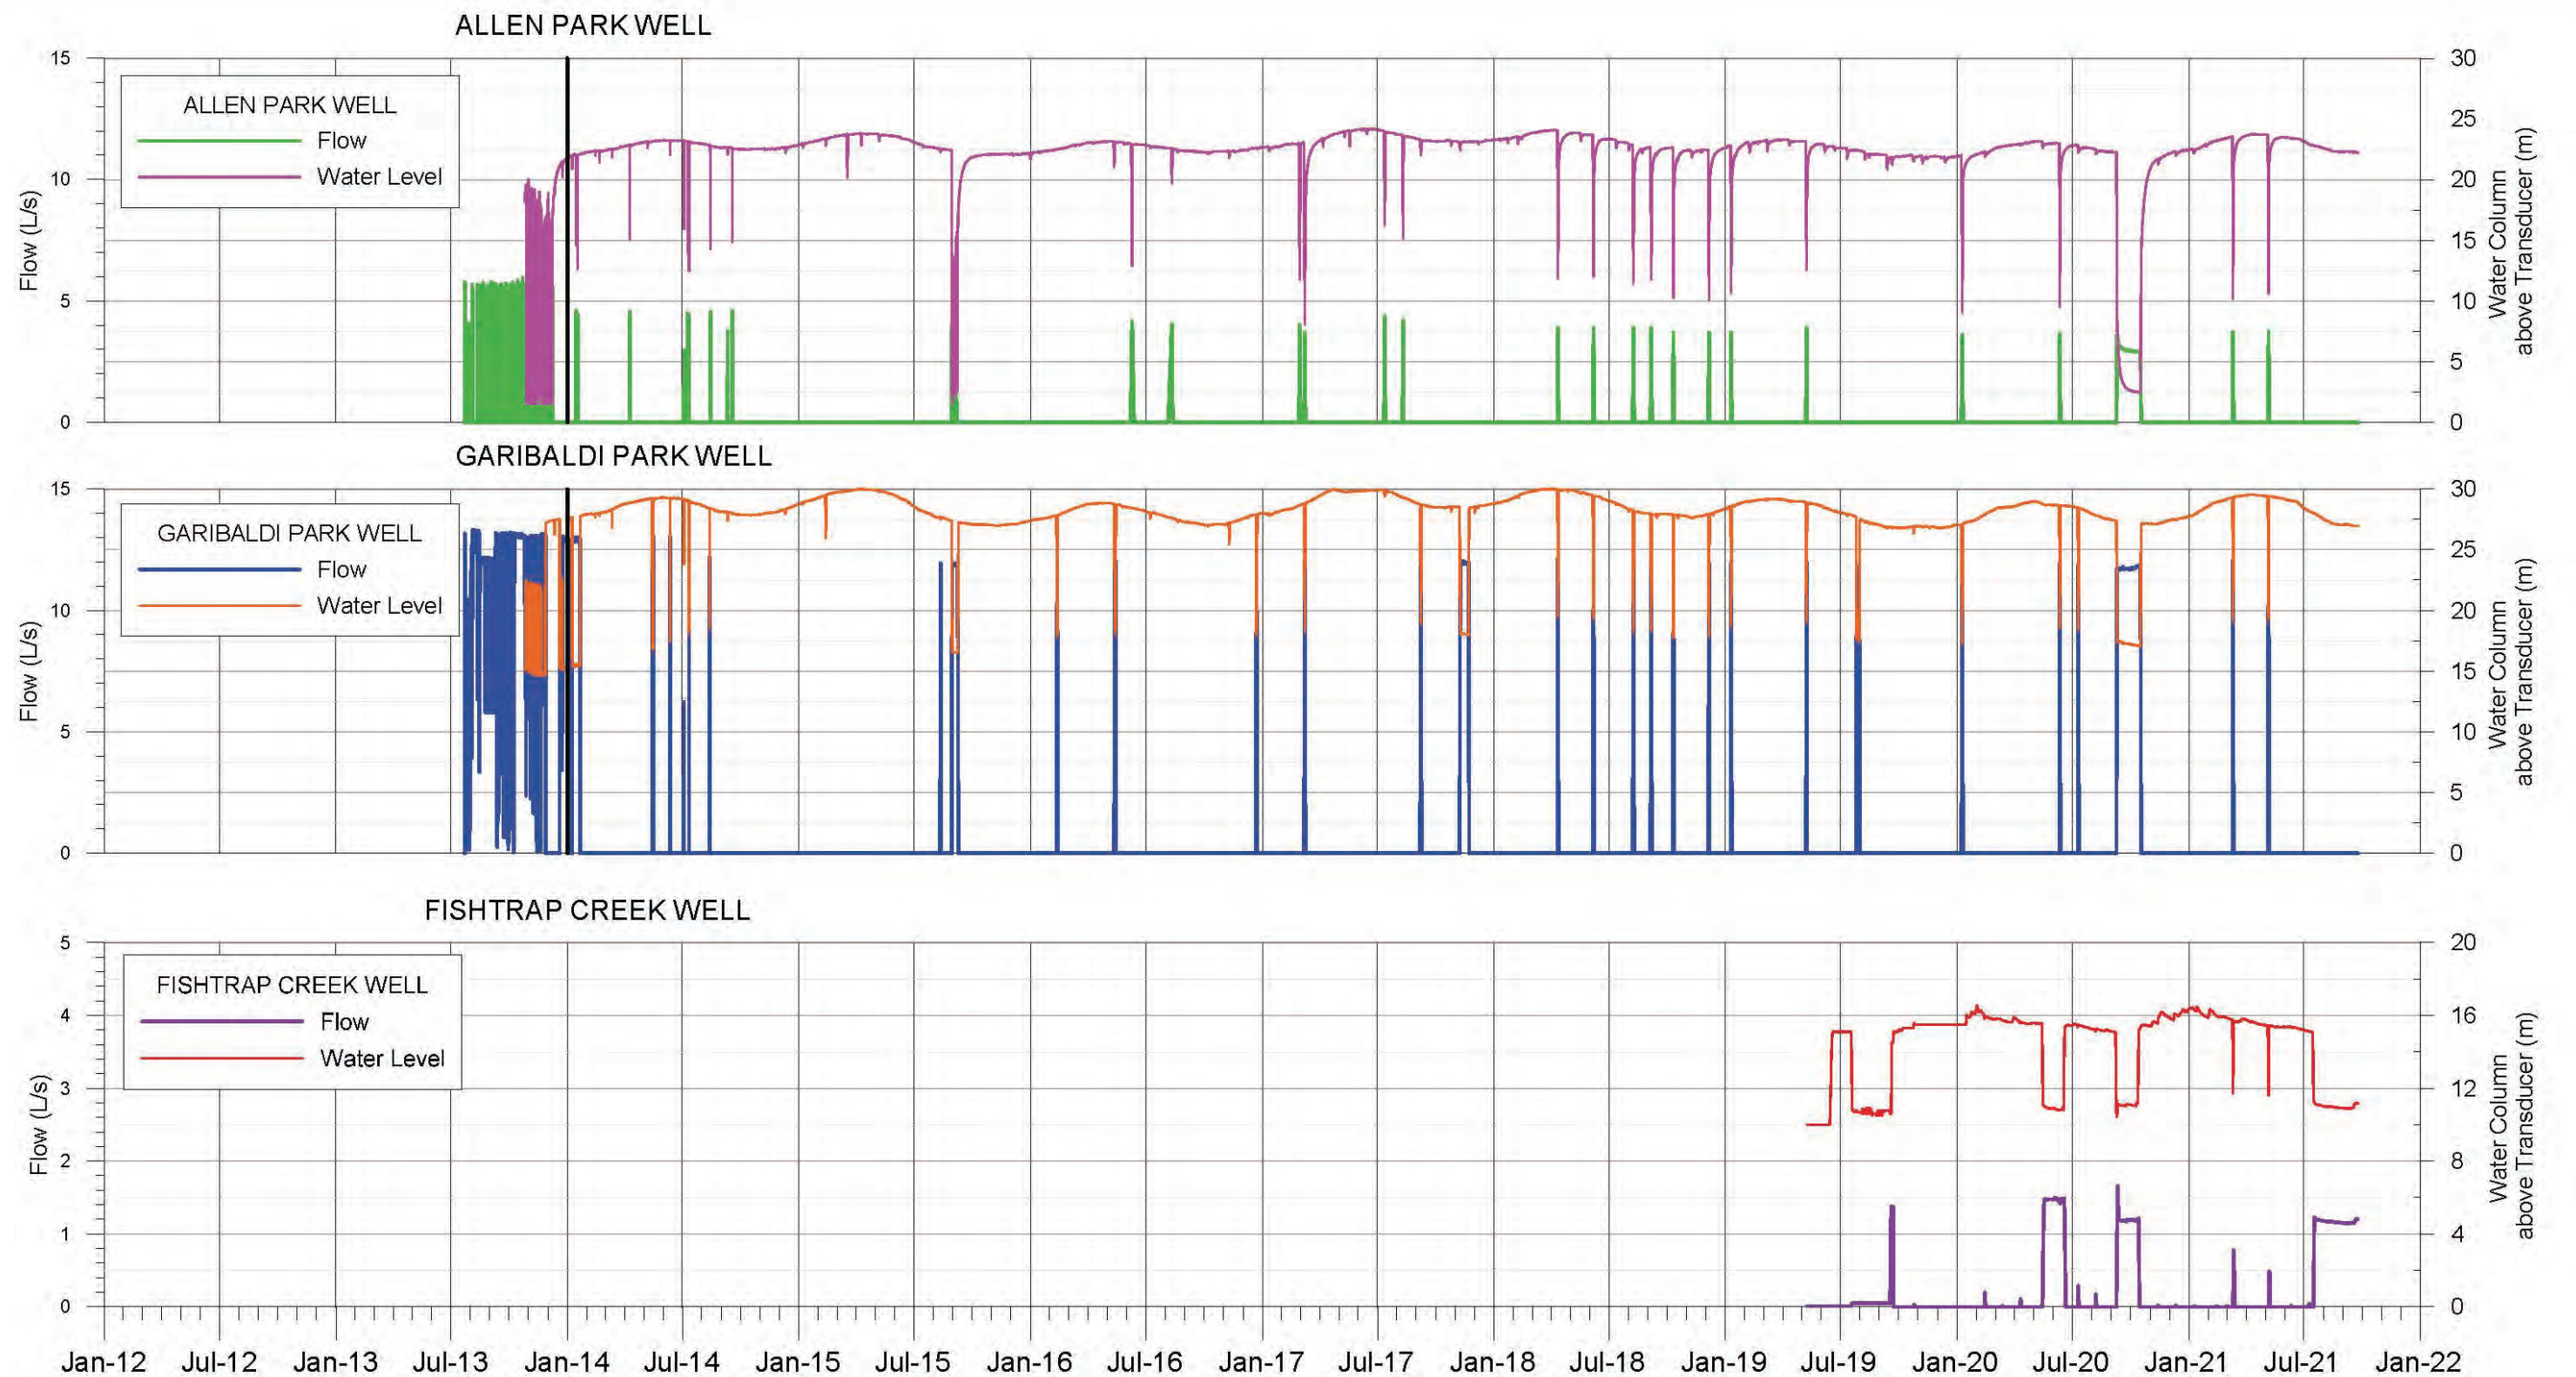
CITY OF ABBOTSFORD UPDATED HYDROGEOLOGICAL ASSESSMENT BEVAN WELLS PROJECT		  PITEAU ASSOCIATES GEOTECHNICAL AND WATER MANAGEMENT CONSULTANTS	
GROUNDWATER LEVELS AND FLOWS IN MITIGATION WELLS AT ALLEN PARK, GARIBALDI PARK, AND FISHTRAP CREEK		BY: SC	DATE: NOV 21
		APPROVED: DJT	FIG: 4-5

Having begun in 2013, the water level record for the Allen and Garibaldi wells (Figure 4-5) is shorter than for the observation wells shown on Figure 4-3. The non-pumping levels generally reflect the pattern noted in other observation wells but are somewhat more muted. Since 2014, the wells have been pumped for short durations for maintenance purposes. The Fishtrap Creek mitigation well was installed in 2019.
