CITY OF ABBOTSFORD
UPDATED HYDROGEOLOGICAL ASSESSMENT
BEVAN WELLS PROJECT

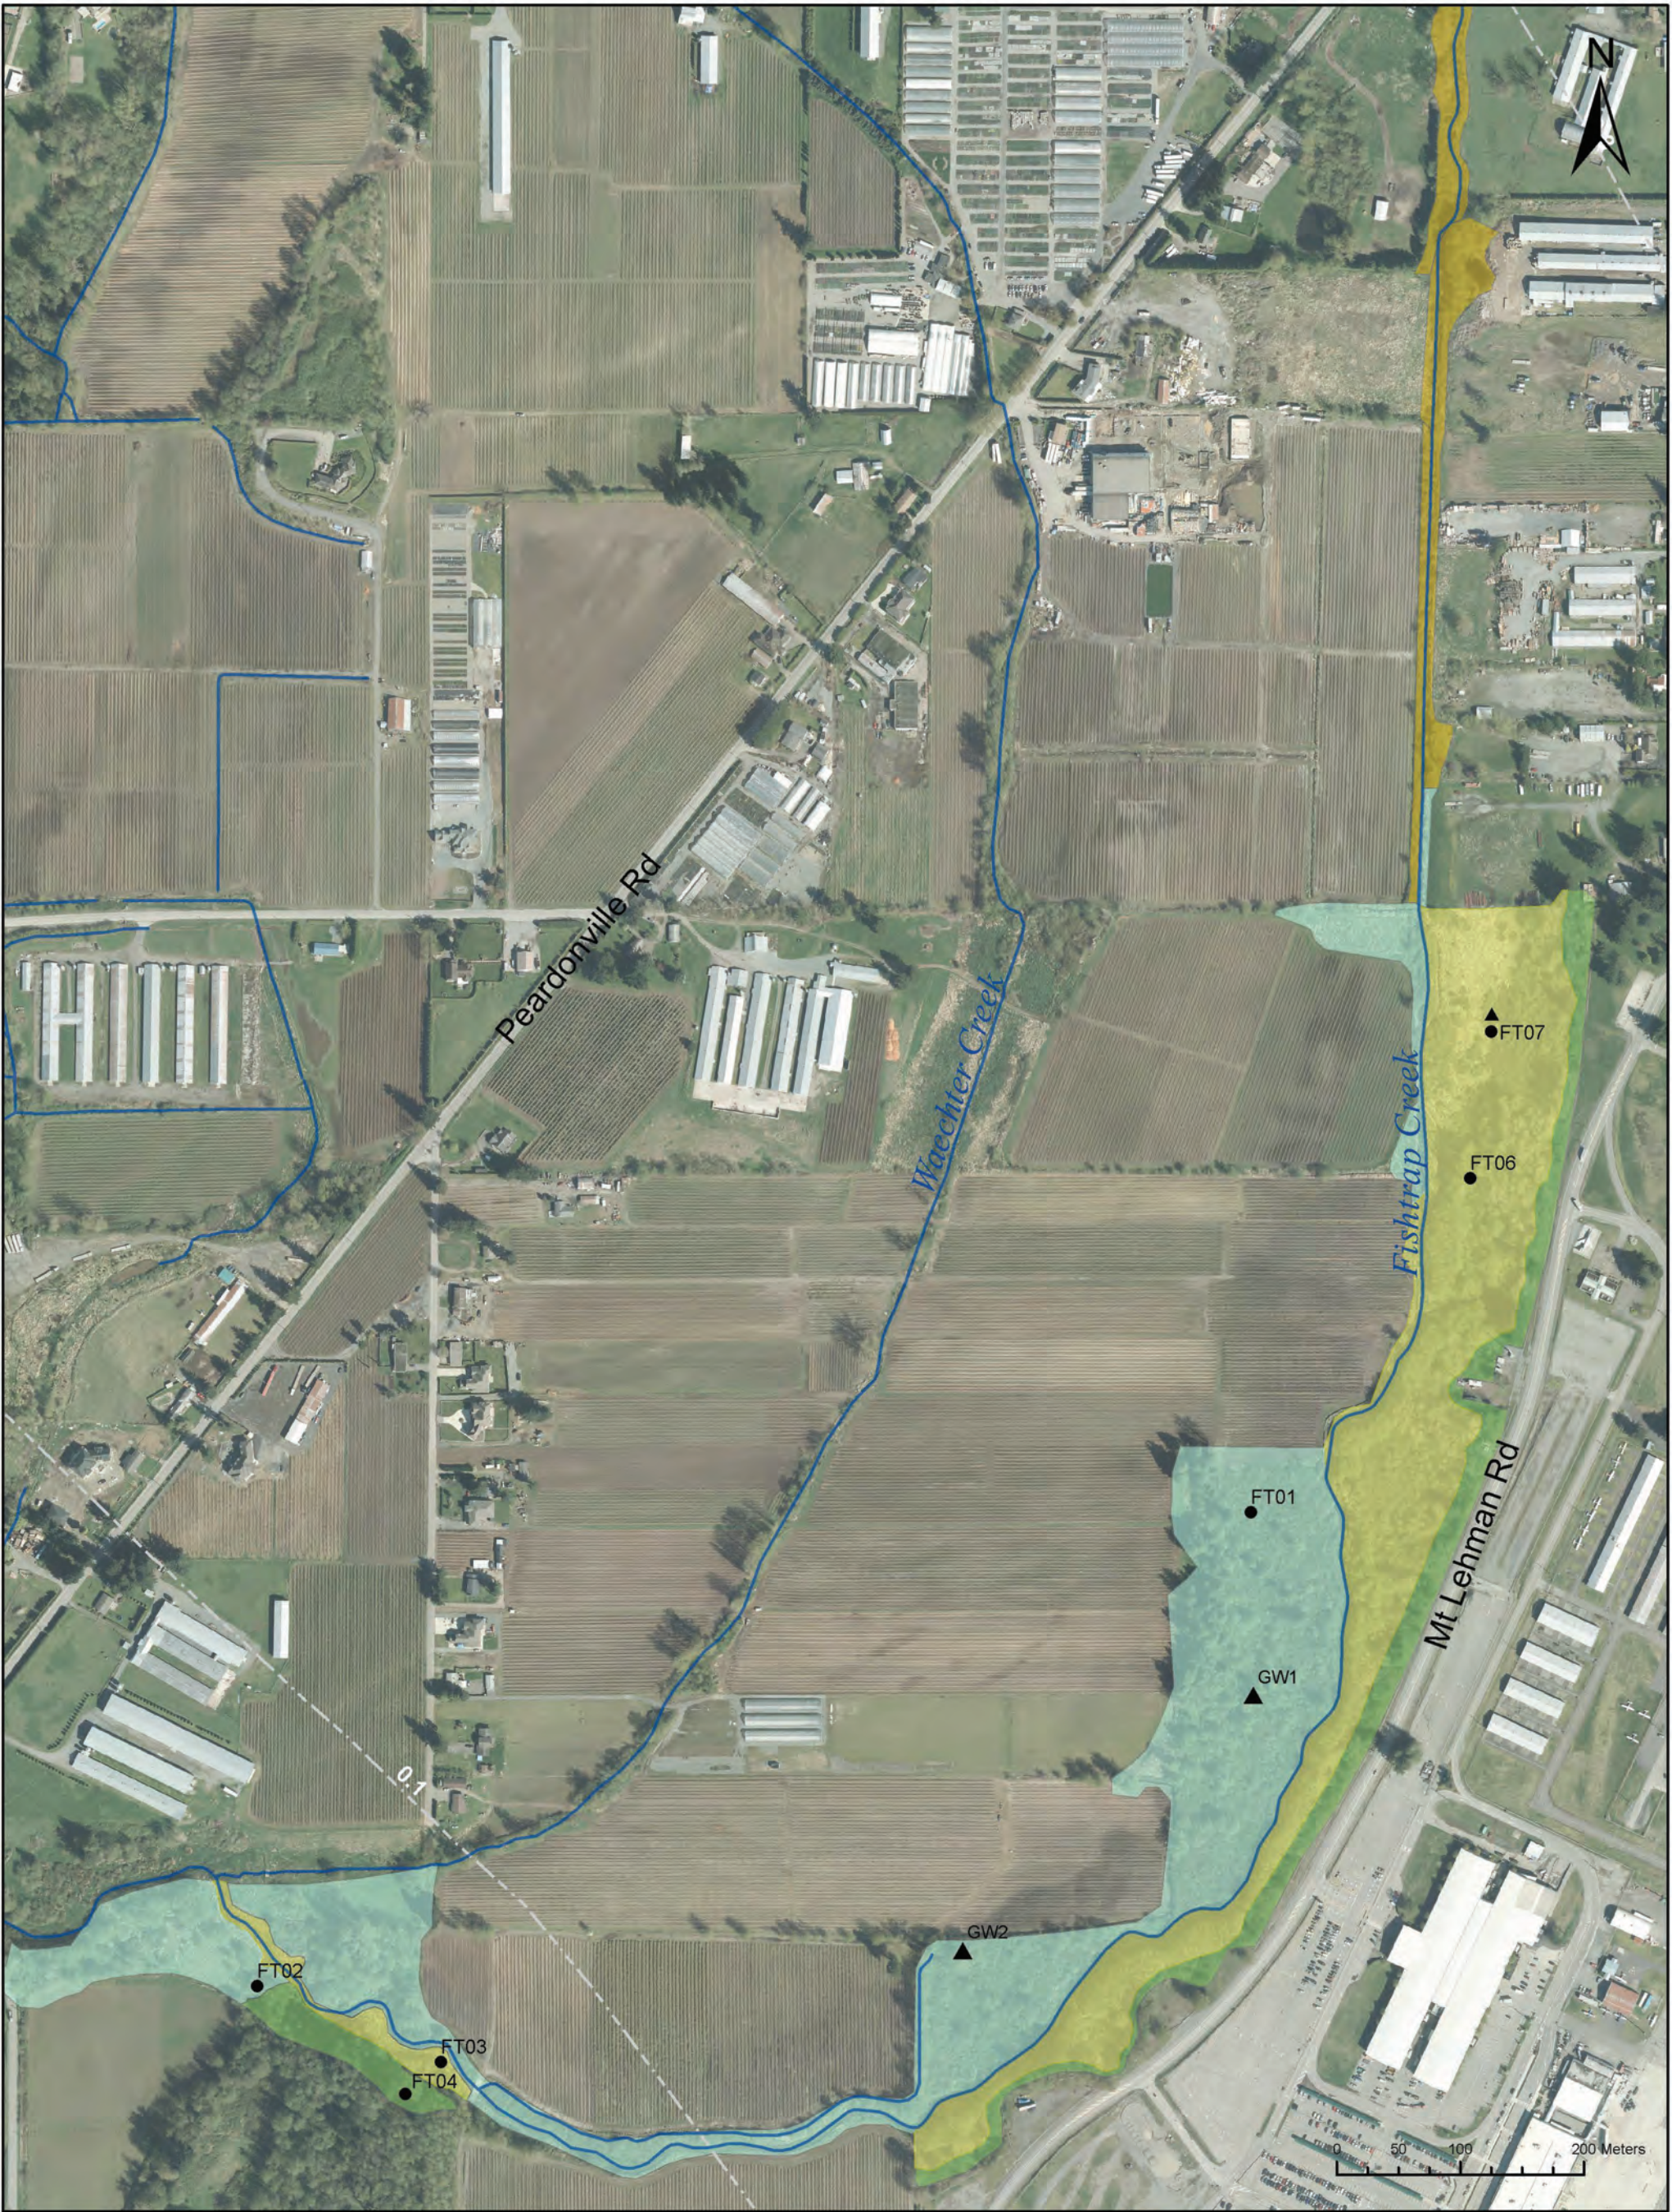
Figure 5-1

- ▲ Shallow groundwater well
- TEM plot
- Watercourse

In spring of 2018, shallow groundwater wells were installed in three study areas within the zone of influence and at three control wetlands (Figure 5-1). Study areas include Fishtrap Creek (3 wells; Figure 5-2), Horn Creek and Boa Brook (2 wells; Figure 5-3), and Downes Creek (8 wells; Figure 5-4). Well installation for the three study areas and the control wetlands took place in spring of 2018. Three groundwater wells were installed at each of the control wetlands (Figure 5-5). Locations of shallow groundwater wells are recorded in Appendix L.

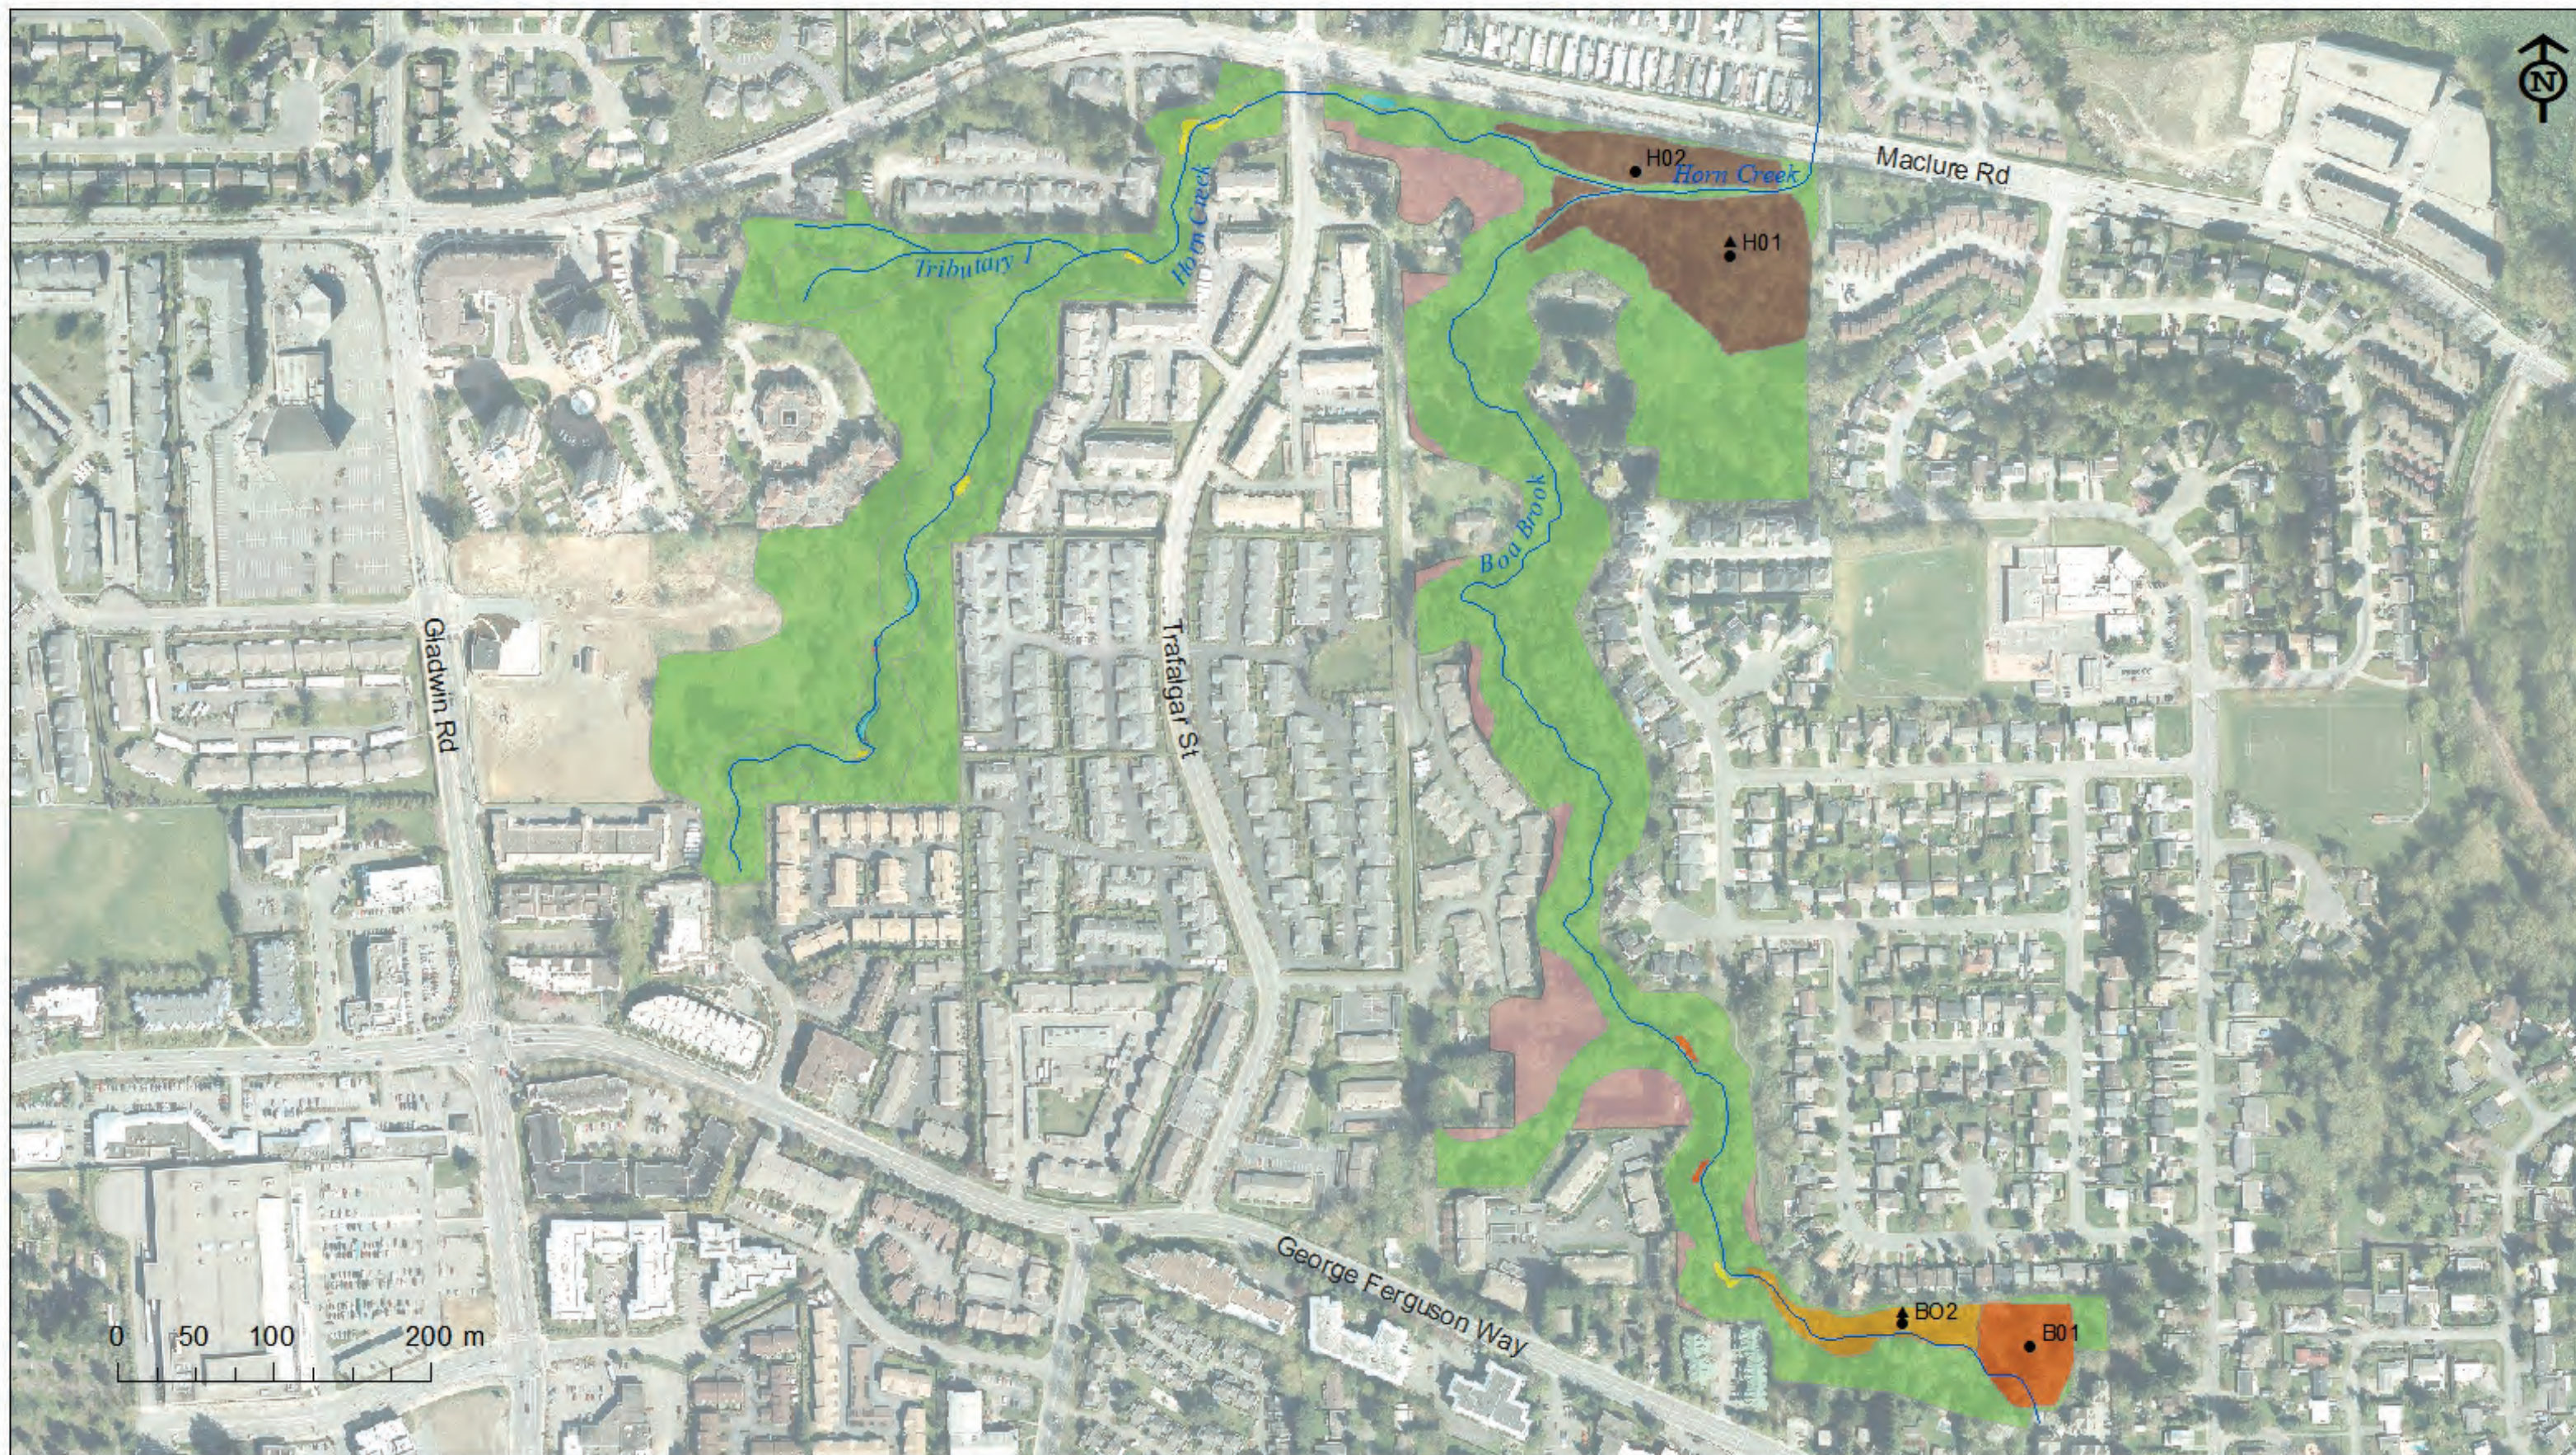
Figure 5-2

- TEM plot
- ▲ Indicator plant plot & shallow groundwater well
- Watercourse

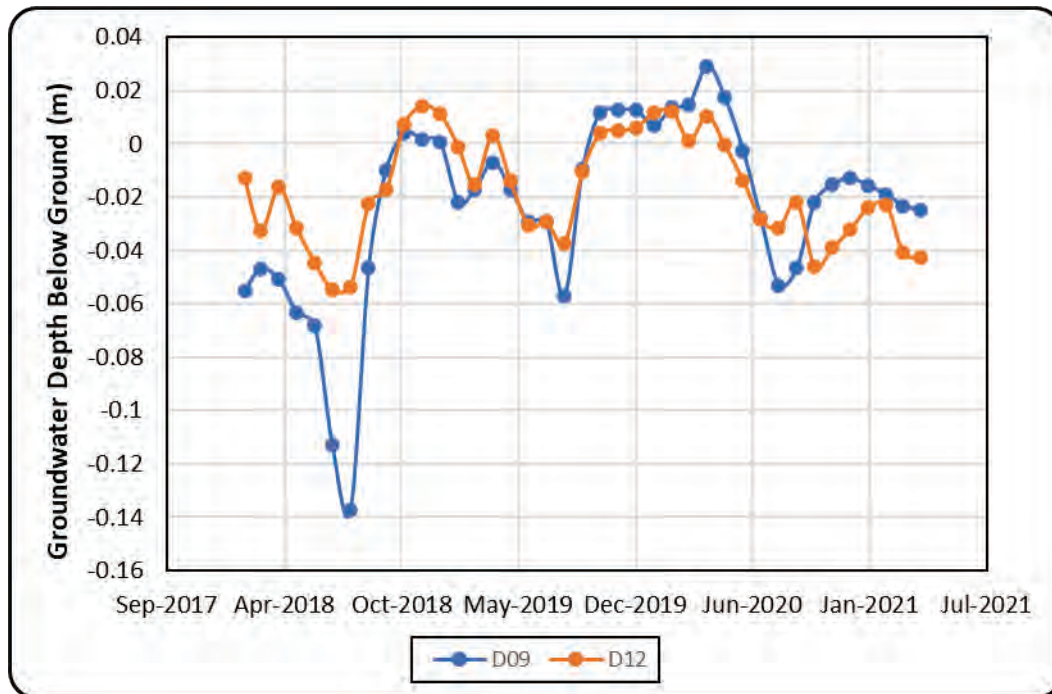
Figure 5-6 Temporal Variations in Groundwater Levels at Two Monitoring Wells in the Downes Creek Watershed

Shallow groundwater data graphs for April 2020 through to April 2021 are attached in Appendix N. Within the Bevan Wells zone of influence and at the control sites, groundwater levels in 2020 tended to be slightly higher overall than in previous years. Several exceptions within the Downes Creek basin were D11, which had lower summer water levels in 2020 than in previous years, and D09 and D12, which had lower 2020 winter water levels than in previous years (Figure 5-6). In both cases, the pattern was only present for a portion of the year. The trend of overall decline in groundwater depth during the summer (late June to late September) occurred at over half of the sites, as observed in previous years. In these cases, the groundwater reached its lowest point in September, and

a sharp increase followed in October.

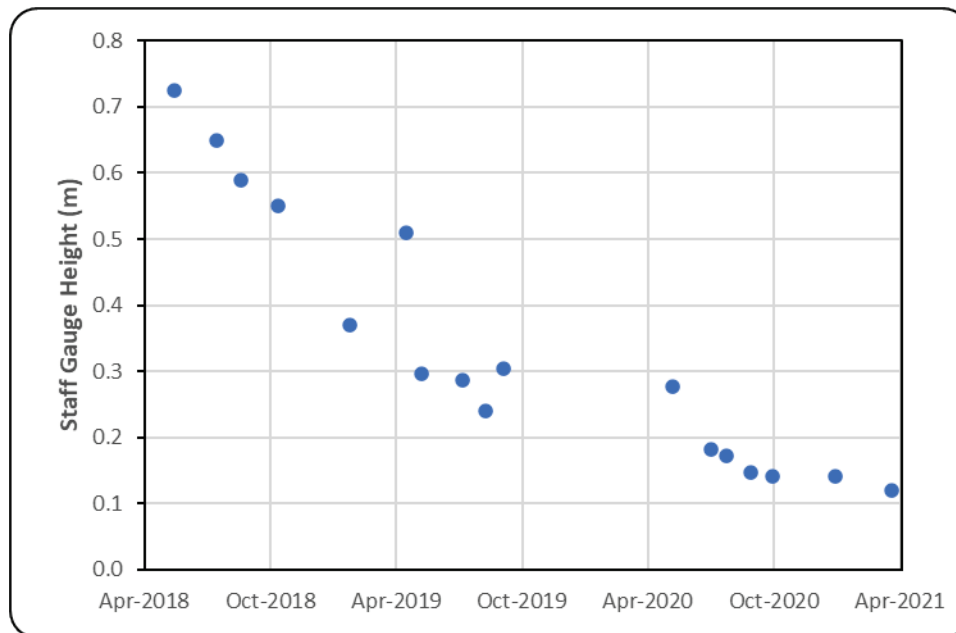
Figure 5-7 Water Levels in the Downes Creek Open-Water Wetland, 2018-2021

Wetland water levels recorded from May 2018 through April 2021 are illustrated in Figure 5-7. This graph shows an overall declining trend in the depth of water within the wetland. The reason for this trend is unclear. It does not appear to be related to the operation of the Bevan wells as no similar trends were observed in the flow of Downes Creek (Section 2.4.1), water levels in the (deeper) monitoring wells (Section 4.1.3), or water levels in the shallow groundwater wells (Section 5.2.1). However, a decline is consistent with the drying trend indicated by the cusum line on Figure 4-3.
