FINAL
Bevan Avenue Groundwater Supply
Development Project

Year 11 Environmental
Monitoring Report

City of Abbotsford
32315 South Fraser Way,
Abbotsford, BC
V2T 1W7

December 2022

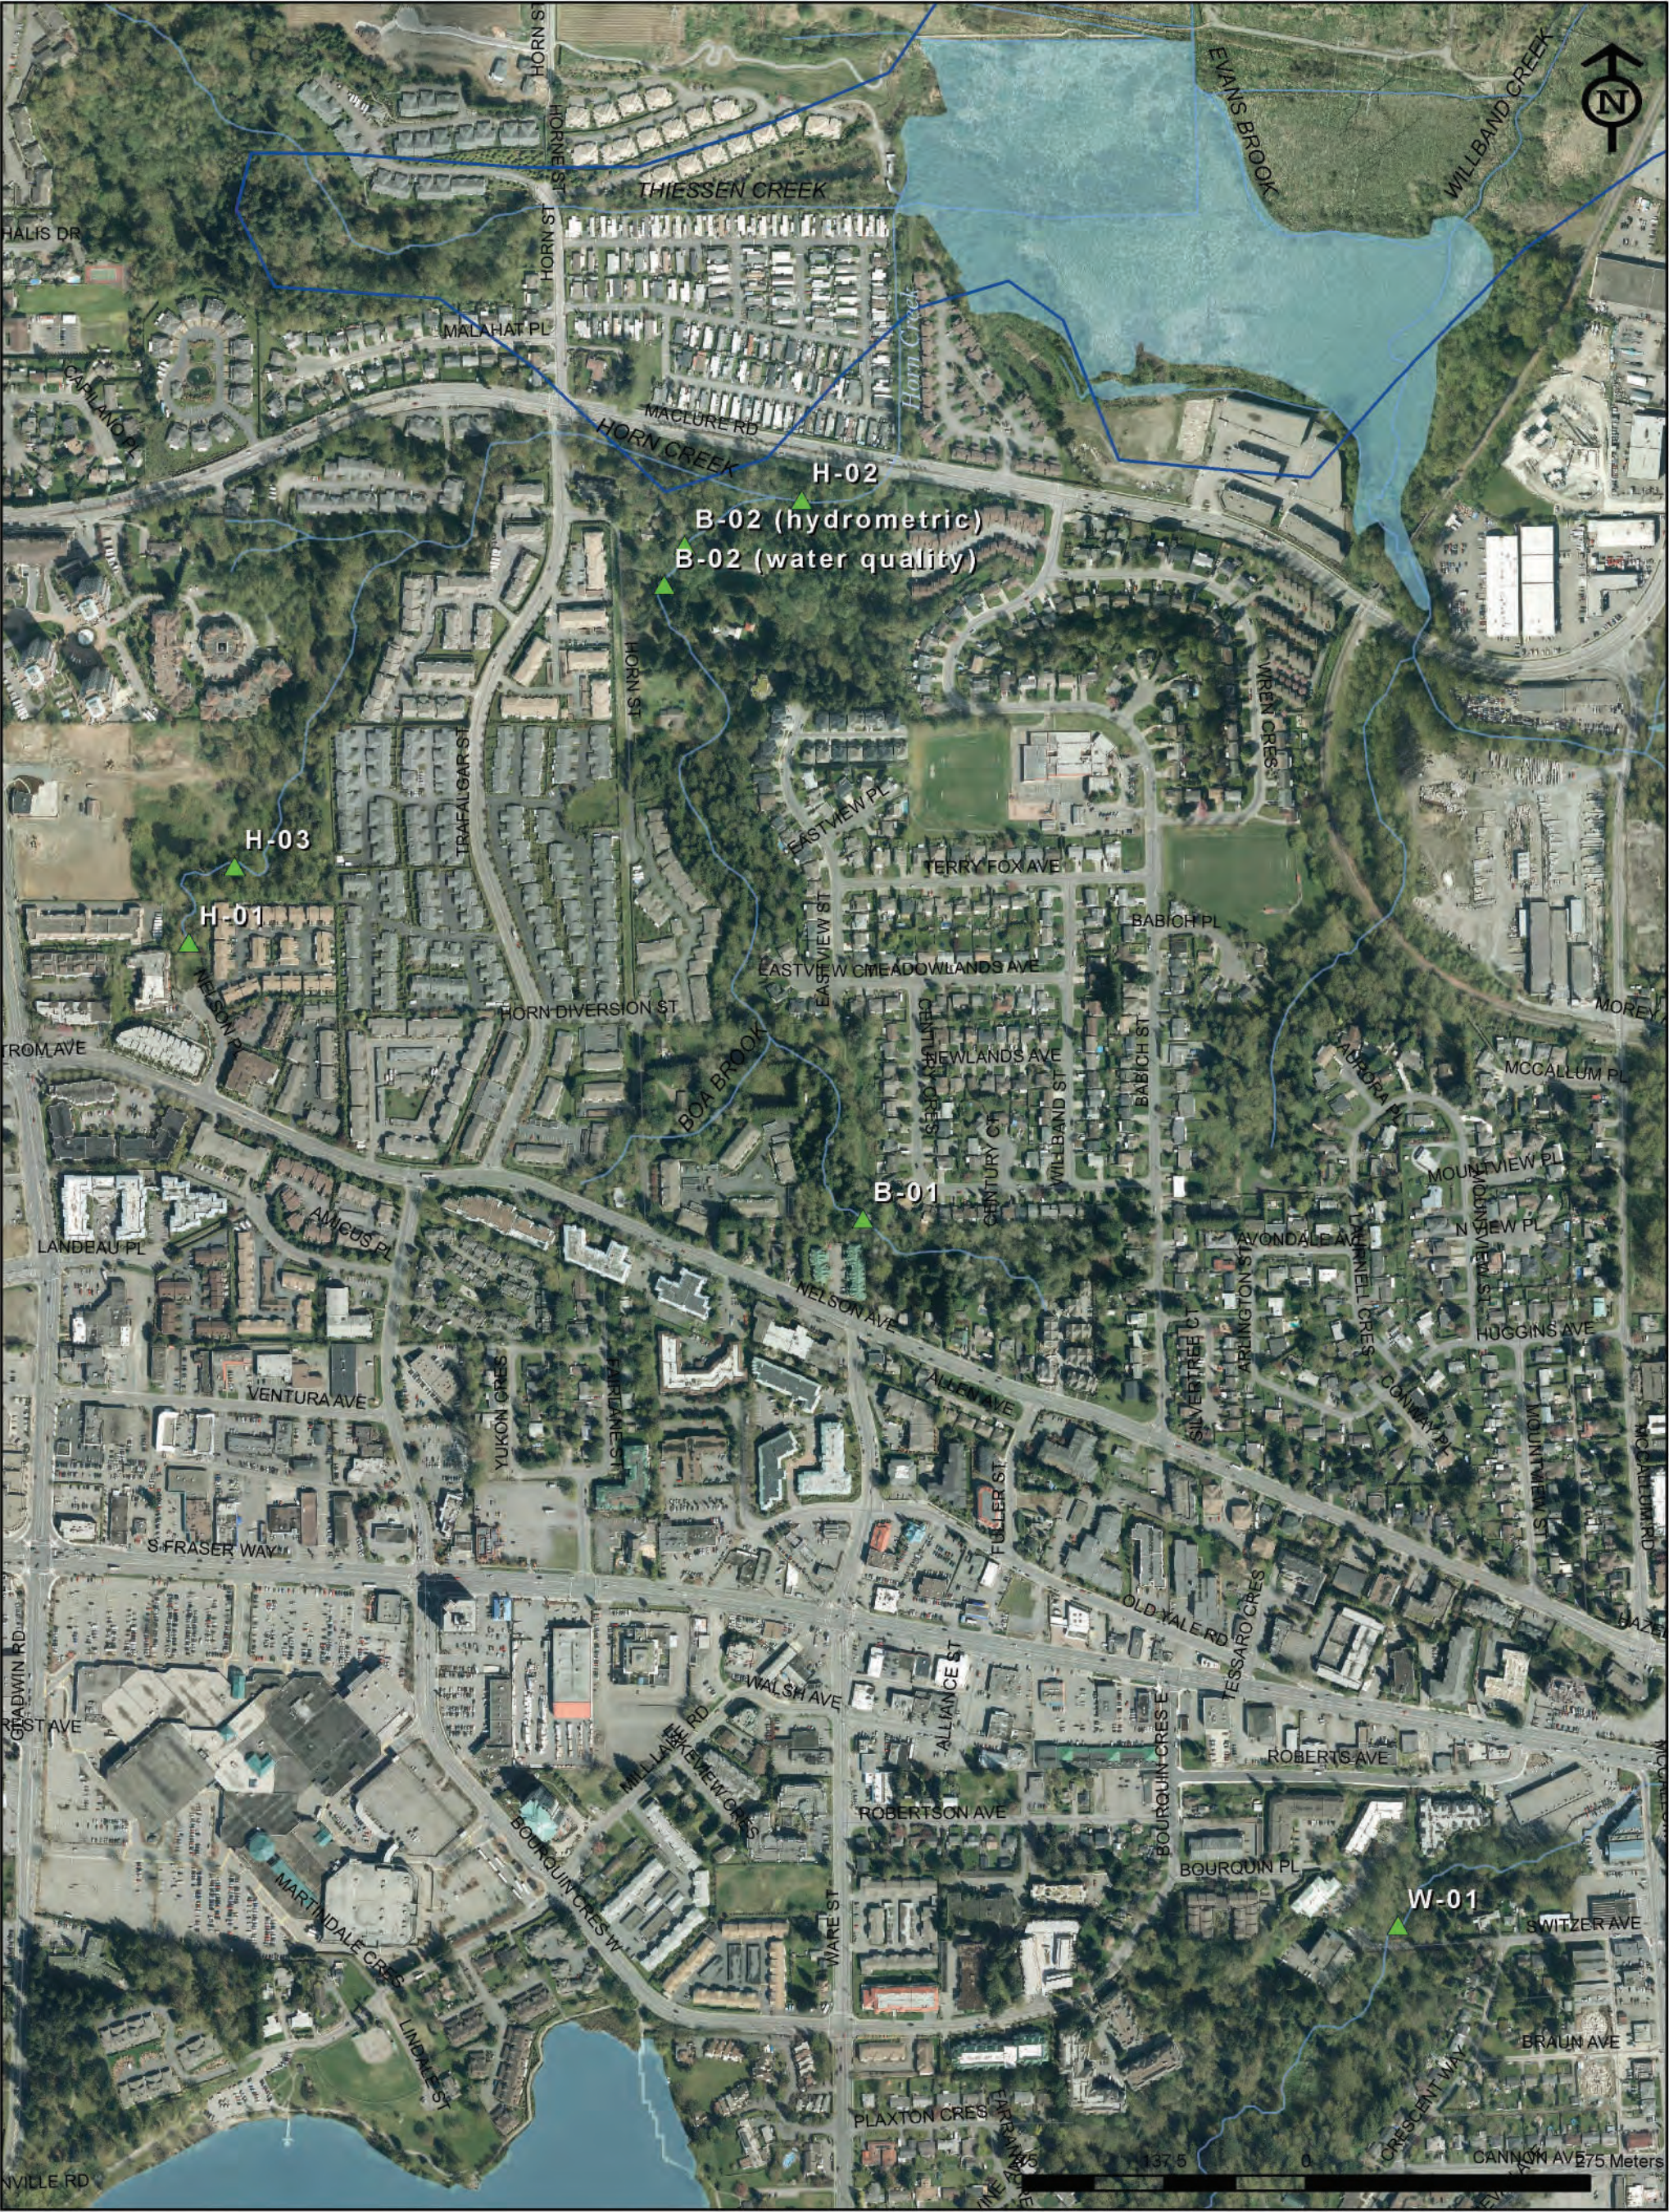
Figure 2-1

Water quality and/or stream flow measurements were taken at 15 sites (watercourses), and water levels were recorded at two sites (water bodies). These are described in Table 2-1 and shown in Figures 2-1 to Figure 2-3.

- H-02 on Horn Creek as a back-up to the SCADA system (Figure 2-1);
- B-02 to better characterize flows in Boa Brook on a continuous basis (Figure 2-1);
- D-02, D-03, and D-04 to characterize flows within the Downes Bowl tributaries to Downes Creek on a continuous basis (Figure 2-2); and
- WT-01 (on Waechter Creek in lieu of F-03) and F-04 to better characterize flows within Fishtrap Creek on a continuous basis (Figure 2-3).

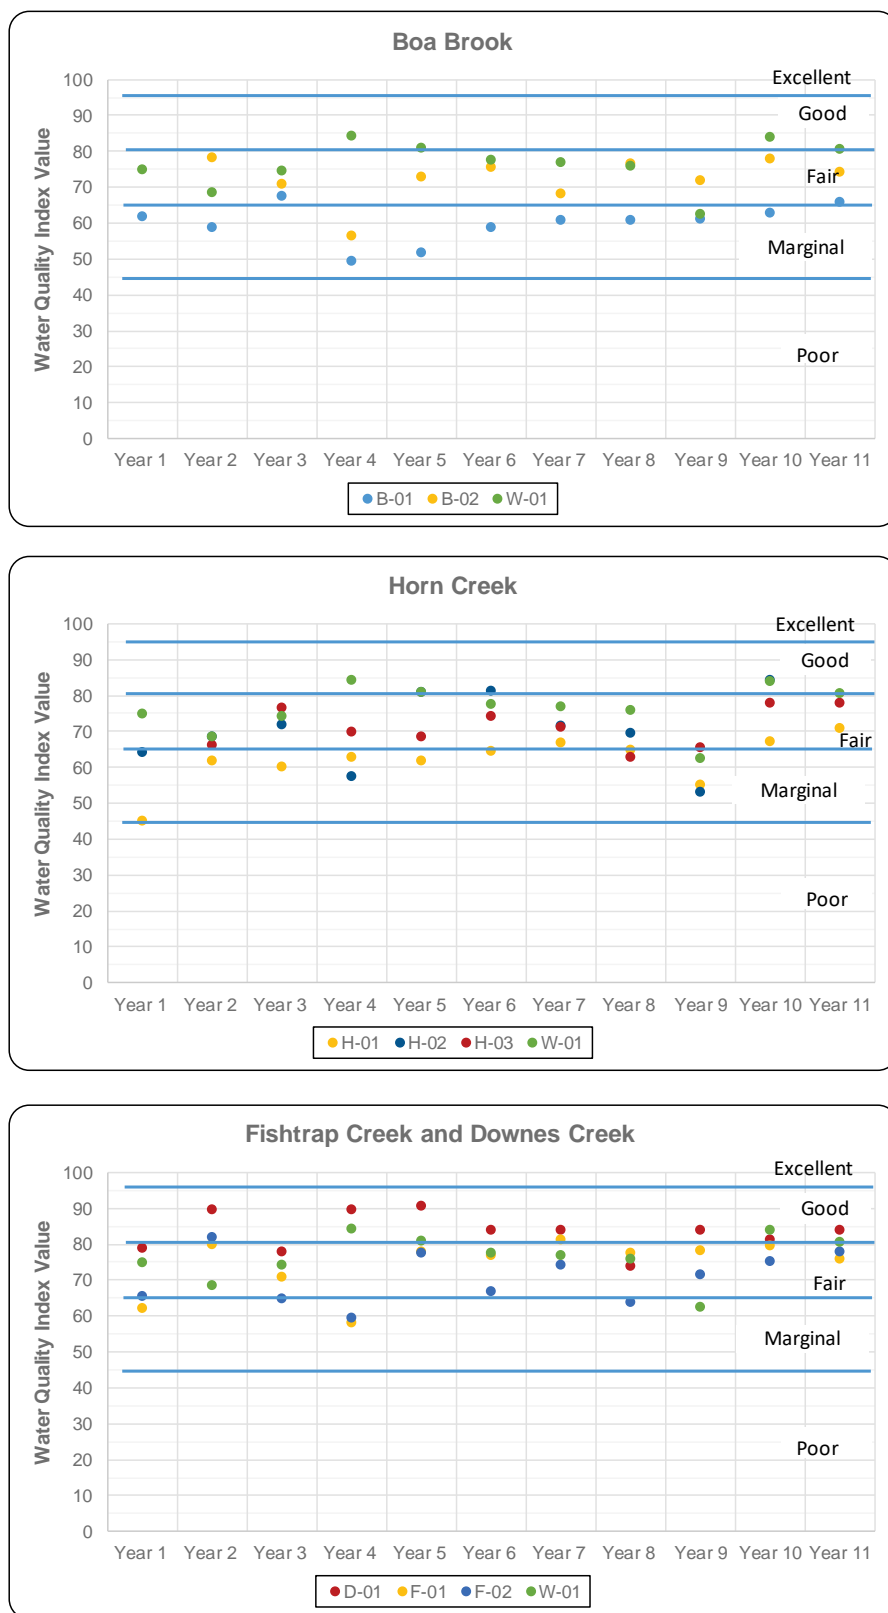
Figure 2-8 Variability in the CCME Water Quality Index, Year 1 to Year 11

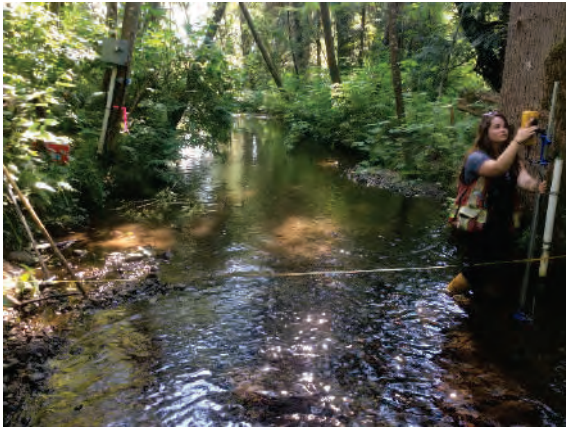
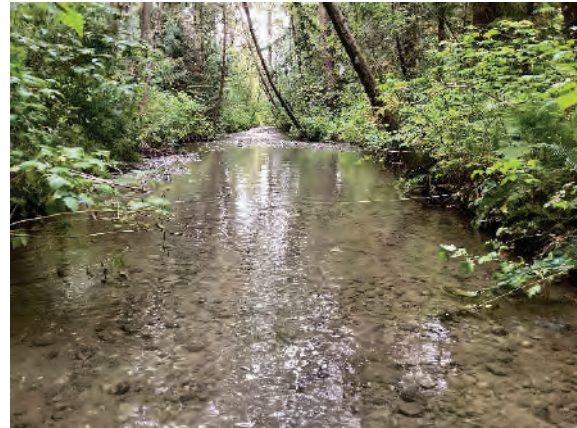
Photographs 3-1 Site 1 (Horn Creek) – July and September 2021

1A Facing Downstream (July 2021)

1B Facing Downstream (September 2021)

Channel morphology at Site 1 was straight, unconfined, and had a low gradient (1-2%). The reach has undercut banks, over hanging vegetation and trace amounts of instream vegetation and small woody debris (SWD). One piece of suspended large woody debris (LWD) upstream from Site 1A was swept downstream between the August 2020 and September 2020 monitoring visits. Deep pools were only observed at Site 1A.

The substrate at Site 1A shifted from a fines (40%) and gravel (55%) mix to primarily fines (83%) in September 2020. By July 2021 (Year 11) the substrate had shifted to 20% fines and 75% gravel, but the proportion of fines increased over the summer, reaching 60% in October. In September ENKON noted that the pool had infilled with fines. Minimal cobbles (5%) were present. D95 ranged from 11 cm to 18 cm for both sites. Embeddedness ranged from 15% to 30% throughout the reach during the four monitoring visits. Canopy closure was moderate for both sites, averaging 29% and 54% for Site 1A and Site 1B, respectively.

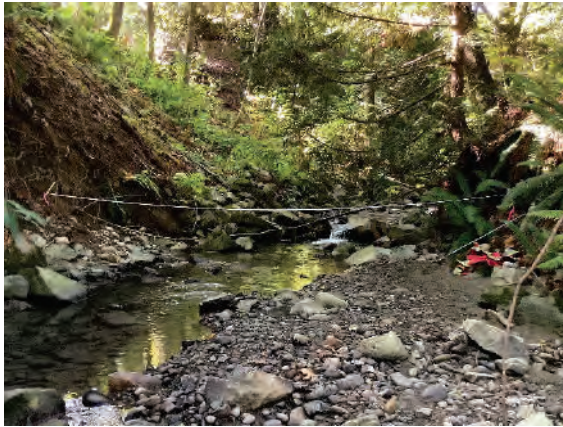
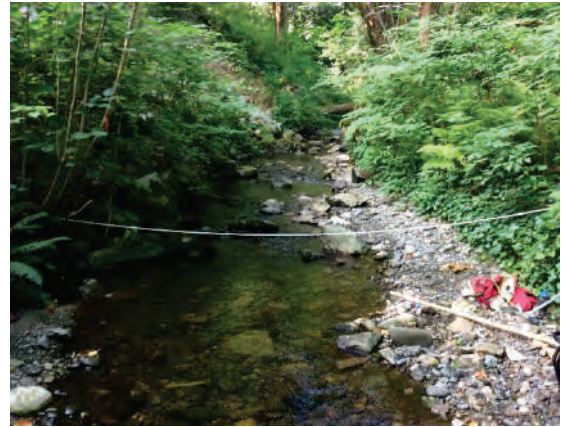
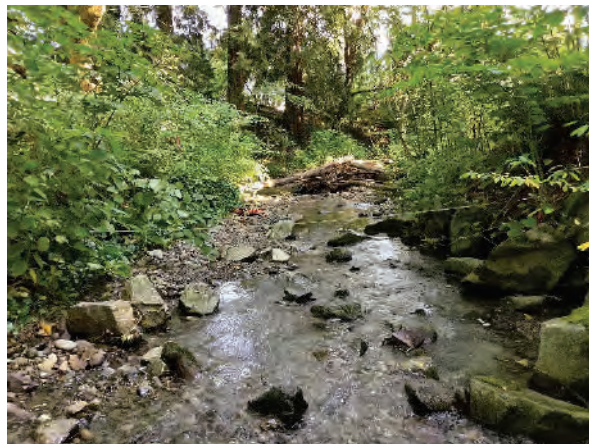
Photographs 3-2 Site 2 (Horn Creek) – July and September 2021

2A Facing Upstream (September 2021)

2B Facing Upstream (July 2021)

2C Facing Downstream (September 2021)

The average substrate embeddedness for this reach ranged from 11% at Site 2A and 2B to 10% at Site 2C in Year 11.

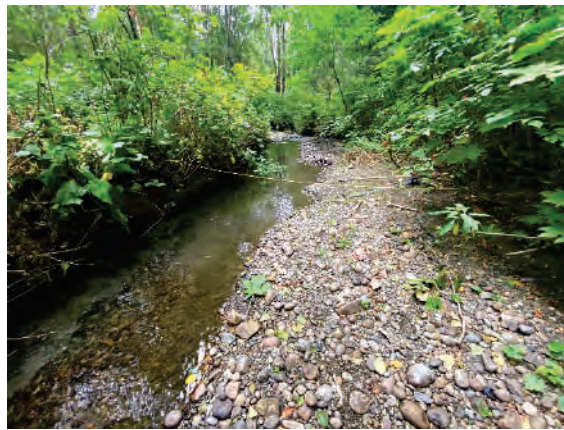
Photographs 3-3 Site 3 (Horn Creek) – August 2021

3A Facing Downstream

3B Facing Downstream

3C Facing Downstream

Channel morphology at Site 3 was straight and frequently confined with a gradient of 1% to 2%. Sand and gravel side bars were observed during all monitoring events. Site 3 had good rearing and overwintering habitat values, along with moderate spawning habitat values for salmonids.

The dominant substrate material at Site 3A (run mesohabitat) was gravel (60%). Fines served as the subdominant material (23%), with small amounts of cobble (13%) and boulders (5%). The dominant cover type was undercut banks with overhanging vegetation subdominant and deep pools subdominant in July 2021 only. Trace amounts of instream vegetation, LWD, SWD, and boulders were also present as potential cover. Crown closure ranged from 45% to 70%.

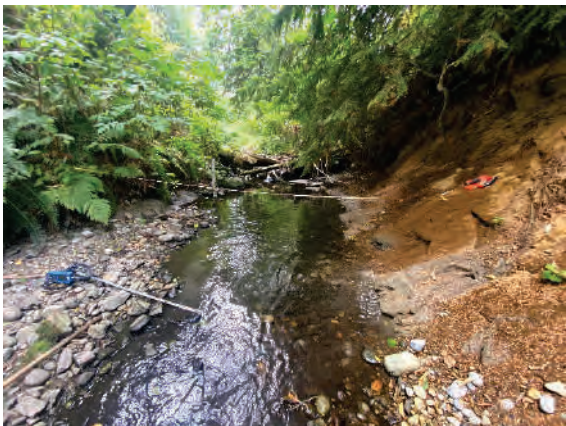
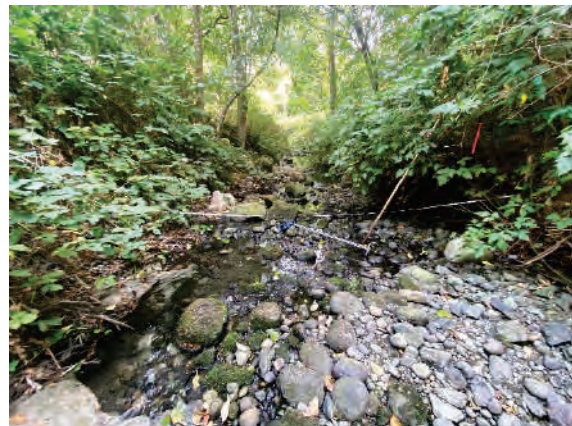
Photographs 3-4 Site 6 (Horn Creek) – August 2021

6A Facing Upstream

6B Facing Downstream

At the pool mesohabitat site (6A), substrate consisted of gravel (63%), fines (23%), and cobbles (14%). Deep pools were the dominant cover type for this site with overhanging vegetation and LWD being the subdominant. Other cover types were present in trace

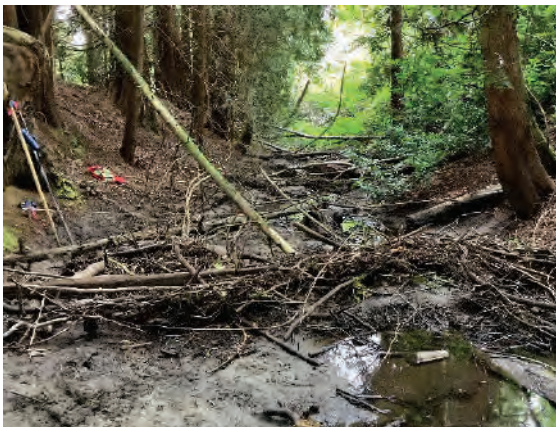
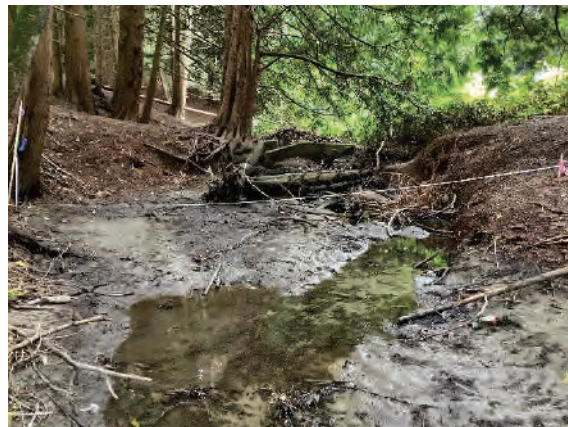
Photographs 3-5 Site 4 (Boa Brook) – September 2021

4A Facing Downstream

4B Facing Upstream

Site 4 had a confined, sinuous channel with a gradient of 1.5%. Side bars consisting of fines were present during most monitoring visits. Crown closure was variable, ranging from 10% to 20% in July, August, and September 2021 but reaching 95% in October at

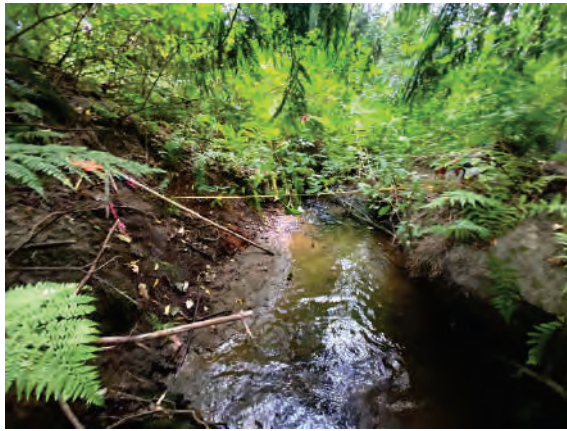
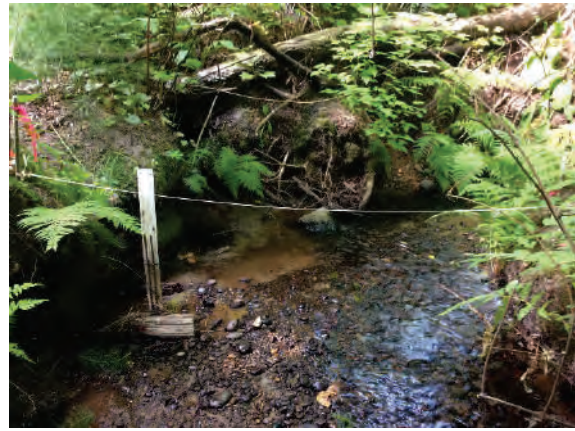
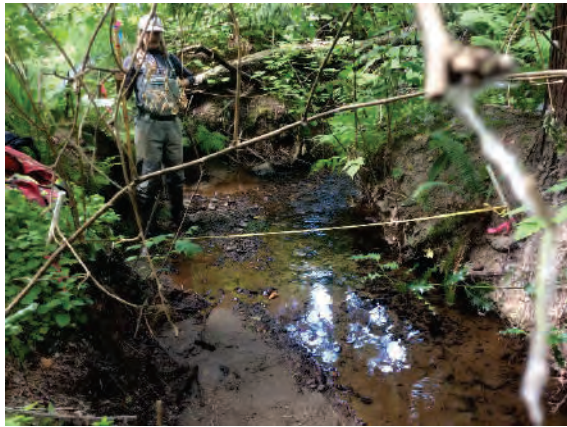
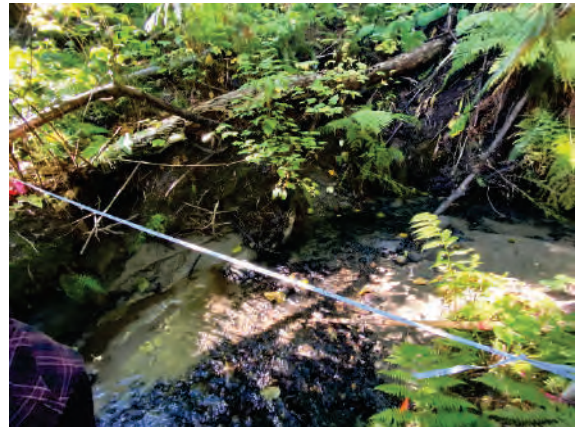
Photographs 3-6

Site 5 (Boa Brook) – Summer 2021

5A Facing Upstream (August 2021)

5B Facing Upstream (July 2021)

**5C Facing Upstream
(July 2021)**

**5D Facing Downstream
(September 2021)**

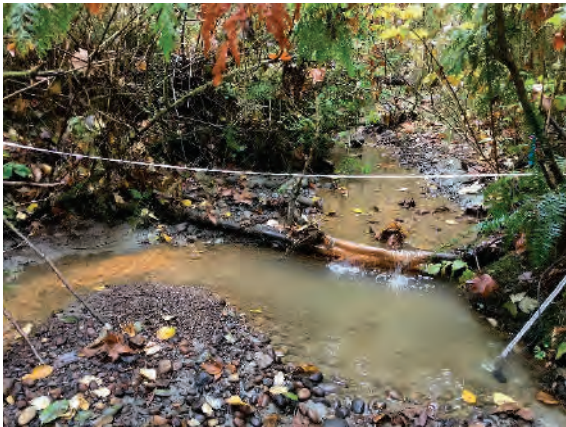
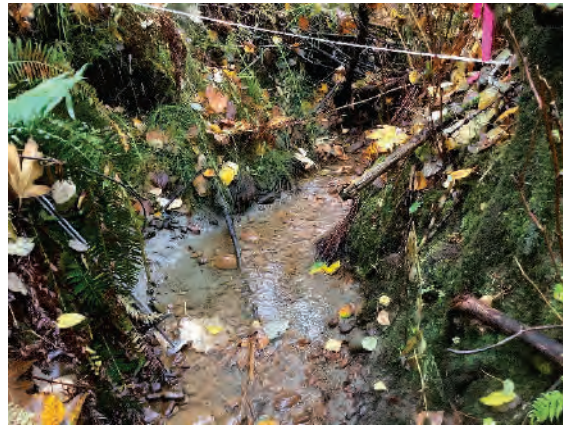
Photographs 3-7 D-02 (Downes Creek) – October 2021

On average, substrate at the D-02 riffle site consisted of 53% gravel and 48% fines. Between August and October 2021, the proportion of fines increased from 40% to 70%. A similar increase in fines was noted in October 2020. The dominant cover type at the riffle was overhanging vegetation with subdominant instream vegetation. Crown closure was high, averaging 94%. D95 averaged 6 cm with embeddeness at 21%.

Site D-02-Pool Facing Upstream

Site D-02-Riffle Facing Upstream

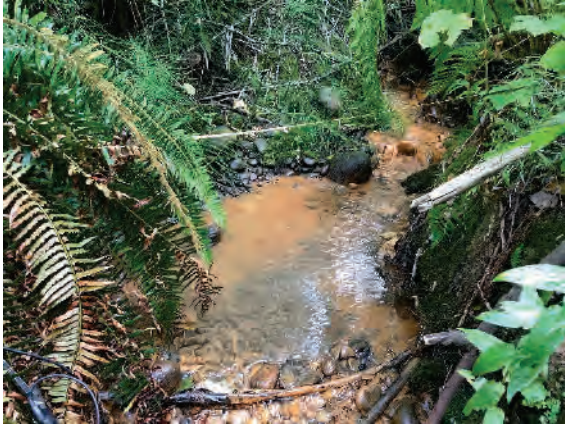
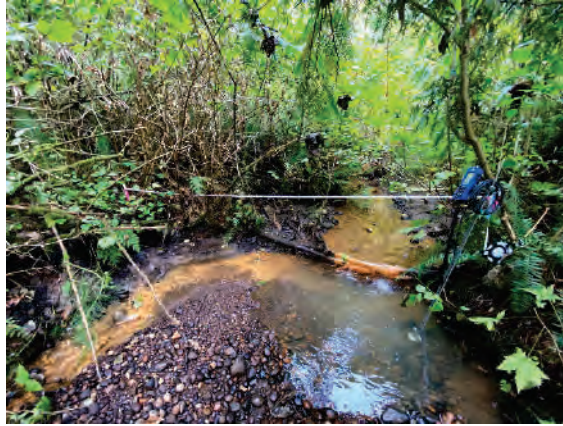
Photographs 3-8 D-03 (Downes Creek) – August and September 2021

and October). The pool mesohabitat substrate was predominately gravel (65%) and fines (29%) with a lesser amount of cobble (6%). The average substrate embeddedness at the riffle and pool mesohabitat were 18% and 8%, respectively. D95 ranged from 10 cm to 14 cm. Crown closure higher at the pool site (61%) than at the riffle site (38%).

**D-03 Riffle Facing Upstream
(August 2021)**

**D-03 Pool Facing Downstream
(September 2021)**

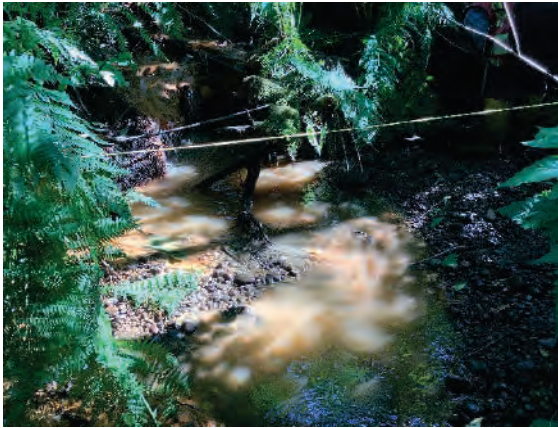
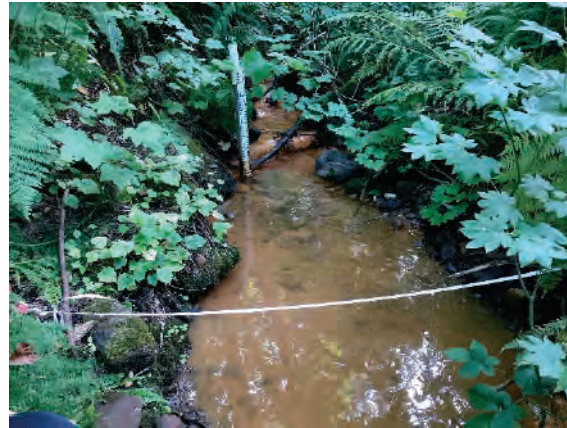
Photographs 3-9

D-04 Pool Facing Upstream

D-04 Riffle Facing Upstream

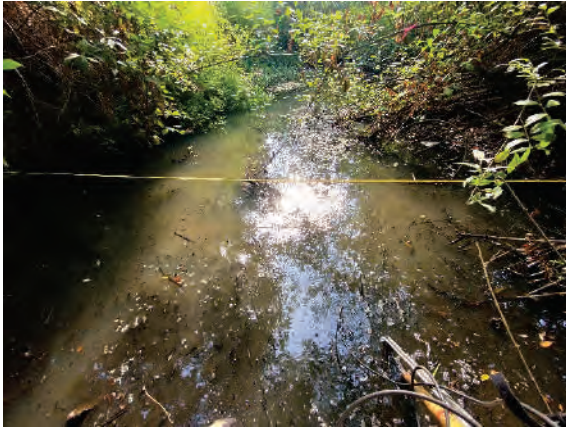
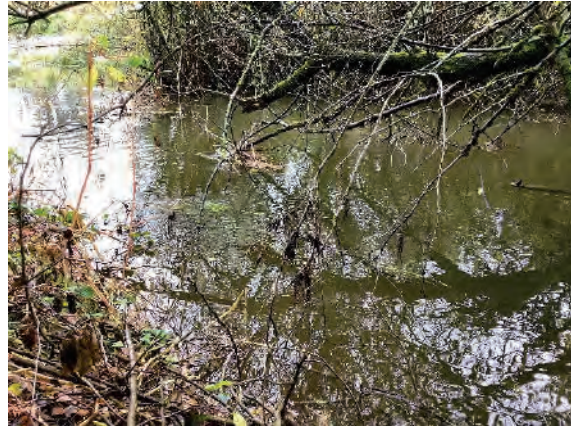
Photographs 3-10 F-01 (Fishtrap Creek) – August and October 2021

The pool site substrate was entirely fines from July through September 2021. The substrate composition shifted to 60% fines, 35% gravel, and 5% boulder in October when the water level was high. The dominant cover type was deep pool with SWD, overhanging vegetation, and instream vegetation as the subdominant types. Canopy closure increased from 35% in July to 80% in October.

**F-01 Pool Facing Upstream
(August 2021)**

**F-01 Riffle Facing Downstream
(October 2021)**

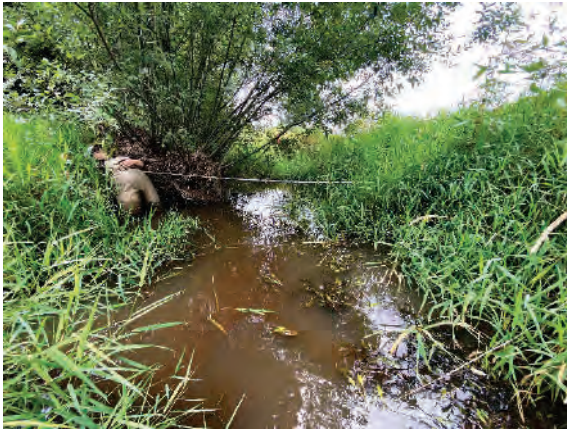
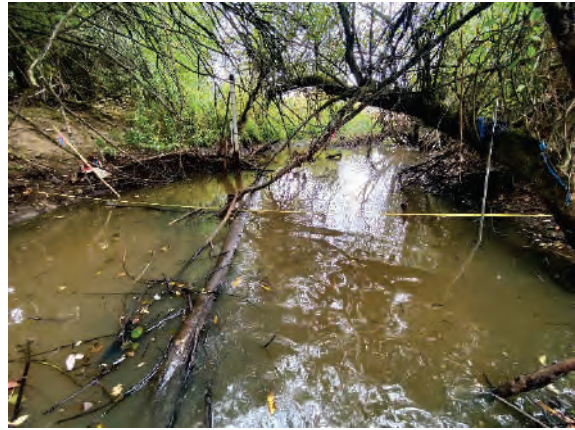
Photographs 3-11 F-02 (Fishtrap Creek) – August 2021

Substrate at the F-02 pool mesohabitat changed the 2021 monitoring period, with the proportion of fines increasing from 40% to 100% and gravel decreasing from 40%-50% to 0%. Average D95 was 10 cm with an average embeddedness of 17%. Cover for fish consisted of deep pool (dominant), with subdominant overhanging and instream vegetation. Undercut banks were subdominant in July only. SWD and LWD were also present, particularly in October. Crown closure averaged 65% at the pool mesohabitat site.

F-02 Pool Facing Upstream

F-02 Riffle Facing Downstream

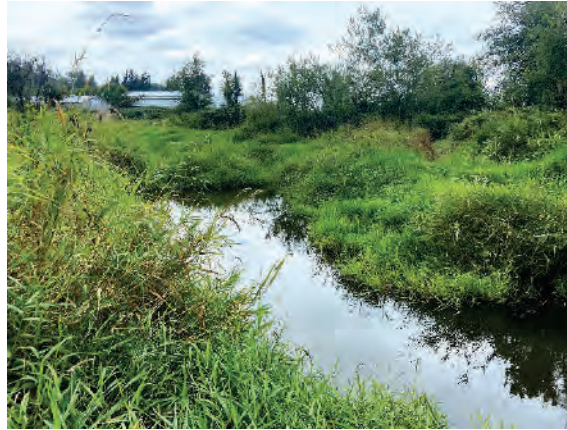
Photograph 3-12

F-03 Pool Facing Downstream

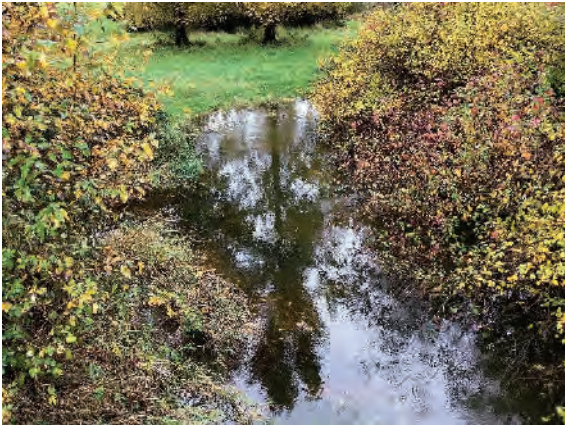
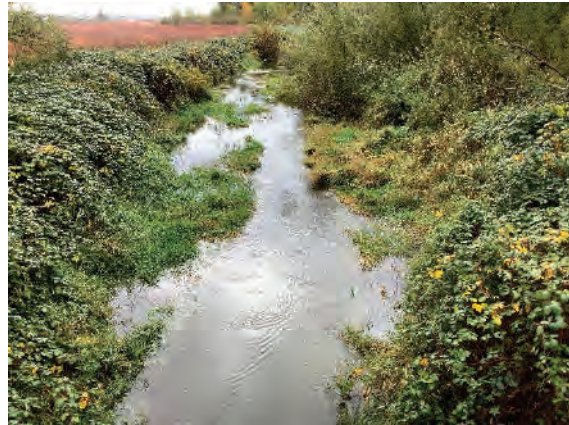
Photographs 3-13 F-04 (Fishtrap Creek) – October 2021

Water depth and clarity limited the visual assessment of substrate composition at the pool mesohabitat. Substrate at the pool mesohabitat averaged 85% fines, 10% gravel and 3% cobble. Cover was primarily deep pools with overhanging and instream vegetation as the subdominant cover. Trace amounts of boulders and undercut banks were present.

F-04 Pool Facing Upstream

F-04 Riffle Facing Downstream
