**CITY OF ABBOTSFORD  
UPDATED HYDROGEOLOGICAL ASSESSMENT  
BEVAN WELLS PROJECT**

## HYDROGRAPHS FOR 2011 TO 2022 SURFACE AND GROUNDWATER LEVEL TRENDS

## 5.0 SHALLOW GROUNDWATER MONITORING

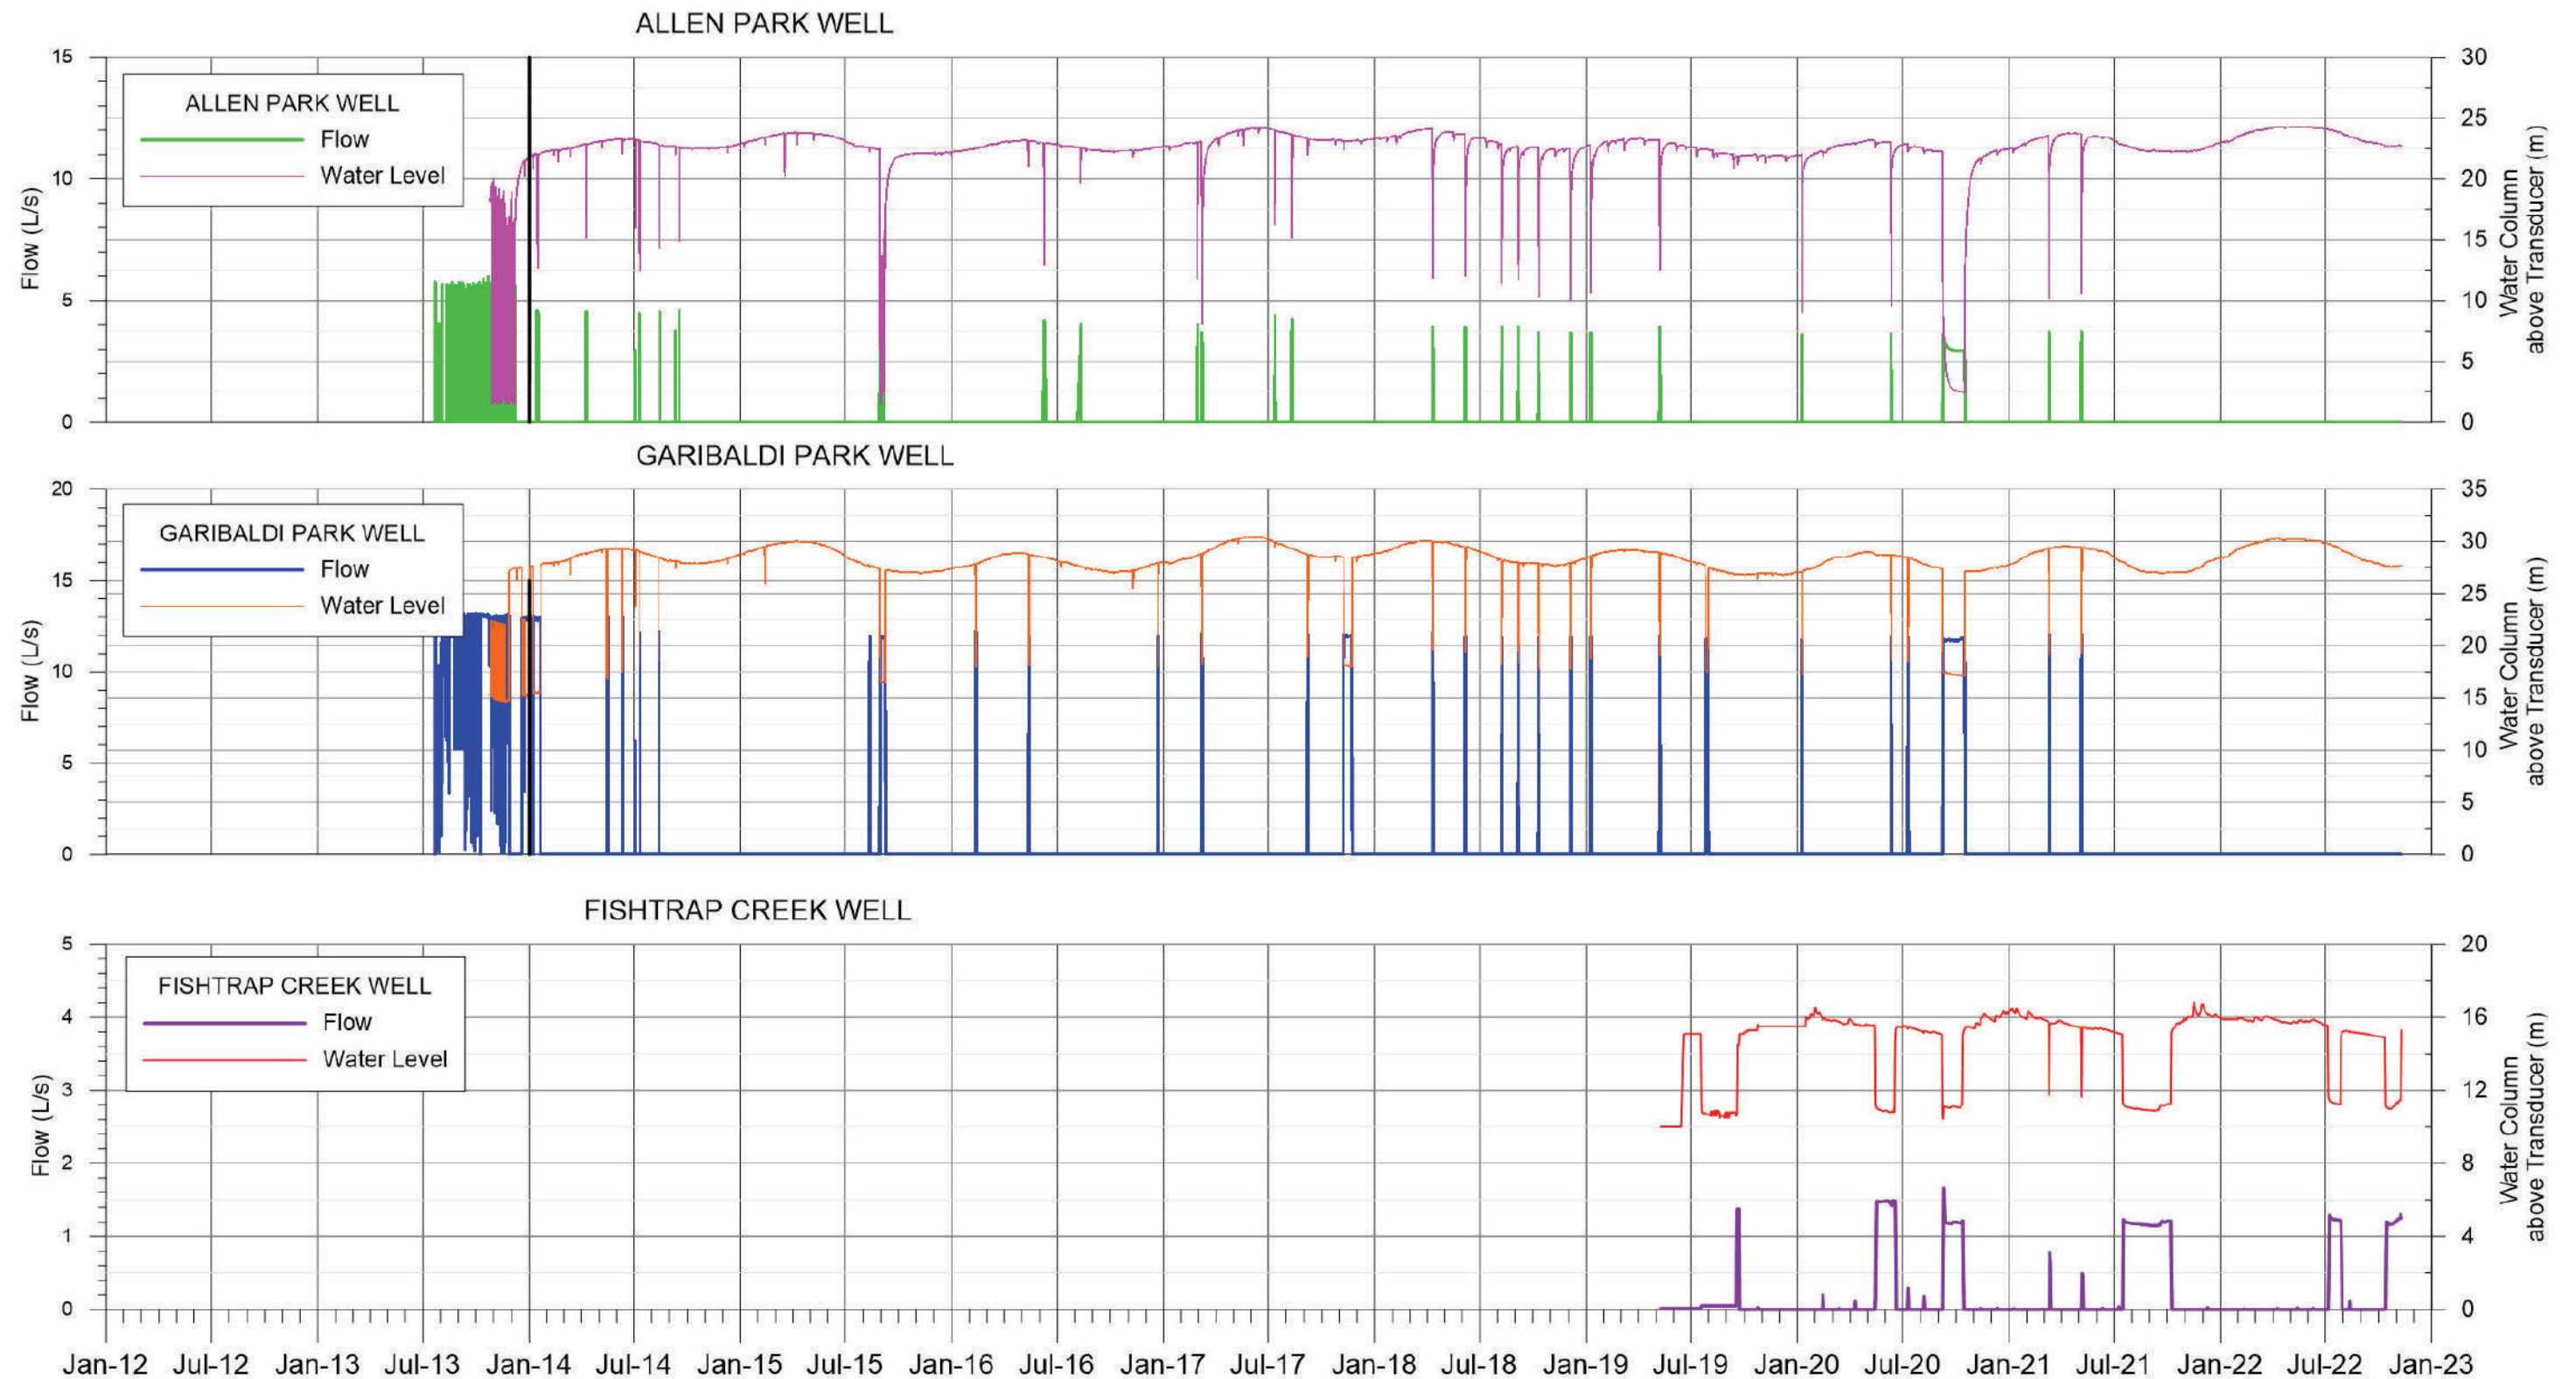
BY:	RC	DATE:	NOV 22
APPROVED:	DJT	FIG:	4-5

**GROUNDWATER LEVELS AND FLOWS IN MITIGATION WELLS**  
**AT ALLEN PARK, GARIBALDI PARK, AND FISHTRAP CREEK**

Having begun in 2013, the water level record for the Allen and Garibaldi wells (Figure 4-5) is shorter than for the observation wells shown on Figure 4-3. The non-pumping levels generally reflect the pattern noted in other observation wells but are somewhat more muted. Since 2014, the wells have been pumped for short durations for maintenance purposes. The Fishtrap Creek mitigation well was installed in 2019. Water level and pumping record in Fishtrap Creek mitigation well are shown on Figure 4-5.

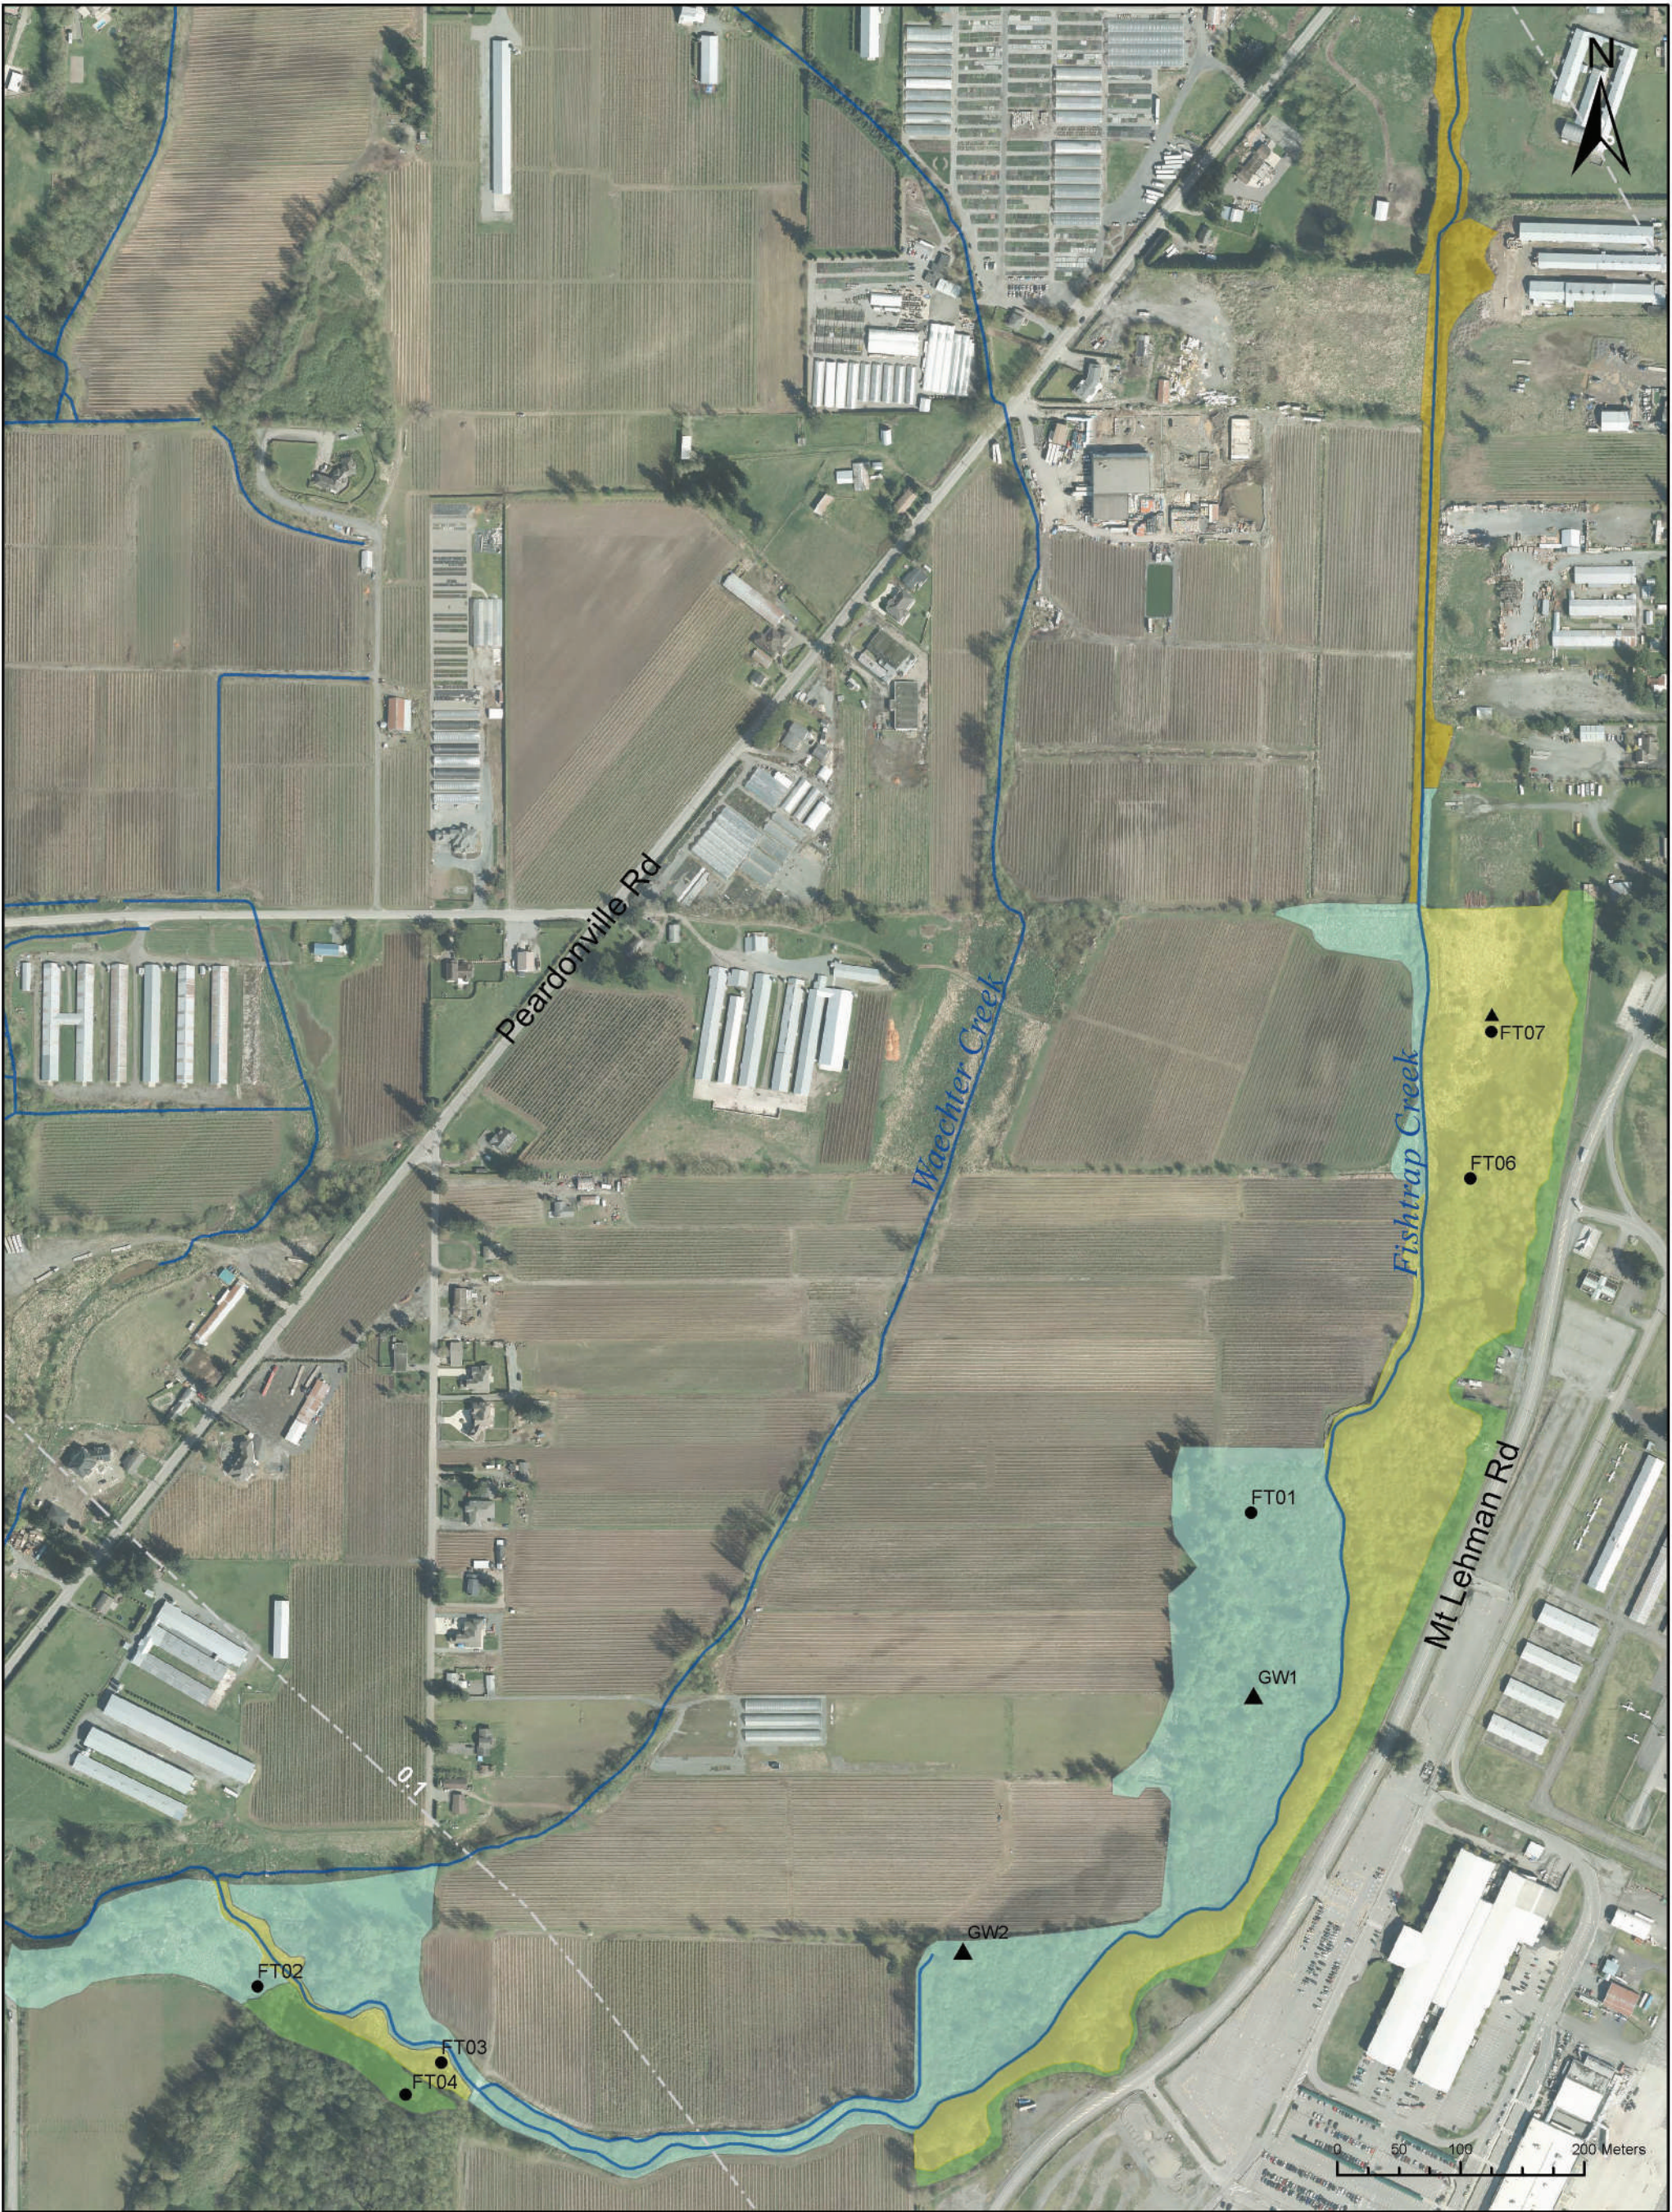
Figure 5-2

**Fishtrap Creek  
TEM Mapping and  
Monitoring Locations**

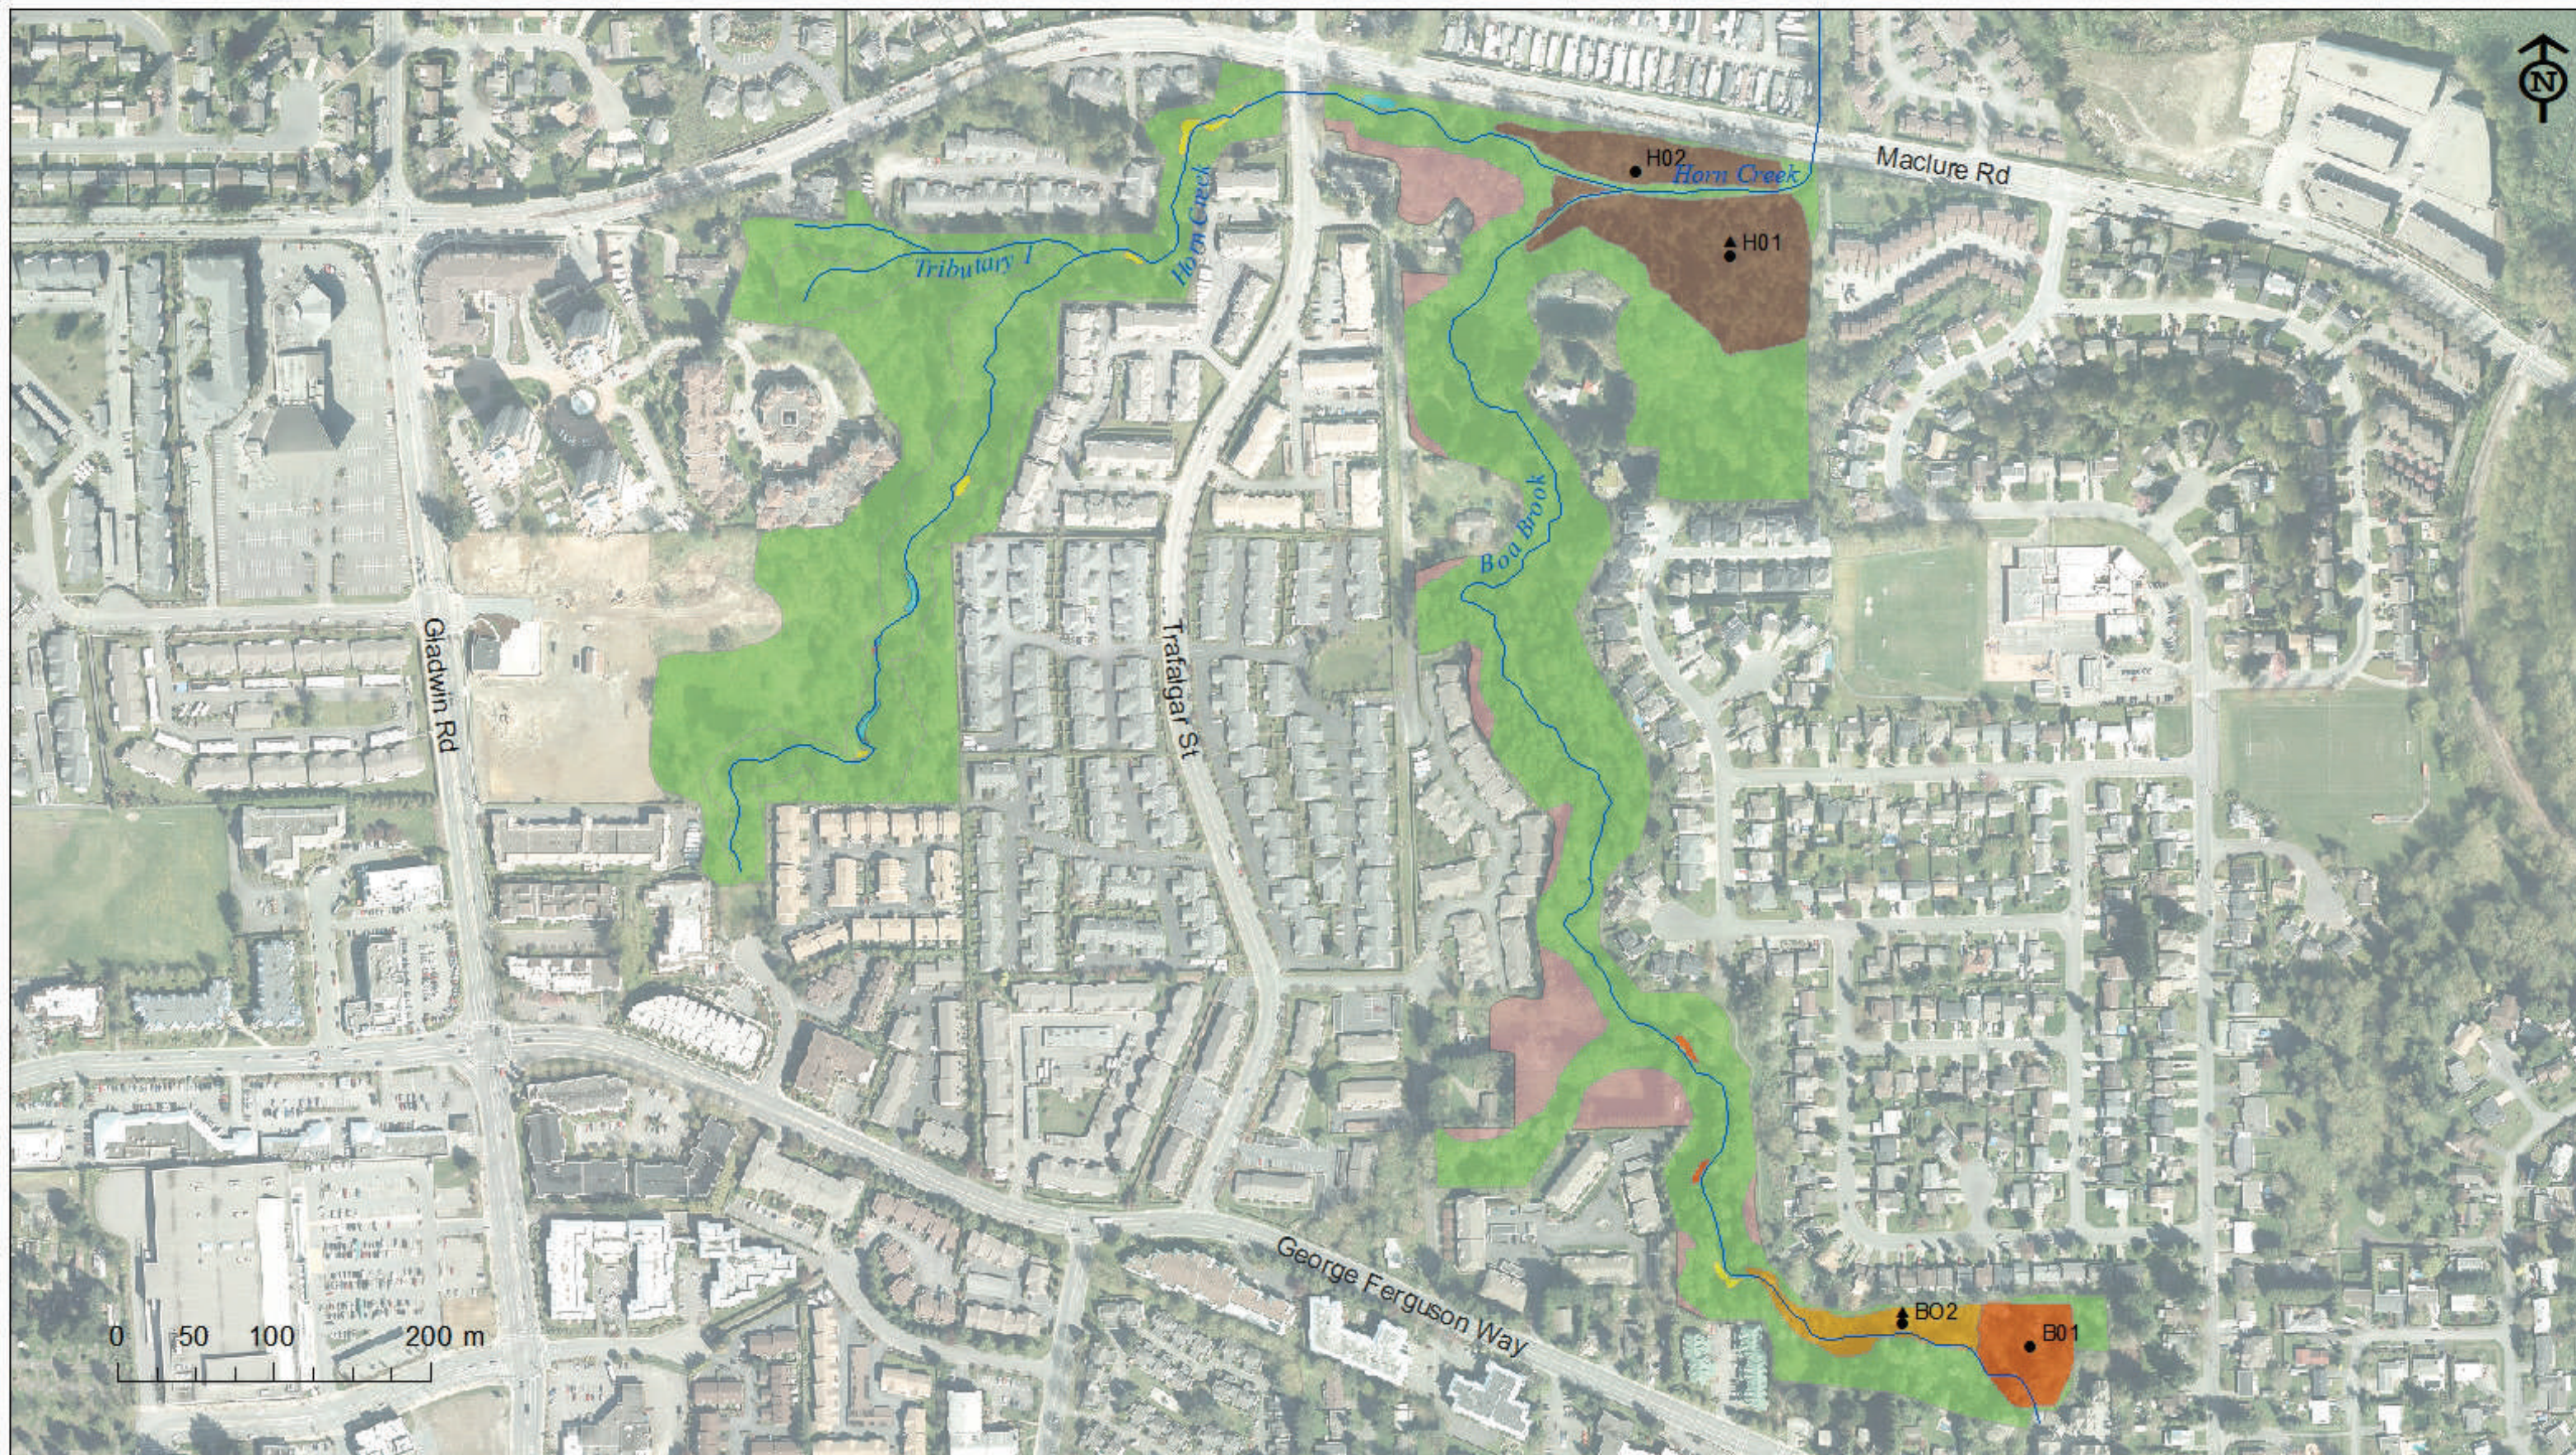
Figure 5-3

### Horn Creek and Boa Brook TEM Mapping and Monitoring Locations

Ten hydric indicator plant plots have been established within the watersheds of interest: 8 plots in the Downes Creek watershed (Figure 5-4) and 2 plots in the Horn Creek and Boa Brook watershed (Figure 5-3). Plot locations are distributed to capture a range of soil moisture conditions ranging from Wm05 sites in downstream confluence areas to Ws53 sites in watershed headwaters. Candidate plot sites required a minimum skunk cabbage patch size of 15m in diameter. Where possible, these plots were installed adjacent to terrestrial ecosystem mapping plots (Section 6.1.2). At Horn Creek, the terrain within the

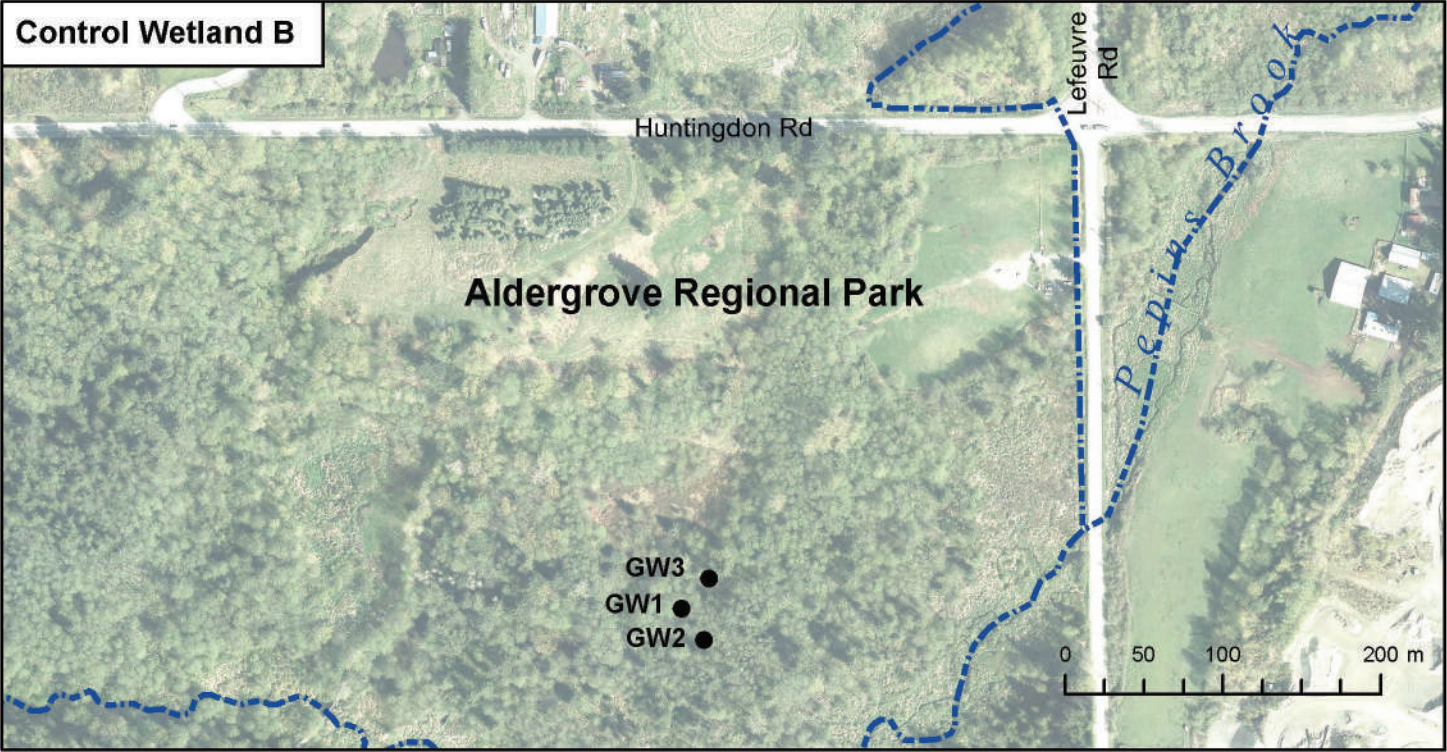
**Figure 5-5**

**Control Wetlands**  
**Shallow Groundwater Well Locations**

In spring of 2018, shallow groundwater wells were installed in three study areas within the zone of influence and at three control wetlands (Figure 5-1). Study areas include Fishtrap Creek (3 wells; Figure 5-2), Horn Creek and Boa Brook (2 wells; Figure 5-3), and Downes Creek (8 wells; Figure 5-4). Well installation for the three study areas and the control wetlands took place in spring of 2018. Three groundwater wells were installed at each of the control wetlands (Figure 5-5). Locations of shallow groundwater wells are recorded in Appendix M.
