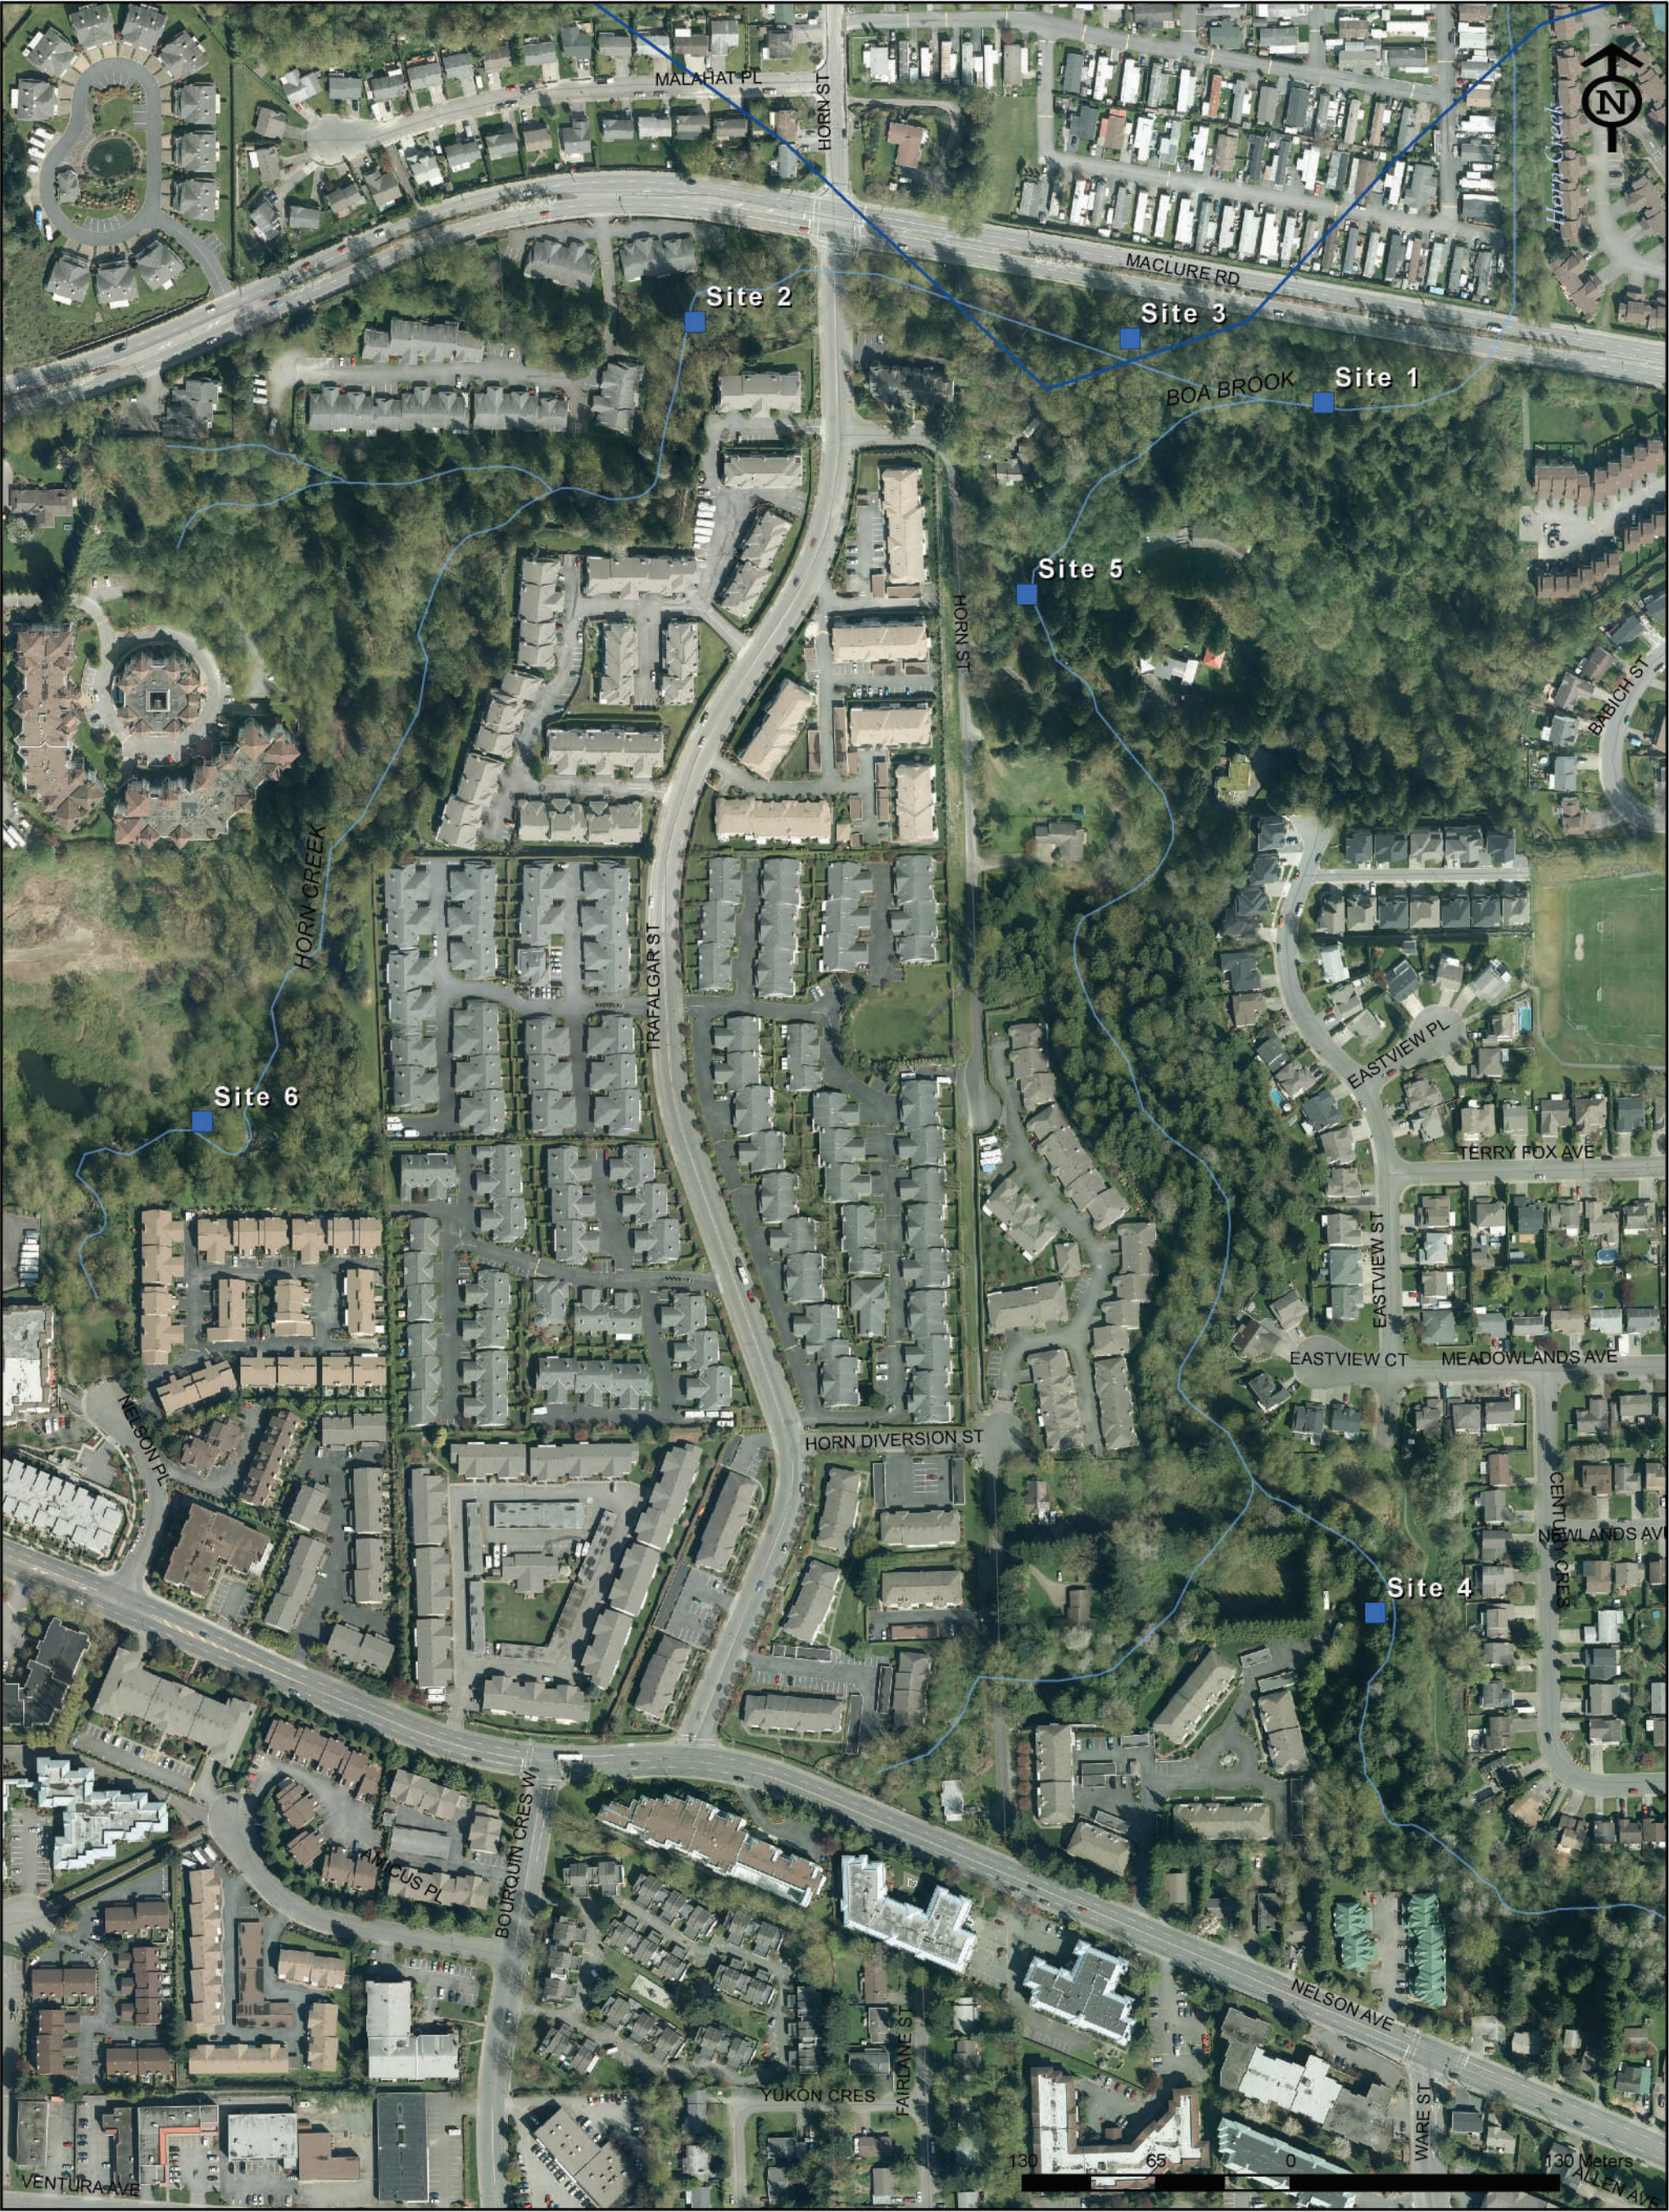
| <b>Legend</b><br><br><div><div></div> Mesohabitat site</div> <div><div></div> Abbotsford-Sumas aquifer</div> <div><div></div> Streams</div> <div><div></div> Waterbody</div> | <div></div> <div>Prepared by:<br/><b>ENKON</b><br/>Environmental Ltd.</div> | <b>Horn Creek and Boa Brook<br/>Mesohabitat Monitoring Sites</b> |

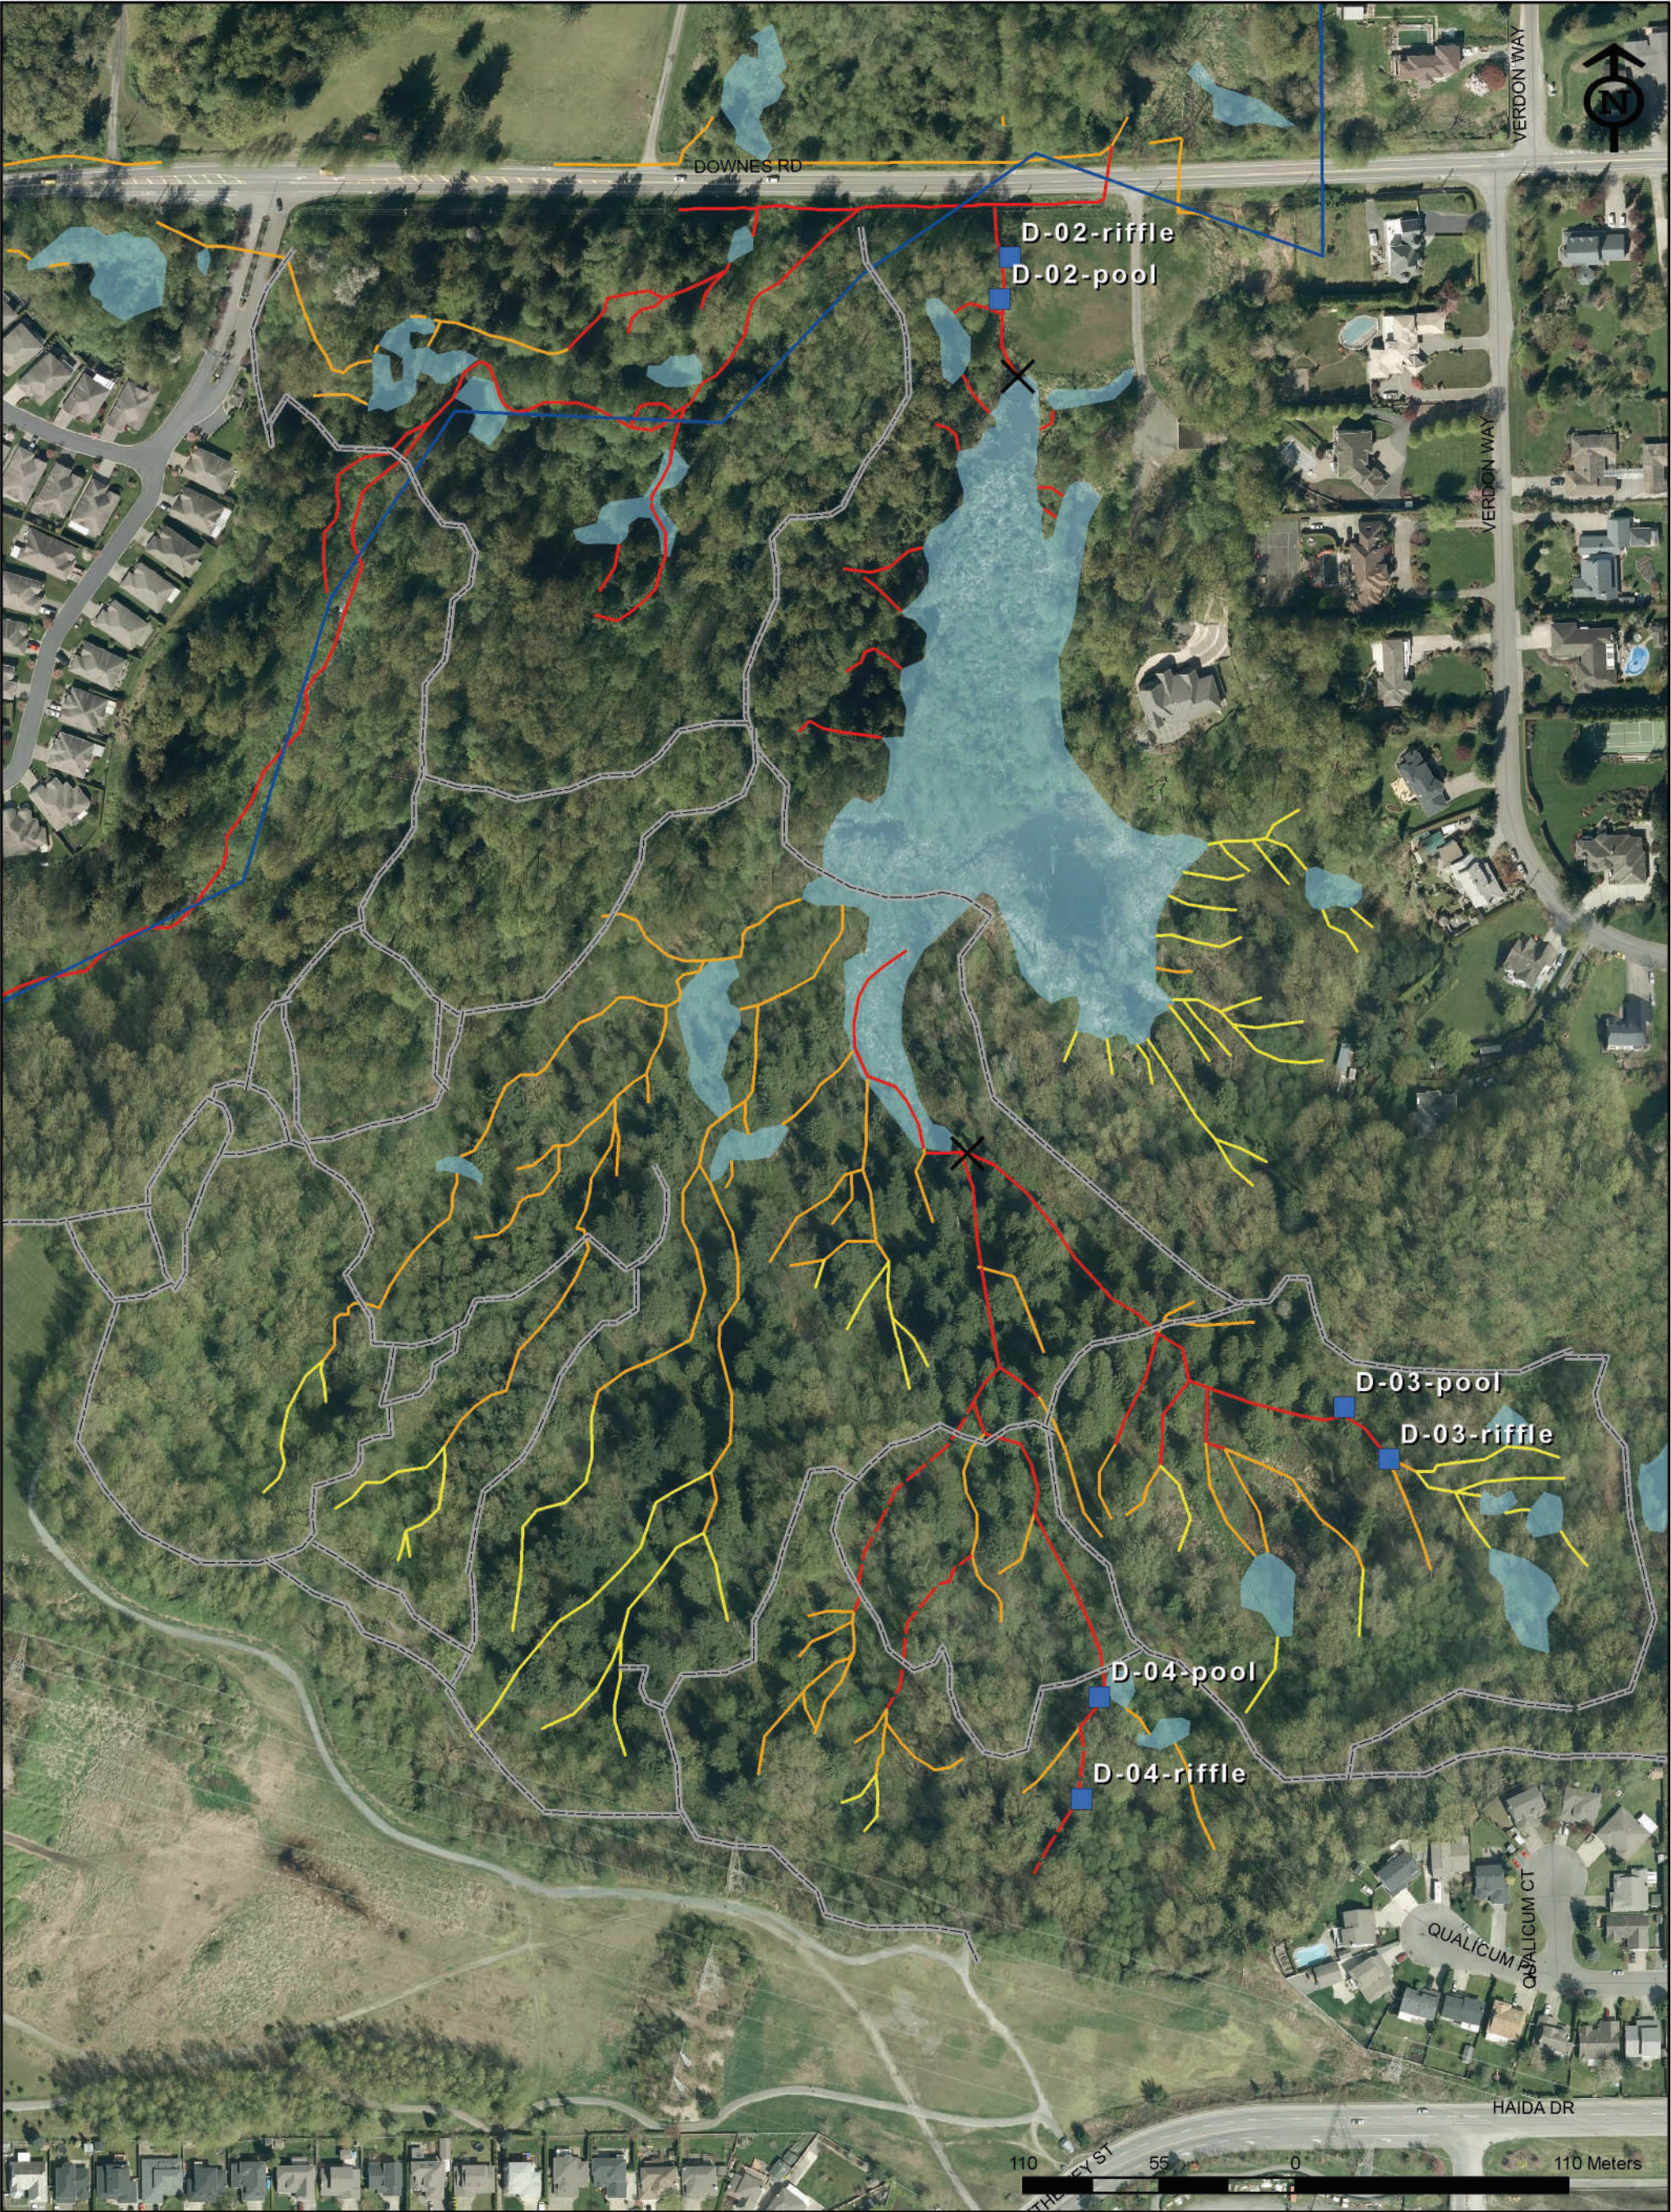
| <div><b>Legend</b></div> <div><div><div><div><div></div></div><div>Mesohabitat site</div></div><div><div><div></div></div><div>DownesTrails</div></div><div><div><div></div></div><div>Abbotsford-Sumas aquifer</div></div><div><div><div></div></div><div>Waterbody</div></div></div><div><div><b>Watercourses (CoA Modified)</b></div><div><div><div></div><div>Class A (fish-bearing)</div></div><div><div></div><div>Class Ao (overwintering)</div></div><div><div></div><div>Class B (food and nutrient)</div></div><div><div></div><div>Permanent (Unclassified)</div></div></div></div><div><div><div><div><div></div><div>ENKON</div><div>Environmental Ltd.</div></div><div><div>Prepared by:</div><div>ENKON</div><div>Environmental Ltd.</div></div></div><div><div>Created: December 2019</div><div>Projection: NAD 83 UTM Zone 10N</div><div>1:2,500</div></div></div><div><div><div>Downes Creek</div><div>Mesohabitat Monitoring Sites</div></div><div><div>City of Abbotsford</div></div><div><div>Figure 3-2</div></div></div></div></div> |

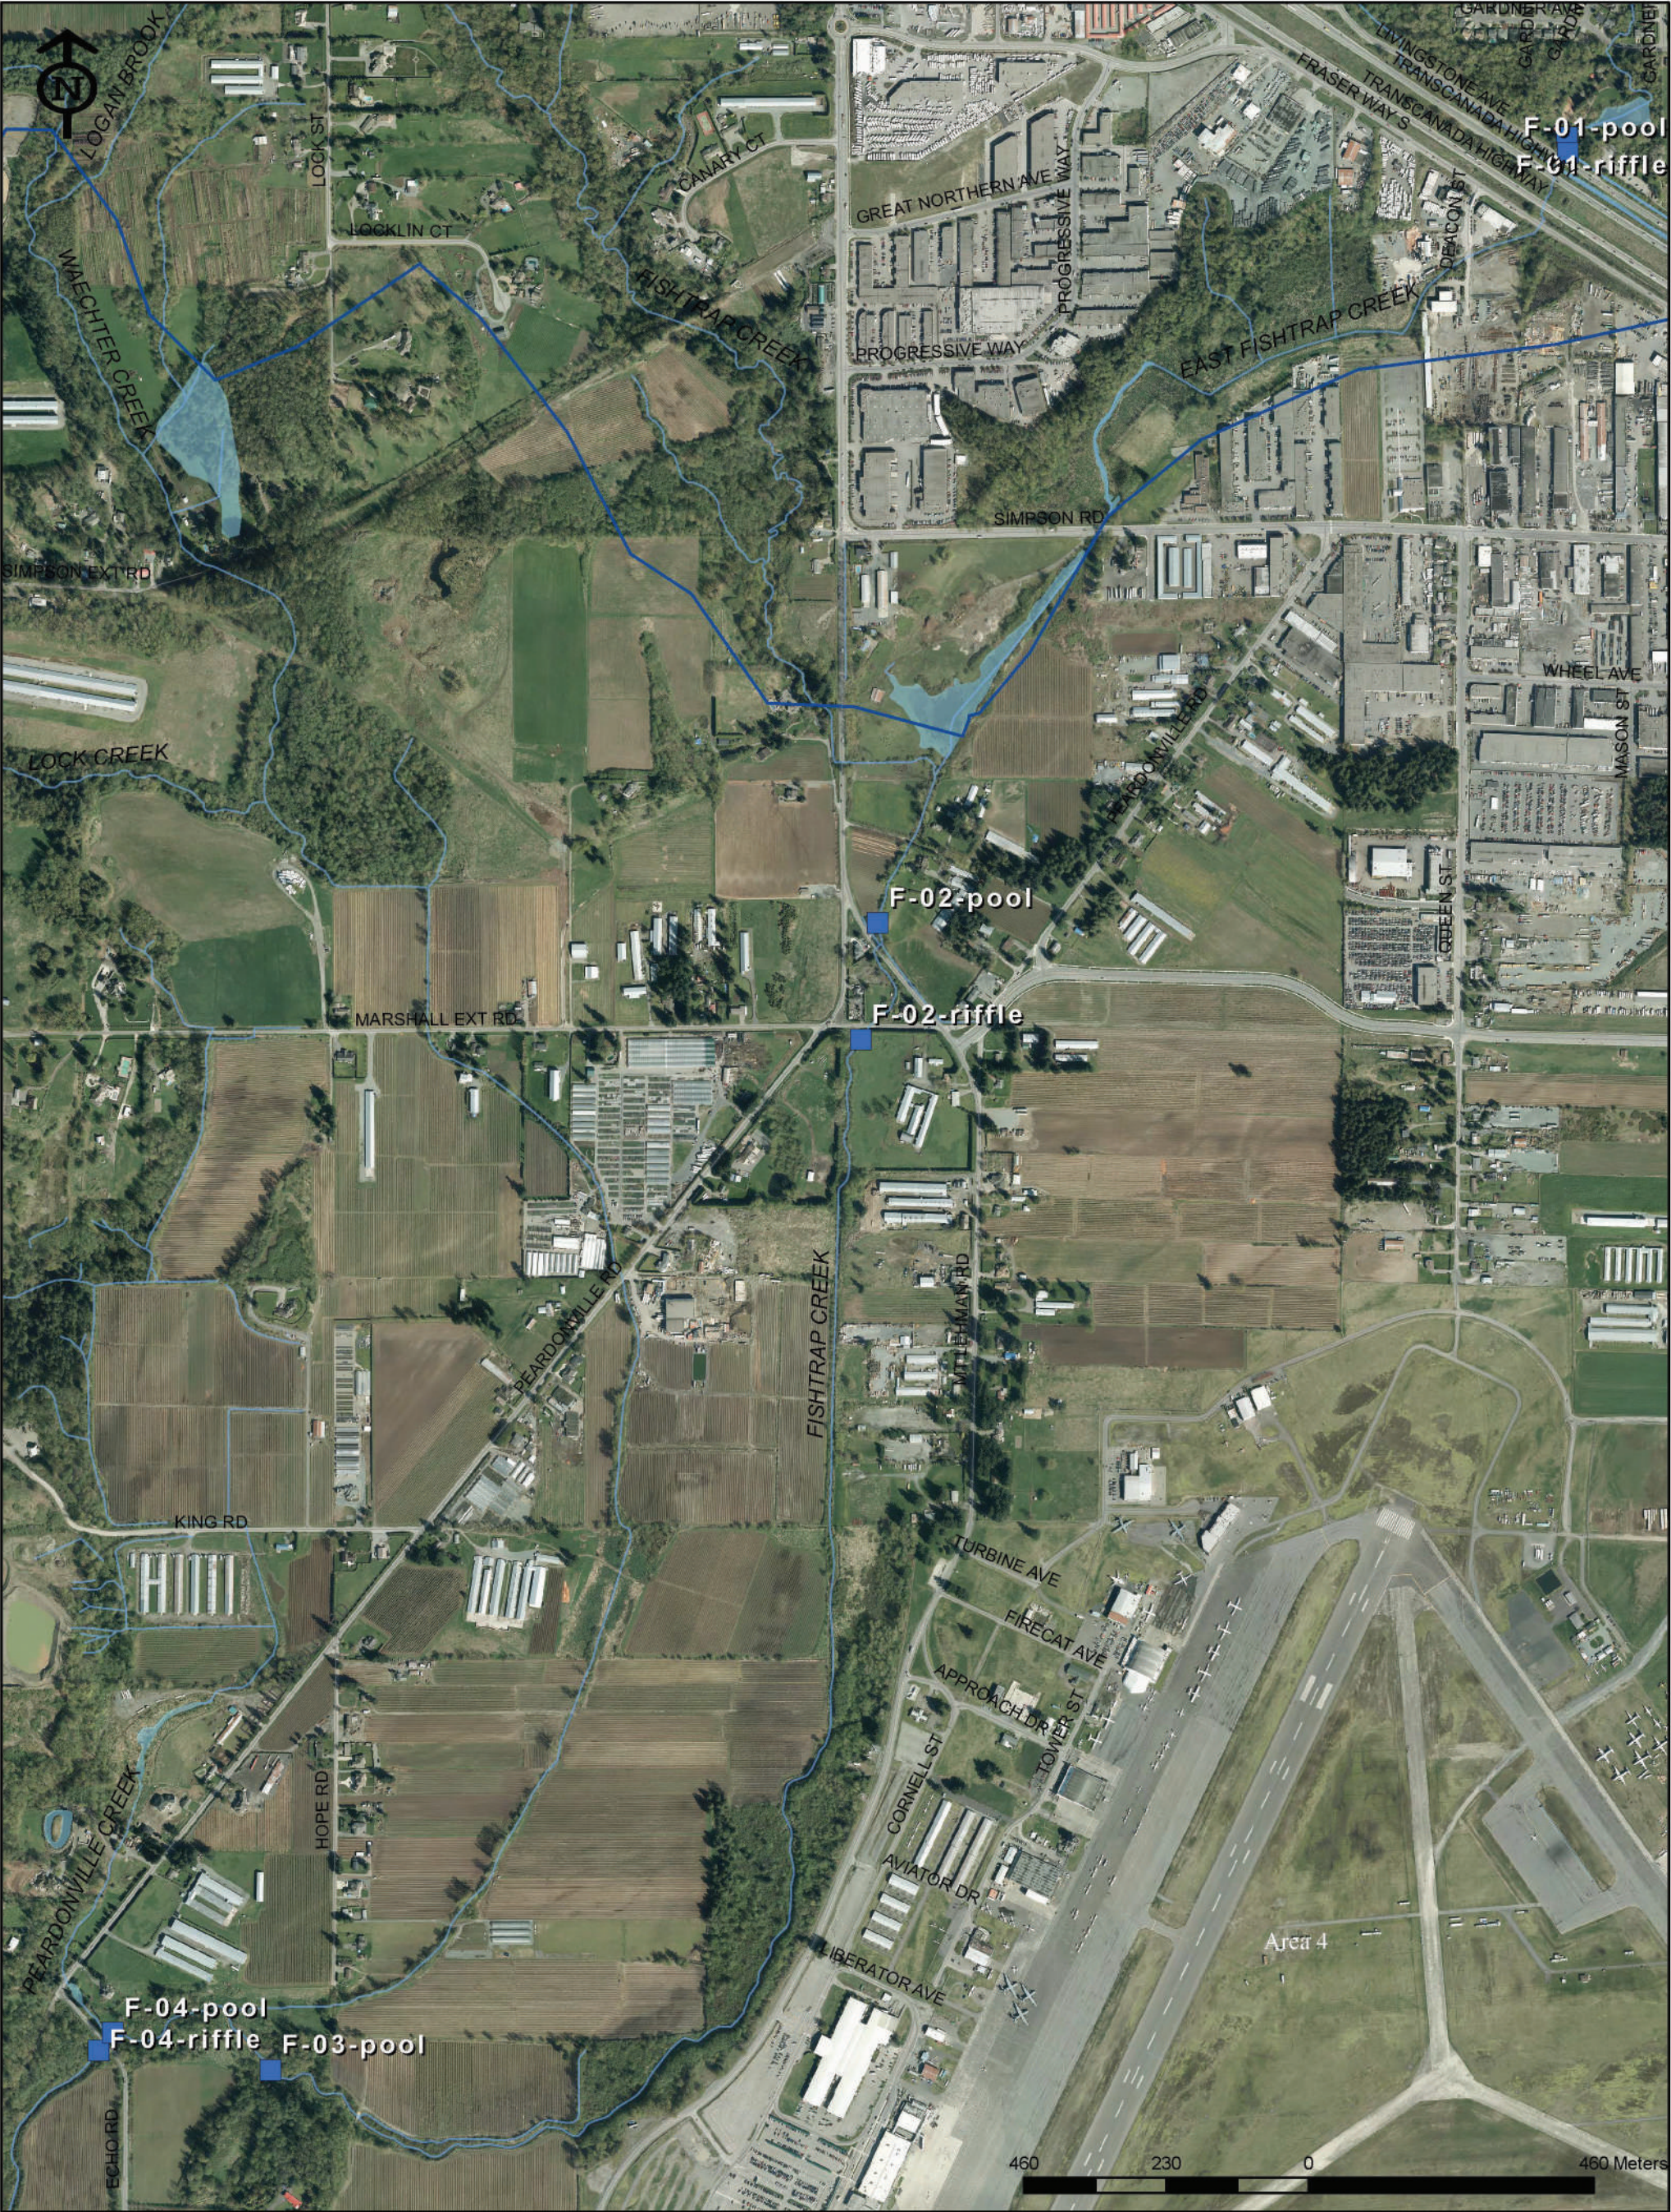
| <b>Legend</b><br><br><div><div></div> Mesohabitat site</div> <div><div></div> Abbotsford-Sumas aquifer</div> <div><div></div> Streams</div> <div><div></div> Waterbody</div> | <div><div>Prepared by:<br/><b>ENKON</b><br/>Environmental Ltd.</div></div> | <b>Fishtrap Creek<br/>Mesohabitat Monitoring Sites</b> |

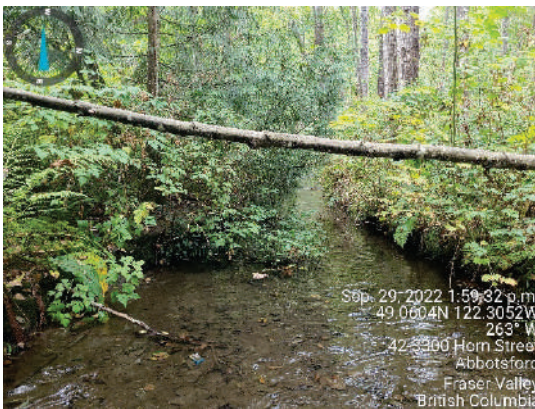
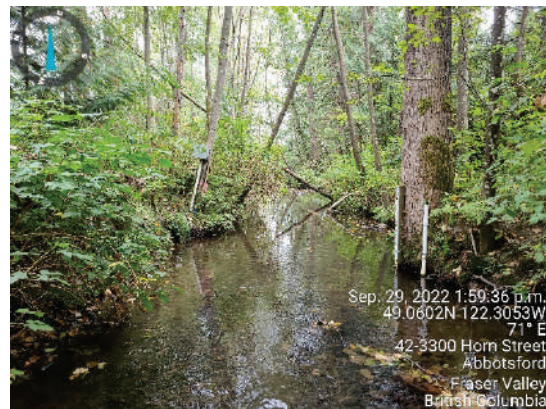
**Photograph 3-1**

**Site 1 (Horn Creek) – September 2022**

**1A Riffle—looking upstream**

**1B Pool—looking downstream**

Channel morphology at Site 1 over the 2022 season, ranging from straight and confined in July, August, and October to straight and frequently confined in September. The reach had a gradient of 2- 4%. Observations of small woody debris (SWD) and large woody debris (LWD) varied between monitoring visits. In July and October 2022, trace amounts of SWD were observed, and LWD was subdominant. In August, trace amounts of LWD and SWD were observed, however, in September, LWD was largely absent from the sample area.

The substrate at Site 1A had shifted from a fines (60%) and gravel (40%) mix in October 2021 (Year 11) to 50% fines, 25% gravel and 25% cobbles mix in July 2022. Over the summer, the proportion of fines decreased to 30% in August, 33% in September, and 10% in October. Gravel and cobble levels fluctuated in proportion to the decrease in fines over the course of the monitoring duration; in August, gravel decreased to 20% and cobbles also decreased to 20%; in September, gravels and cobbles increased to 33%, and in October, gravel decreased slightly to 30% and cobbles increased to 50%. Boulders, which were not observed during the preceding months, comprised 10% of the substrate at Site 1A and Site 1B in October.

The substrate at Site 1B fluctuated in a similar fashion but had a higher proportion of gravel (40%) in July, with 40% fines and 20% cobbles. In August, fines had increased to 50%, which correlates with the downstream movement of fines from Site 1A during this month. Gravels at this location oscillated between 25% and 40%, and cobbles ranged from 20% – 55%. At both sites, D95 ranged from 9 cm to 12 cm. The presence of undercut banks ranged from trace to dominant, and no deep pools were observed. Overhanging vegetation ranged from sub-dominant to dominant, and no instream vegetation was observed at either site. Embeddedness ranged from 20% to 40% throughout the reach during the four monitoring visits. Canopy closure was moderate to good for both sites, averaging 59% and 55% for Site 1A and Site 1B, respectively.

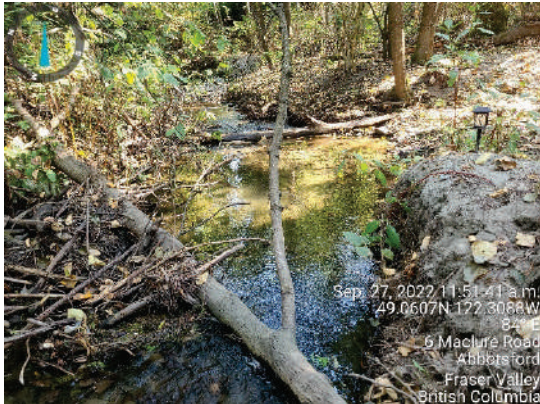
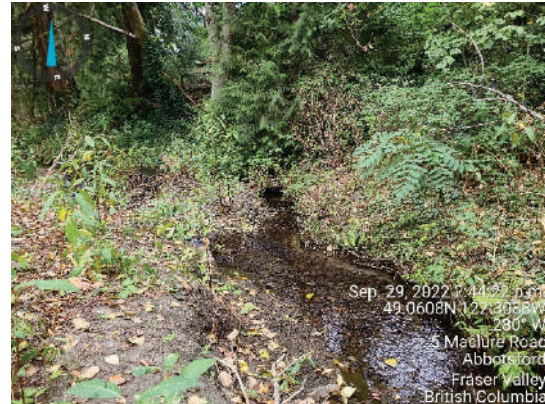
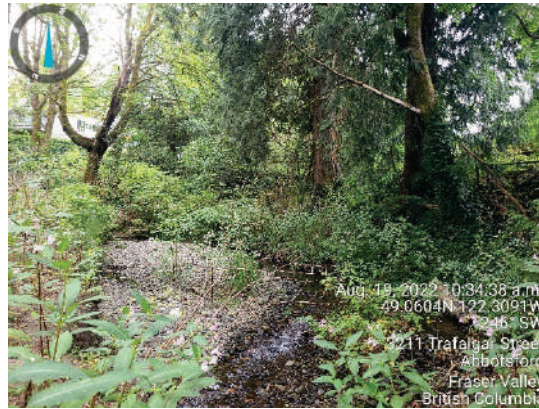
**Photograph 3-2**

**Site 2 (Horn Creek) –September 2022**

**2A Pool—looking downstream)**

**2B Run—looking upstream**

### **2C Riffle—looking upstream**

The substrate at Site 2A was dominated by fines (50%) in July and August, but fines fell to 40% in September and 10% in October. Gravels decreased in tandem with fines and fell from 40% in July to 10% in October. Cobbles were low in July (10%) but increased to 75% in October. Boulders were only observed in October and comprised 10% of the substrate during this month. The embeddedness at this site ranged from 5% to 45%. Deep pools were observed in July at Site 2A and in August at Site 2B but were absent during subsequent months.

The substrate at Site 2C fluctuated in a similar fashion as Site 2A and 2B; fines decreased from 33% to 10% and were absent during the October assessment. Gravels ranged from 23% to 45% in August and September and fell to 10% in October. Cobbles ranged from 43% – 45% from July to September and rose to 80% in October. Boulders were only observed in October, comprising 10% of the substrate.

D95 at this reach ranged from 10 cm to 18 cm. Crown closure ranged from good to excellent across this reach, averaging 60%, 69%, and 70% at sites 2A, 2B, and 2C, respectively. SWD and LWD ranged from trace to dominant across this reach. Overhanging vegetation also ranged from trace to dominant, and instream vegetation was only noted in trace amounts in October at sites 2A and 2B.

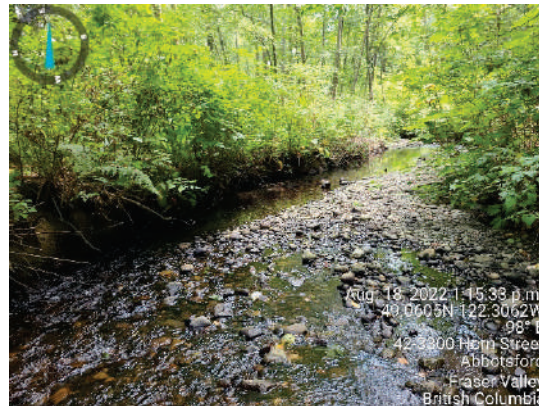
**Photograph 3-3**

**Site 3 (Horn Creek) – August 2022**

**3A Run – looking upstream**

**3B Riffle—looking upstream**

**3C Pool—looking downstream**

Channel morphology at Site 3 was frequently confined with a gradient ranging from 2% to 5%. Sand and gravel side bars were observed during all monitoring events. LWD and SWD were present throughout the reach in trace amounts. Site 3 had good rearing and overwintering habitat values, along with moderate spawning habitat values for salmonids.

The substrate at Site 3A was variable over the 4-month observation period. Fines ranged from 5% to 33%; gravels oscillated from 33% in July to 40% in August, then reduced to 33% in September, and rose again to 40% in October. Cobbles ranged from 33% to 49%, and boulders were present in August (5%), September (20%), and October (10%).

Embeddedness for this reach ranged from 5% to 60%. D95 ranged from 11 cm to 23 cm. Overhanging vegetation cover was excellent, ranging from dominant to subdominant at each observation month. Deep pools were not present at Sites 3A and 3B and were observed at Site 3C with depths ranging from 43 cm to 55 cm. Crown closure was moderate across this reach, averaging 55%, 43.75%, and 32.5% at Sites 3A, 3B, and 3C, respectively. Overhanging vegetation was dominant to subdominant, and instream vegetation was not observed. Undercut banks ranged from nonexistent to subdominant in September at Site 3A. At Site 3B, undercut banks were subdominant in July and October, dominant in September, with only trace indications were observed in August. Undercut banks were more prevalent at Site 3C and were observed during all four assessments.

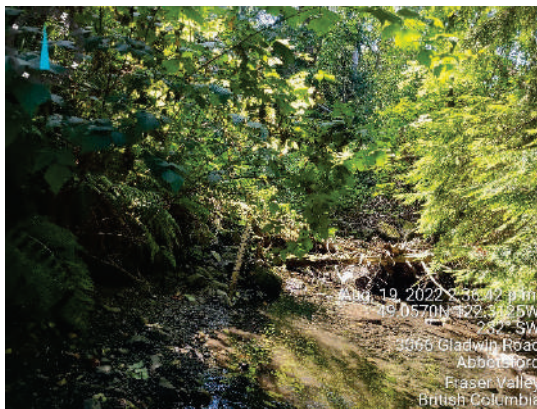
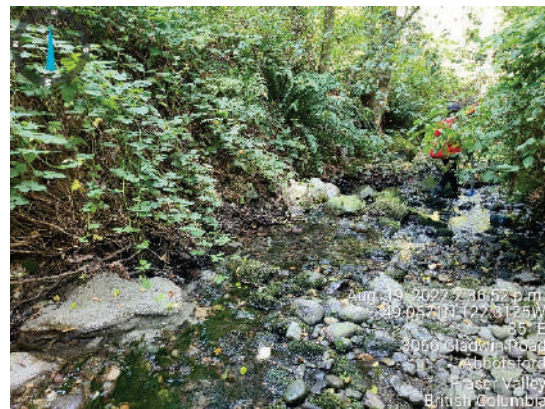
**Photograph 3-4      Site 6 (Horn Creek) – August 2021**

**6A pool looking upstream**

**6B riffle looking downstream**

The channel pattern had shifted significantly from Year 11. In 2021, Site 6 was observed to be straight with a confined channel. In Year 12 (2022), the channel morphology had shifted to meandering at Site 6A and irregular to intermittent at 6B, with a frequently confined channel throughout. The gradient averaged 4.5%, and bars were present on either side of the stream throughout this reach. The gradient was steeper than the 2% observed in Year 11 (2021).

The substrate at Site 6A was variable throughout the four-month observation period. Fines ranged from 20% to 33%, reaching the highest value in August at 33%. Gravel remained largely consistent, ranging from 30% to 33%. Cobble content ranged from 30% to 45%, and boulders were observed at 10% in July and September and at 5% in October. Embeddedness ranged from 3% to 35% with an average of 17.75%. Crown closure at this site averaged 38.75%, and overhanging vegetation ranged from dominant to subdominant at both sites. Trace amounts of instream vegetation were observed throughout the reach in August and October and were subdominant in August at Site 6B. Undercut banks ranged from trace to dominant in October. Deep pools were not observed at either site. Trace amounts of LWD were observed at Site 6A, while SWD ranged from dominant from July to September to negligible in October. D95 at Site 6A ranged from 10 cm to 23 cm, with an average of 18.75 cm.

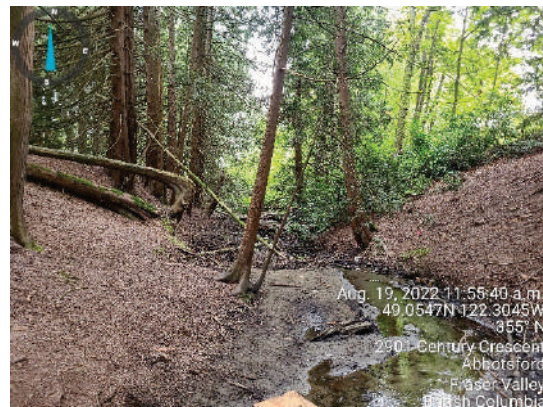
**Photograph 3-5**

**Site 4 (Boa Brook) – August 2022**

**4A looking upstream**

**4B looking downstream**

The channel morphology at Site 4 had shifted from confined and sinuous in 2021 to frequently confined, irregular, and intermittent in 2022 with an average gradient of 2.75%. Bars were present throughout this reach during all observation months, and crown closure remained high with an average of 70% across both sites. Islands were not present, and no instream vegetation was observed. Overhanging vegetation at both sites ranged from trace to non-existent. The substrate for both sites consisted of 100% fines during all observation months, therefore no D95 measurements were taken as no boulders were present.

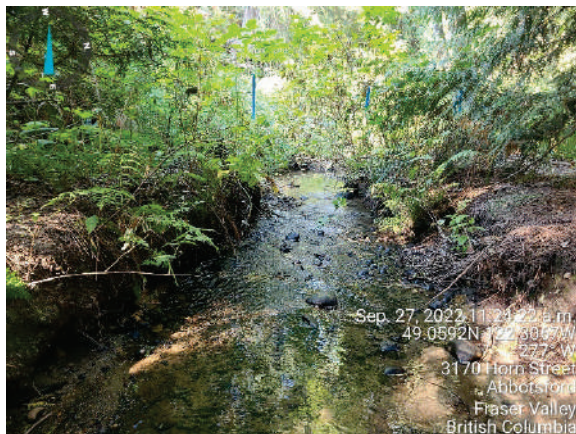
**Photograph 3-6      Site 5 (Boa Brook) – September 2022**

**At 5B, looking downstream to 5C and 5D**

**5A looking upstream**

The channel pattern was variable across this reach; Site 5A had a pattern that ranged from straight to irregular; and Sites 5B, 5C and 5D had a pattern that ranged from meandering to irregular. Channel morphology across the reach ranged from confined to frequently confined by steep ravine slopes. Bars were present at all sites during all observation months, except in September at Site 5A. Islands were not observed at any point along this reach. The gradient ranged from 2%-4%, with an average of 3.5%. Deep pools were not observed at sites 5A through 5C but were noted at 5D in August, September, and October. Undercut banks were evident, ranging from trace to subdominant at Sites 5A, 5B, and 5D, but dominated at Site 5C with one that undermined the west bank by approximately 30 cm. Overhanging vegetation ranged from dominant to trace, and was least dominant at site 5C. No instream vegetation was observed. SWD was present in trace amounts at Sites 5A, 5B, and 5C, but was subdominant to dominant at Site 5D from July through September; LWD was not present at Site 5A or 5B but occurred in trace to subdominant amounts at Sites 5C and 5D.

The substrate at Site 5 was variable. At 5A fines ranged from 5% to 55%, with the lowest percentage observed in September. Gravel ranged from 20% to 60%, and cobbles ranged from 13% to 45%. Boulders were only observed in October, comprising 5% of the substrate. Embeddedness ranged from 2% - 35% with an average of 21.25%. D95 sizes ranged from 14 cm to 26 cm, averaging 18.75%. Crown closure was high at this location, ranging from 65% to 70% in July, August and October, but fell to 20% in September. While this may have been due to the prolonged drought during the growing season, it is not consistent with increased leaf drop that generally begins near the end of September.

The substrate at Site 5D also had a high proportion of fines, ranging from 80% to 90%. In July and August, the remainder of the substrate consisted of 5% gravel, 5% cobbles and 5% boulders. In September, gravel was absent from this site, and the remainder was comprised of 2% cobble and 8% boulders. In October, gravel had increased to 10% and cobble to 5%. Boulders were absent. Embeddedness ranged from 3% to 35%, with an average of 17.75 %. Crown closure ranged from 30% to 45%, averaging 38.75%. Overall, this reach had poor spawning and rearing habitat for salmonids, due to the high percentage of fines that were consistently observed over the four months.

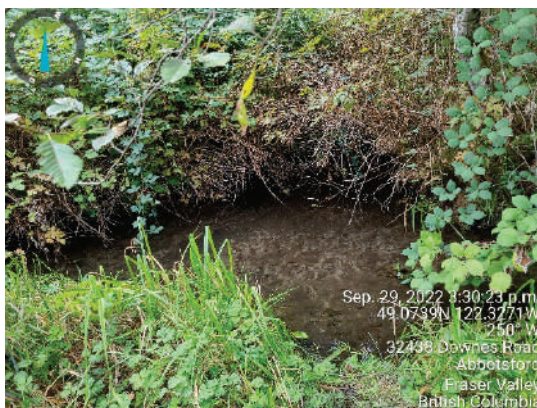
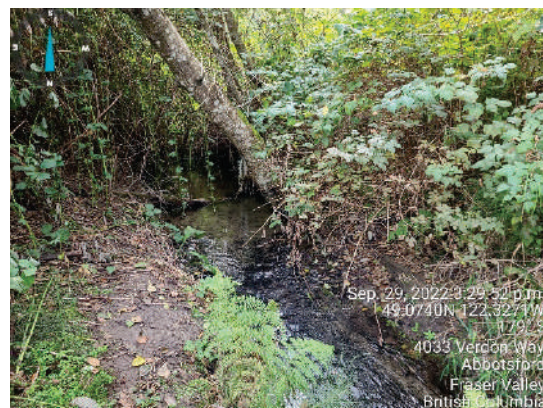
**Photograph 3-7**

**D-02 (Downes Creek) – September 2022**

**Site D-02-Pool Facing Downstream**

**Site D-02-Riffle Facing Upstream**

D-02 is an extremely low gradient (0.6%) stream with a straight and confined channel. The gradient differs from Year 11, when the gradient was reported as 2%. Side bars were noted at D-02 pool in August and at D-02 riffle in August and September but were not observed at any other time. No islands were observed. Instream vegetation was present in trace amounts at both sites, while overhanging vegetation was consistently dominant. No deep pools were observed. Slight undercutting was noted at D-02 pool in August and October and at D-02 riffle in August and September. There was no LWD at either site, while SWD was present at D-02 pool in July, September, and October. SWD ranged from subdominant to trace at D-02 riffle.

The substrate at D-02 pool consisted entirely of fines and is not consistent with suitable salmonid habitat. The substrate at D-02 riffle was more variable, but fines comprised the highest proportion during all four months, ranging from 35% to 95% of the substrate. Proportions of gravel ranged from 5% in July to 45% in September. Cobbles comprised up to 10% of the substrate but were not observed in October. Boulders were not present along this reach. Embeddedness occurred only in September (5%) and October (25%).

Due to the high percentage of fines, this reach does not supply high quality spawning or rearing habitat for salmonids. However, during the October monitoring, two adult salmonids were observed swimming upstream but not passing through the culvert under Downes Road.

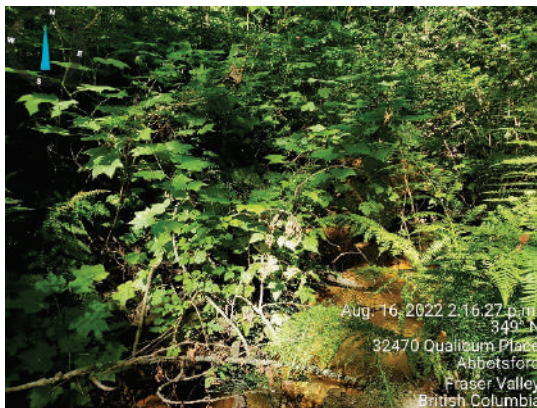
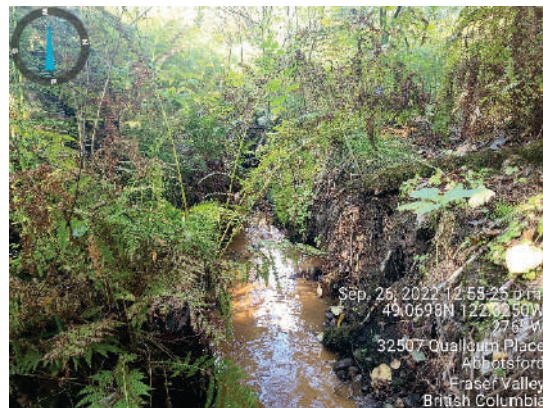
**Photograph 3-8**

**D-03 (Downes Creek) – August and September 2022**

**D-03 Riffle Facing Upstream  
(August 2022)**

**D-03 Pool—looking downstream**

The substrate at the pool mesohabitat was comprised of fines ranging from 20 % to 60% and gravel ranging from 15% to 45%. Cobbles ranged from 10% to 35%, and boulders ranged from 5% to 10%. The substrate at the riffle mesohabitat included fines ranging from 10% to 30% and gravel ranging from 20% to 60%. Cobbles ranged from 15% to 65% and boulders ranged from 5% to 25%. Embeddedness ranged from 5% to 35%, averaging 21.25%. D95 ranged from 7cm to 49cm, with the largest being observed at D-03 riffle in July and August.

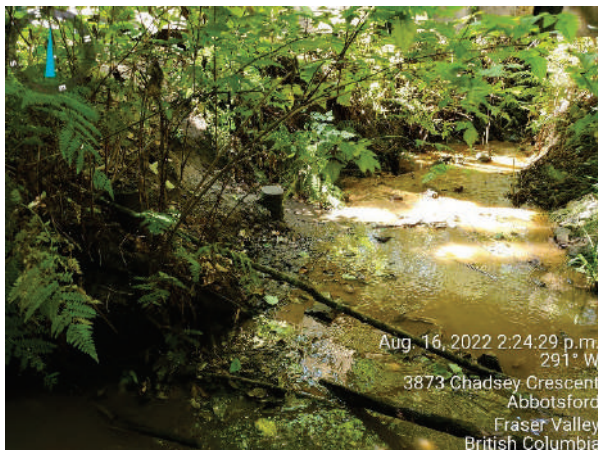
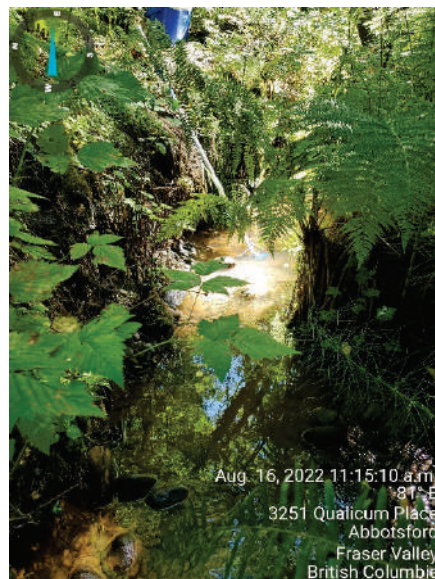
**Photograph 3-9**

**D-04 (Downes Creek) – August 2022**

**D-04 Pool Facing Upstream**

**D-04 Riffle Facing Upstream**

The pool mesohabitat substrate was dominated by fines ranging from 45% to 70%. Gravel ranged from 15% to 35%, and cobbles ranged from 15% to 20%. Boulders were not observed. Embeddedness ranged from 5% to 15%. The riffle mesohabitat substrate had a lower percentage of fines throughout the monitoring period, ranging from 15% to 50%. Cobbles ranged from 10% to 55%, and gravel ranged from 15% to 50%. Boulders comprised 10% to 20% of the substrate. D95 ranged from 7cm to 15 cm, with an average of 11.6 cm.

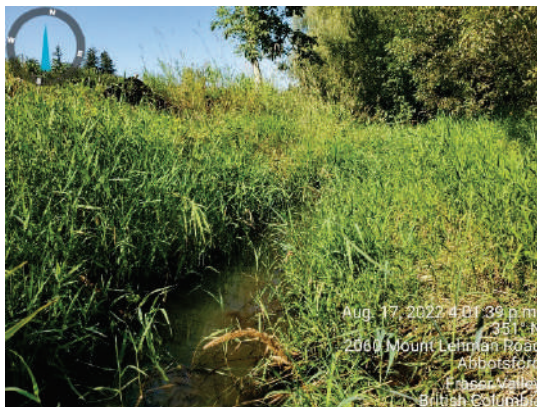
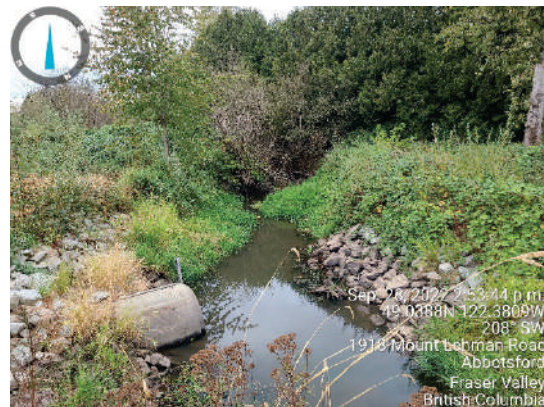
**Photograph 3-11      F-02 (Fishtrap Creek) – August and September 2022**

**F-02 Pool Facing Upstream**

**F-02 Riffle—looking downstream**

The pool mesohabitat was dominated by fines and gravel throughout the four-month assessment period. No cobbles or gravel were present. The substrate composition consisted of 40% fines and 60% gravel in July, 20% fines and 80% gravel in August, 100% fines in September, and 40% fines and 60% gravel in October. Embeddedness ranged from 4% to 30%, except with 0% observed in August. SWD was present in trace amounts in August and October, and LWD was absent from the pool mesohabitat.

Overhanging and instream vegetation at the pool mesohabitat ranged from subdominant to dominant. Crown closure was 5% in July and August, increasing to 30% in September and returning to 5% in October. The increase in crown closure in September was due to a partially fallen cedar bough that was hanging over the site; it had fallen onto an adjacent bank in October. Deep pools dominated in July and October but were non-existent in August and September. During this two-month period water levels dropped by approximately 1.2 m from August to September due to extremely dry conditions. By October water levels had risen substantially, and mesohabitat was assessed 6 m upstream due to the unsafe depth for wading at the monitoring site.

Crown closure ranged from 15% to 100%, with the highest cover observed in August when the entire site was flooded. This apparent increase in cover is somewhat misleading, as the stream occupied a larger area while it was flooded, necessitating that mesohabitat measurements incorporate a wider area. However, it is also likely that canopy cover during August was overestimated. Deep pools were dominant in July, August, and October, and

Based on the observations collected during the four-month period from July to October 2022, this site provides moderate rearing and overwintering habitat and refugia for salmonids in the summer months, due to the presence of deep pools throughout the year and the robust overhanging and instream vegetation. However, due to the lack of cobbles and gravel, this location is rated as poor for spawning habitat.

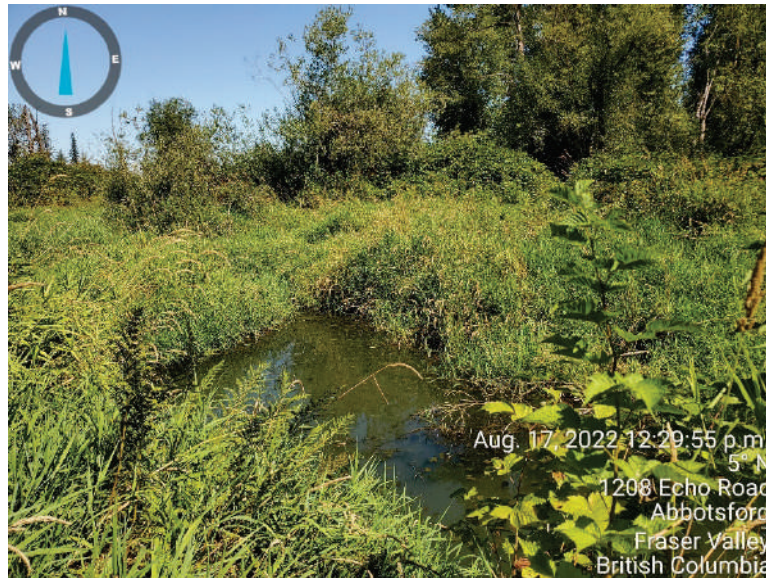
**Photograph 3-12      F-03 (Fishtrap Creek) – August 2022**

**F-03 Pool Facing Downstream**

F-03 lies within an agricultural area and is characterized as a low gradient (<1%), frequently confined, meandering to intermittent channel type. The channel characteristics had changed from 2021, when channel morphology was straight. No bars or islands were present along this section of the stream, and undercut banks were observed only in August (dominant) and September (trace). Substrate was inferred to be dominated by fines (100%) in July, August, and October, as the water depth was unsafe for a thorough assessment; however, water was clear in July and August, and the substrate was visible. In October, the water was too turbid for a proper substrate assessment. In September, fines had reduced to 45%, gravel occupied 45% of the substrate, and boulders made up the remaining 10%.

No overhanging vegetation was evident at this site, except for trace amounts observed in September. Crown closure was non-existent. Instream vegetation dominated throughout the observation period. SWD occurred in trace amounts, and LWD was absent except for trace amounts observed in August. Deep pools dominated throughout the observation period and would provide substantial refugia for salmonids and other aquatic species.

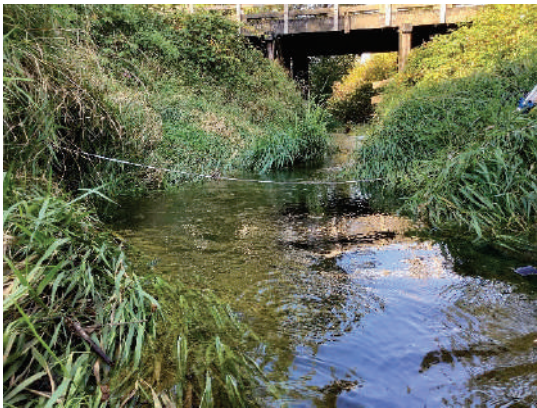
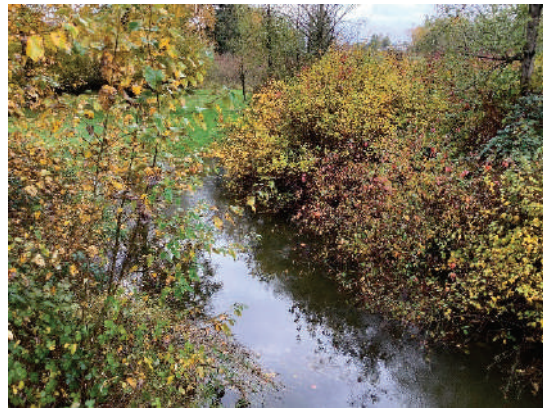
**Photograph 3-13**

**F-04 (Fishtrap Creek) –September and October 2022**

**F-04 Riffle—facing upstream**

**F-04 Pool—facing upstream**

Substrate at the pool mesohabitat consisted of a mix of fines and gravel, with no cobbles or boulders present. Fines ranged from 40% to 80%, with the lowest observed in September. Gravel ranged from 20% to 60%, with the highest being observed in

September. SWD dominated at the pool habitat, while LWD varied from trace amounts in July and August to dominant in October but was absent in September. Slightly undercut banks were observed in August and October, and deep pools dominated from August to October. Embeddedness was low at the pool site, ranging from 0% to 5% throughout the observation period. The highest embeddedness occurred in September when gravel made up a larger proportion of the substrate.

Substrate at the riffle mesohabitat remained largely consistent, comprised of a relatively even mix of fines (40% to 50%) and gravel (50% to 60%) throughout the observation period. The average embeddedness was 12.5%, with 20% observed in July and 5% observed in October. Crown closure was 0%, with trace to subdominant amounts of overhanging vegetation. Instream vegetation largely consisted of reed canary grass (*Phalaris arundinacea*), which was dominant from July to September but had died by October. D95 size ranged from 3.5 cm to 5 cm from July to September, excluding October.
